BRIEF DESCRIPTION ABOUT A SERIOUS BUS ROLLOVER ACCIDENT
(Presented by Hungary)

Date: 1. July, 2002 early morning hours, gloom

The scene of the accident: close to Balatonszentgyörgy, Hungary, main road No.7. a roundabout

The coach: 3 years old HD coach. License number: LB 02930. Berkhof "Excellence 3000" body on DAF chassis, type DE 33WS. Max total mass 18600 kg

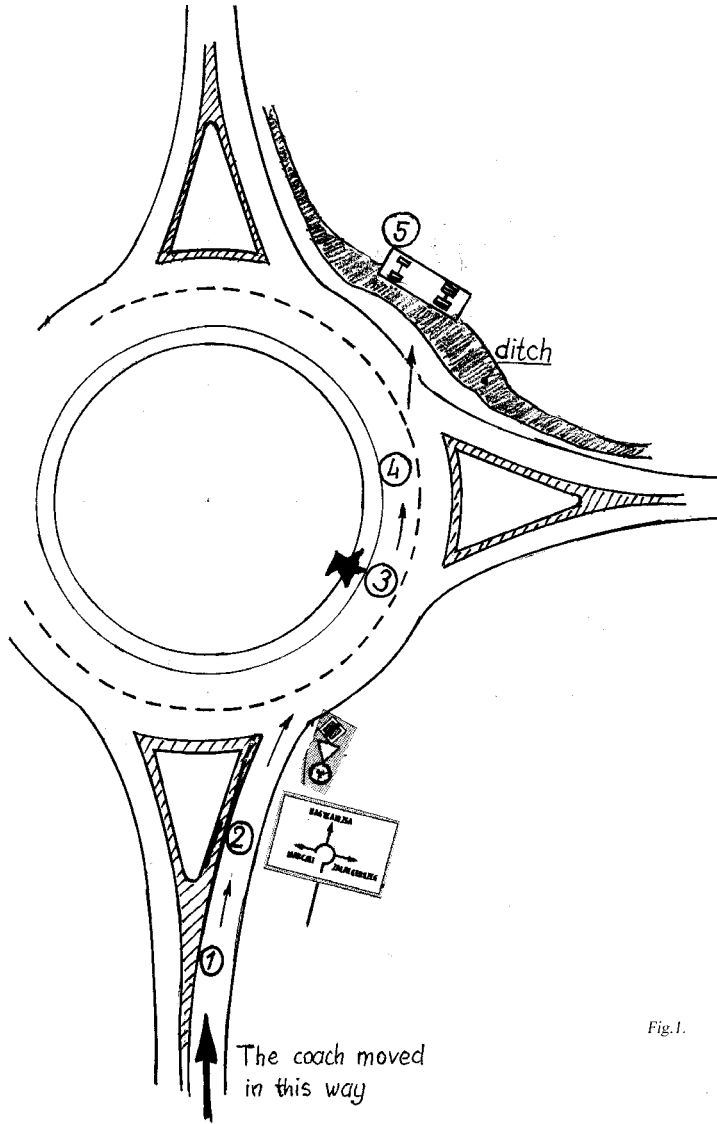
Fig.1.

Brief description of the accident (See Fig.1.): The coach speed was 84 km/h when closing the roundabout (1) The driver did not realise the situation, his reaction and the braking was too late. In the approaching section of the roundabout (2) the bus was drifting and was not able to perform the right hand curve. The front left wheel hit (speed around 70 km/h) the 10 cm high central curbstone of the roundabout (3) which produced an unexpected sudden steering on the right for the driver. The driver made a sudden left hand correction, the bus turned on its right side (service door side) (4) The speed of the coach in this moment was 40-50 km/h. On its side the coach slipped away (20-25 m) until a ditch on the outer side of the roundabout (5) The cantrail of the bus was hit by the other side of the ditch, the superstructure collapsed and finally the bus stopped on its roof. See Fig.2. The speed values are given by the police.

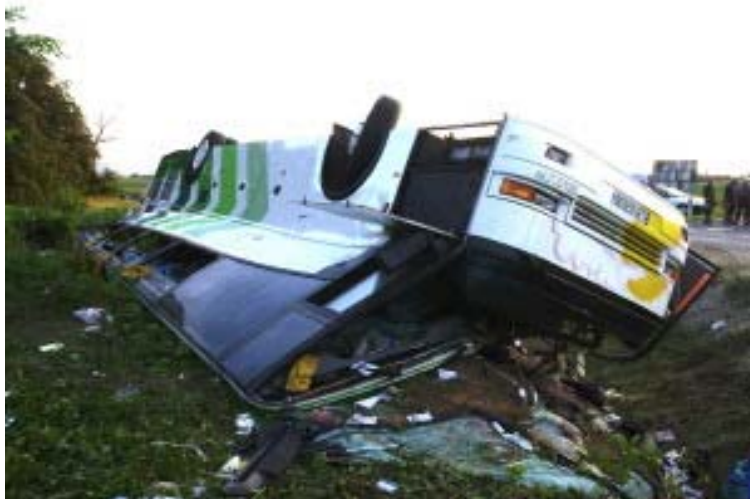
Fig.2. (in the main text) and Figure A4. show the deformation of the superstructure, the location of the plastic hinges (PH) Figure A5. shows the difference between the deformation of the front and rear part of the coach. The difference is due to the different height of the rigid part in the front and rear wall. (Their side wall supporting effect is different) The front rings collapsed with a 4 PH-s mechanism, but the rear rings had the same result with 6 PH-s.

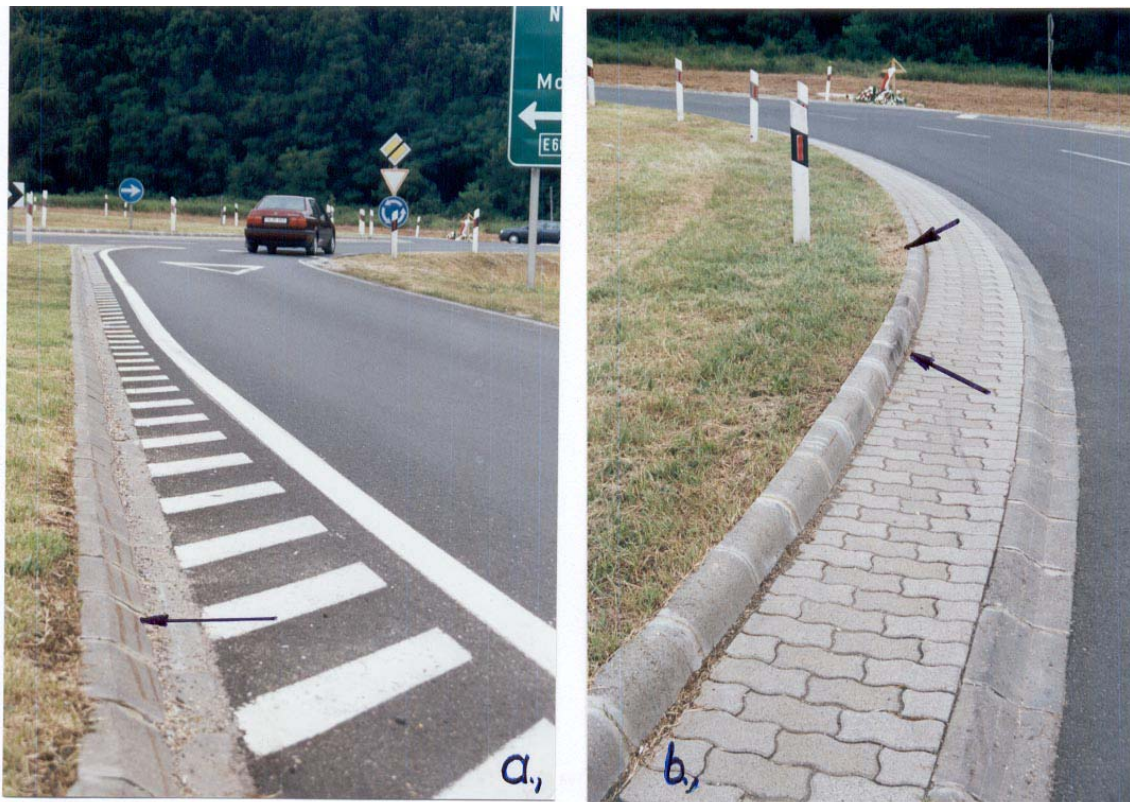
Figure A1.gives some details of the roundabout. A bus is just entering in a normal way into the roundabout. Figure A2. shows the curb stones with the traces of the bus. The ditch can be seen on Figure A3.

- a) the curb stone of the approaching way with the trace of the bus wheel , when the bus was drifting.
- b) the curb stone of the central circle of the roundabout with the trace of the left front wheel when getting the sudden, unexpected steering force.

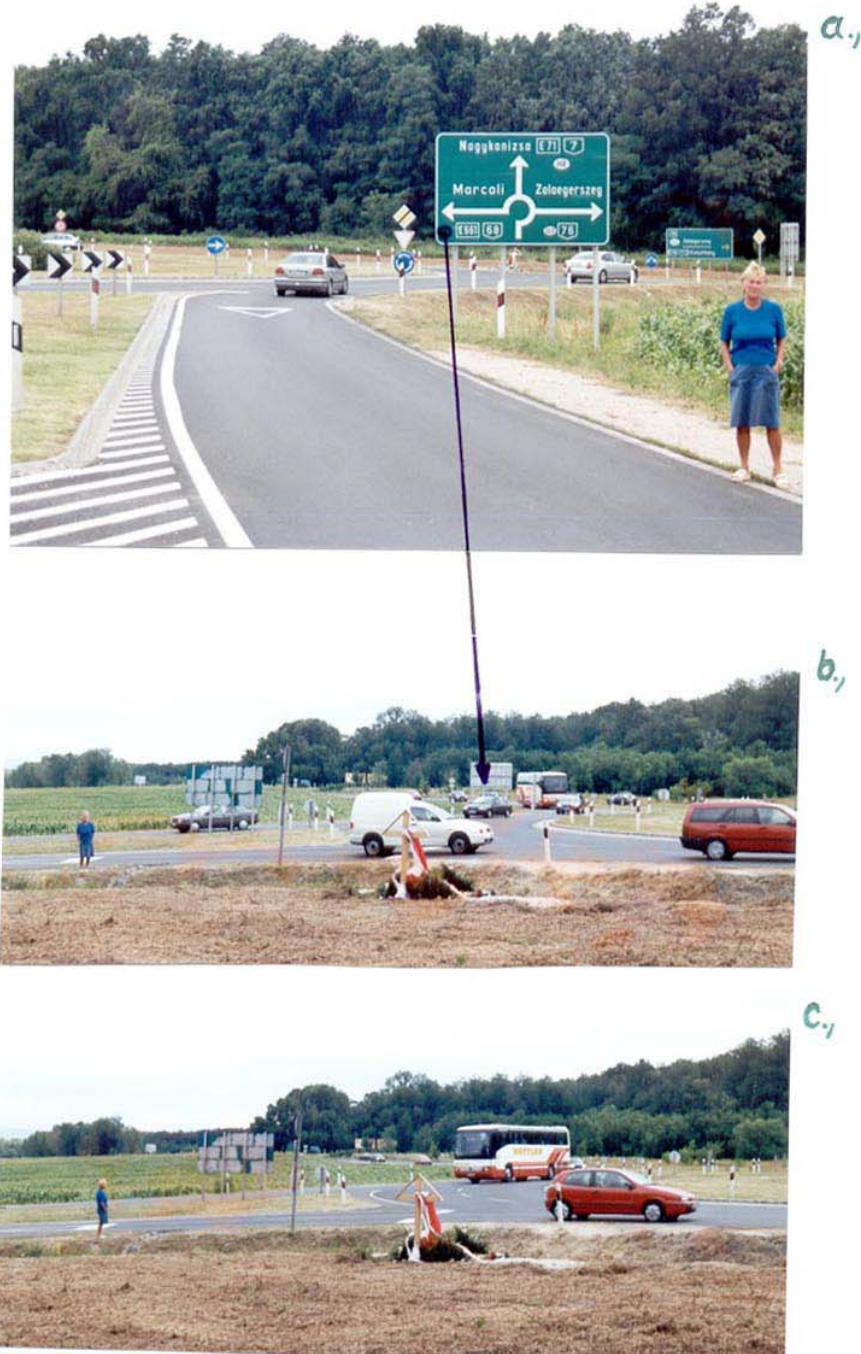
Figure A1.

- the approaching of the roundabout with the traffic signs
- the other side of the roundabout with the ditch, where Polish bus stopped on its roof. A bus is in the approaching way, entering into the roundabout.
- the bus is in the roundabout.

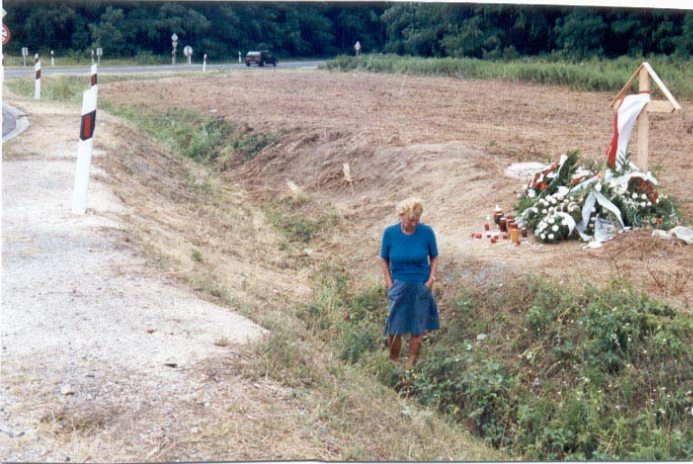
Figure A3.
The ditch where the bus landed.
Considerable soil deformation can
be observed.

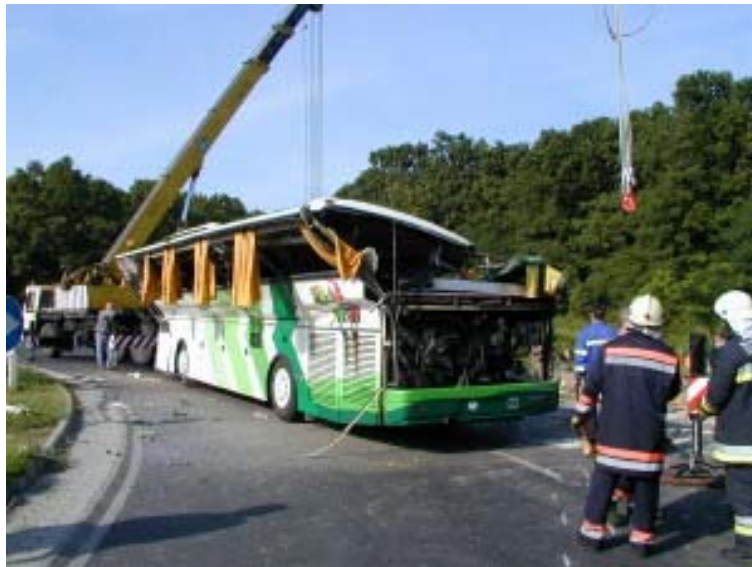
Figure A4

Rigid parts and elements: the whole underfloor structure, the whole roof structure, the front and rear walls under the glazing, window and door pillars between the PH-s.

Plastic hinge locations on both sides:

in the front part: at the floor level and at the roof (4 PH-s deformation model)

in the rear part: at the floor level, at the waistrail and at the roof (6 PH-s deformation model)

Plastic zone locations: on the side walls at the floor level

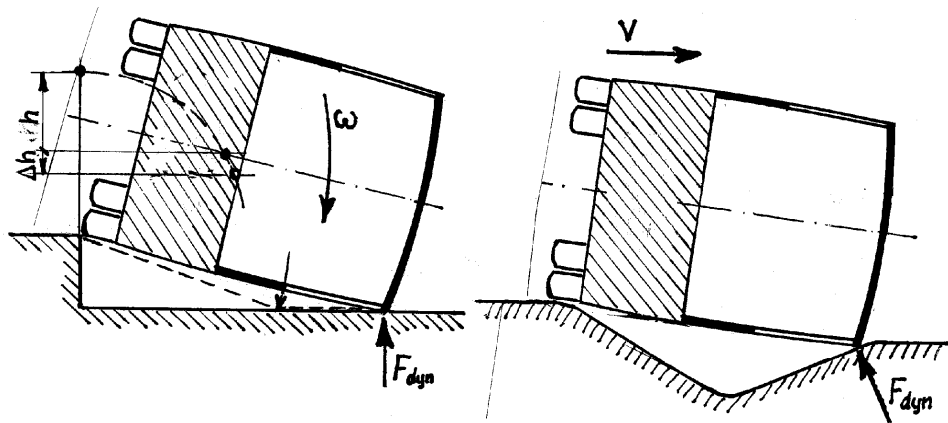
Figure A6

At the first glance this accident is a rather different one, but analysing it, the similarity to the standard rollover test is obvious. Figure A6. shows the direction of the dynamic impact forces. The energy input in both cases may be estimated, but it shall be emphasised that these estimations are very rough, first approximations only, because a lot of data are missing, they were estimated (e.g. height of the coach's CG, the friction coefficient between the road and the bus, the energy absorbed by the soil at the impact, etc.)

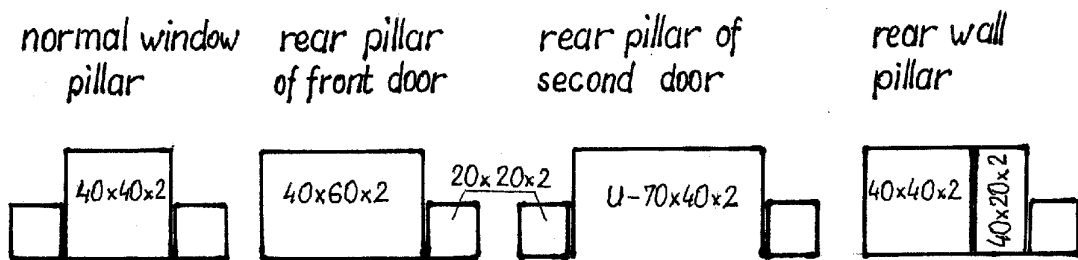
Figure A7

On both side there are 6 window pillars (the frame of the windscreen is not included) which are side wall pillars, too. No special reinforced pillars (rings) in the front or rear. The cross sections of the pillars are shown on Figure A7. (the values were measured on the structure) The waistrail is a quadratic profile 40x40 mm, the grids have a profile of 40x20 mm. The seats are connected to the side walls (height 250 mm) but they could not provide considerable support, the seat frames, legs were broken almost everywhere.
