Detailed technical analysis of a severe bus rollover accident

The accident happened on 17. 04. 2005 in the morning hours (9⁴⁵) at the Grand St. Bernard Pass with a tourist coach (operator: a Swiss company MARTI) driving from Switzerland to Italy. The information about the accident was collected from the media listed below. The accident was a typical, severe rollover accident.

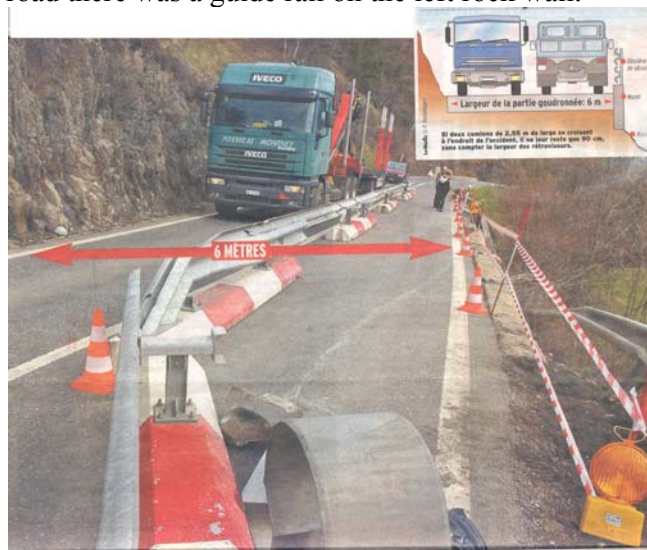
Fig.2. Narrow mountain road

The road was a serpentine mountain road with a wet, but not a slippery surface. Fig.1. shows the map of the event. The total width of the road was 6 m (see Fig.2.) The bus drove upwards the hill and the accident happened after a left curve. From these two reasons the speed of the bus could not be too high. On the right side of the road there was a guide rail on the left rock wall.

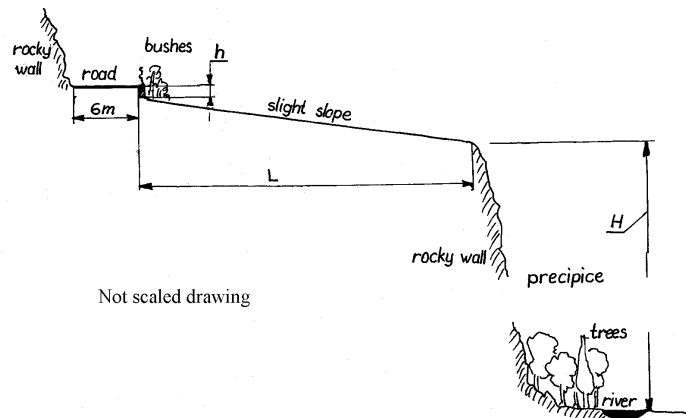
Fig.3. The path of the rollover process

The scene of the accident was reconstructed from the photos given by the newspapers. Fig.3. shows the cross section of the road and the path of the rollover process. The different estimations in the media were $H \approx 100-200$ m, $L \approx 50-60$ m and $h \approx 0,6-1,6$ m changing alongside the road where the bus was rolling down. Next to the road, at the beginning of the slight slope there were bushes, small young trees, but the whole slope was grassy ground covered by thin snow (see Fig.4.) Down, at the bottom of the precipice a small river flows in a forest. Fig.5. gives an impression about this place and the rocky wall of the precipice.

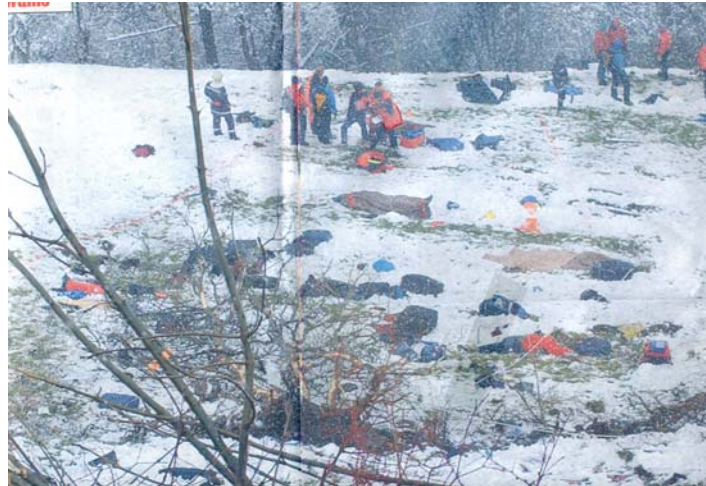
Fig.4. View of the 50-60 m long slight slope

- In the first period of the rollover (rolling down on the slight slope) many passengers (14) were ejected. Some newspaper reported that only those passengers survived who were ejected. But on the photos (see Fig.4. and Fig.7.) 1 or 2 dead bodies may be recognized covered by shroud.
- 13 persons remained in the bus when it started to roll down into the precipice, that was reported
- Finally 5 dead passengers were found in the bus and one survival close to the bus, but being ejected.
- One report mentioned that among the ejected passengers 6 were dead.

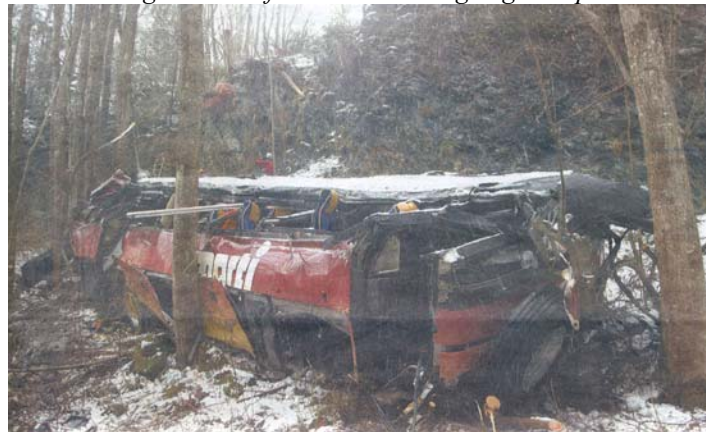
Fig.5. Down in the precipice (front wall view)

The rollover process started after the left curve where the road was already straight. The bus broke out the safety guide rail (its height and strength cannot hold back a bus) but the reason of that is not known and probably never will be known because both of the two drivers died. The bus rolled down to the slight slope and it had more rotations. It was a normal, regular lateral rollover as the path of this motion may be seen on Fig.4. The newspapers mentioned 6 or more rotations. If the superstructure of the bus did not collapse at the first impact, then – coming from the contour of the bus – the number of the rotations could be 4-5. If the superstructure collapsed, the number of the rotations could be 6-7. From Fig.4. – by a prudent estimation – 6 rotations may be rendered. After that the bus rolled into the precipice and its motion was not a regular lateral rotation anymore. This is proved by the seriously damaged front wall (Fig.5.) and rear wall (Fig.6.) Finally the bus stopped on its wheels, held this position by a tree.

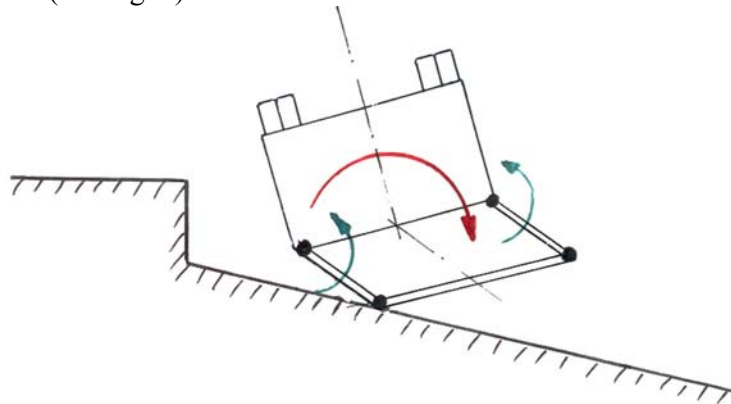
Fig.8. Deformation at the first impact

Possible injury mechanism It will be never known how the accident really happened. The following is an estimation. If no one on the board used the safety belt, (there was no report about that) at the first impact, when the door side can trail hit the ground, the side windows (as well as the windscreen and the rear window) were broken and the large-scale distortion of the superstructure started (see Fig.8.)

The bus was rolling down around the cantrail as axis of rotation and the superstructure (the window columns) was "rotated" around the waistrail as axis related to the rigid "lower part" of the bus. That means: the passengers and crew, sitting on the door side (14 persons as it was said above) could be ejected, because there was no roof anymore "above" them. The people sitting on the left side were closed and maybe pressed by the "down coming" roof. Their position became worse and worse with every rotation on the slight slope. 13 persons remained in the bus when it started to roll down into the precipice, most of them were probable dead. Falling down the bus could have different contacts with the rocky wall and not only on its superficies but may be on its front and rear walls and these different impacts could eject further bodies. One person survived this whole process, this is a miracle.

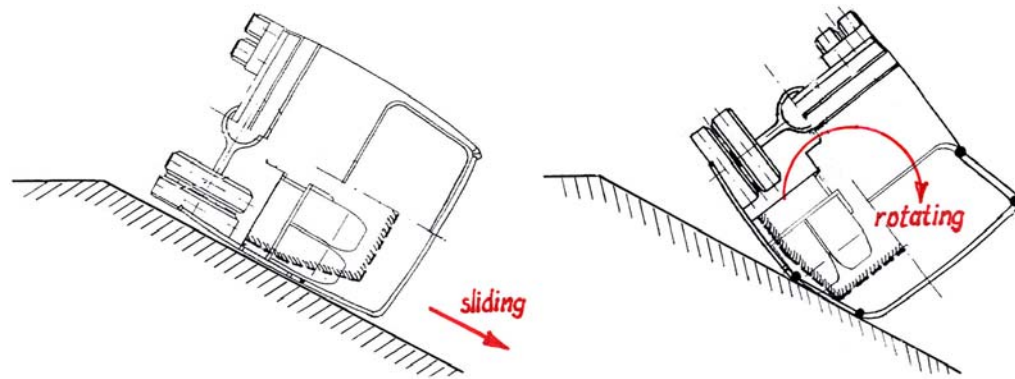
Fig.9. Slight slope situation

2. Analysing the situation, four combinations may be considered: strong or weak superstructure rolling down on slight or steep slope.
3. On a slight slope the two possible situations are shown on Fig.9. If the superstructure collapses the bus becomes a "semi-cylindrical body" and continues the rotation. If the superstructure is strong enough and it does not have considerable distortion, the bus is slipping on a certain distance and stops.

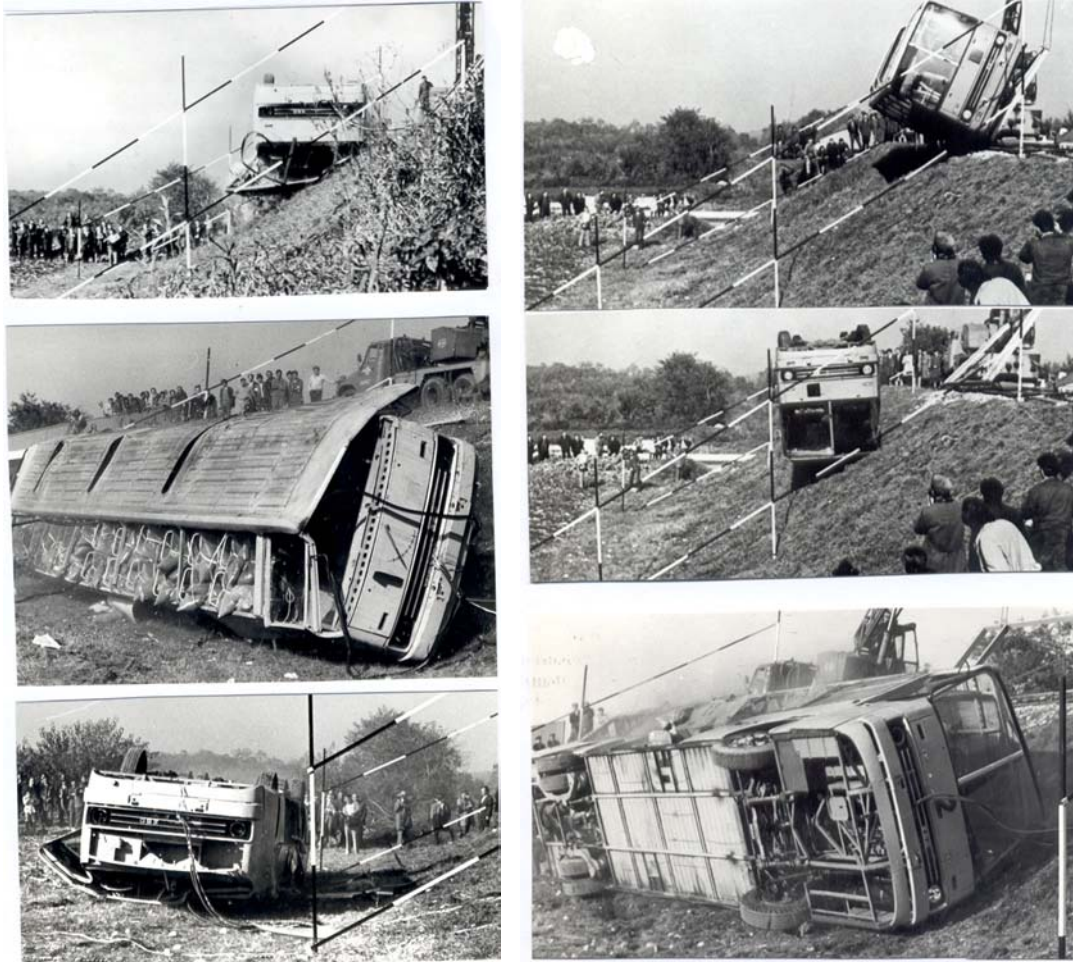
Fig.10. Weak superstructure on steeper slope

4. On a steeper slope the situation could be different but the result similar. In the mid of the '70-s 4 rollover tests were made on a standard 6:4 slope ($\approx 33,5^\circ$) in Hungary. Fig.10 shows the rollover process with a weak superstructure (type IKARUS 250 original design) The superstructure collapsed at the first impact and the bus – as a "semi-cylindrical body" rolled down and stopped at the end of the slope on its roof ($1\frac{1}{2}$ rotation) Fig.11. shows the same rollover test with the same bus type but having a reinforced superstructure. At the first impact the superstructure did not collapse, the bus continued the rotation (the cantrail served as the axis of the rotation) When the other side cantrail contacted the ground – again no considerable deformations – it became the new axis of the rotation and finally the bus stopped on its right side ($1\frac{1}{4}$ rotation)

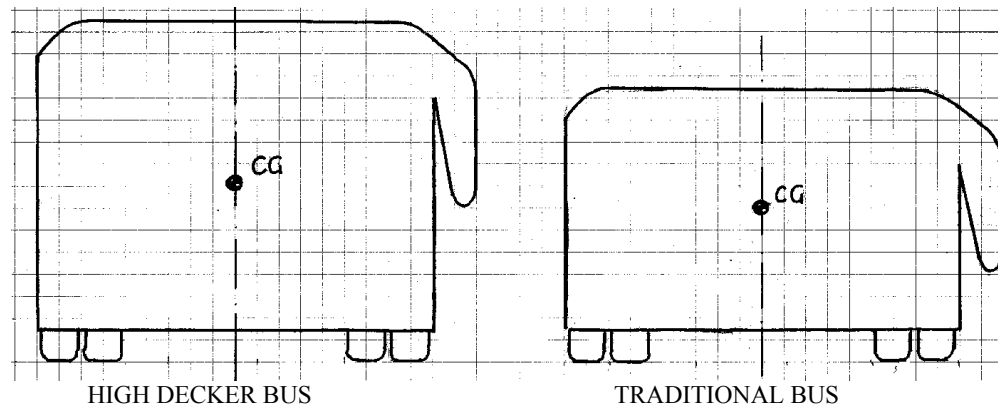
Fig.12. Shape of "semi-cylindrical bodies"

5. It is interesting to mention an essential difference between the traditional and HD buses in this respect. This difference is between the shape, contour of their "semi-cylindrical body" (rigid body) when their superstructure collapsed (see Fig.12.)

a) In the case of HD buses this contour is almost a square with a side ratio $\approx 2,5:2,3$ which makes easier the continues rotation.

b) In the case of traditional buses this is an oblong with a side ratio $\approx 2,5:1,6$ This makes more difficult the continues rotation
