Observation of different windscreen glass fracture modes

during headform impactor tests

OICA

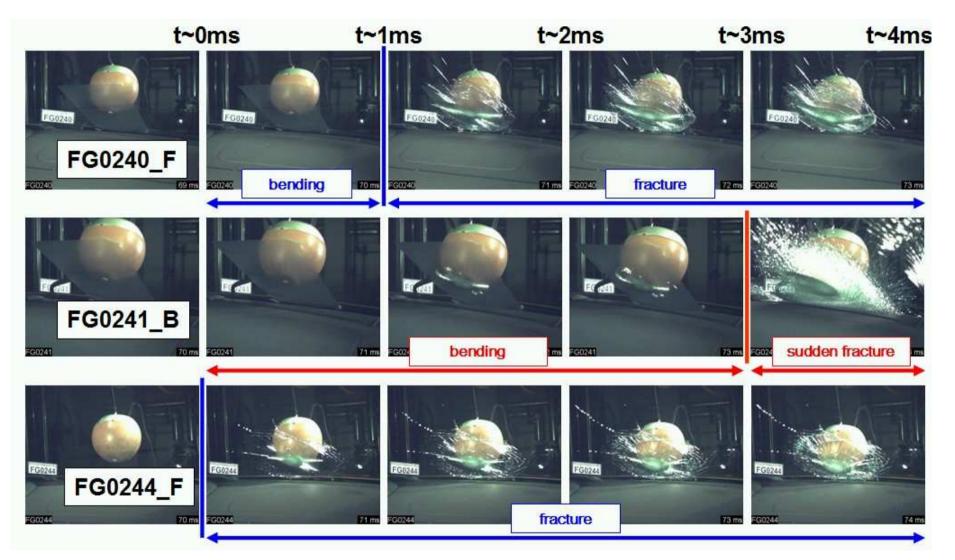
Impact angle = 65°

Observation of two different fracture modes:

- 1. Fracture begins after contact of impactor on windscreen short bending phase
- 2. Sudden fracture occurs after a longer bending phase

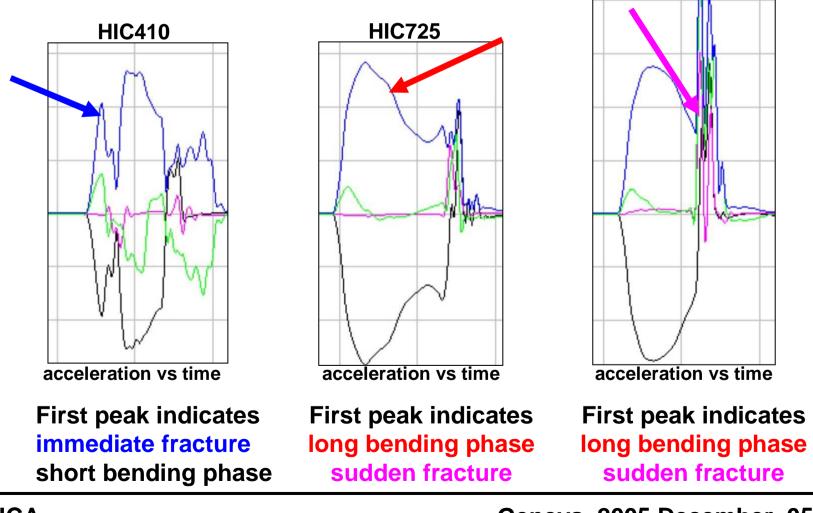
Reference to INF GR PS 134: "Head impact tests in the centre of the windscreen" Three identical tests with different first peaks and big scatter of HIC (EU Phase 1, 4.8kg impactor, 35km/h, 35°) HIC1084
