Informal presentation on the protection of steering gear attached to the chassis frame and a associated parts on heavy truck in connection with road accidents.

ENGLISH SUMMARY

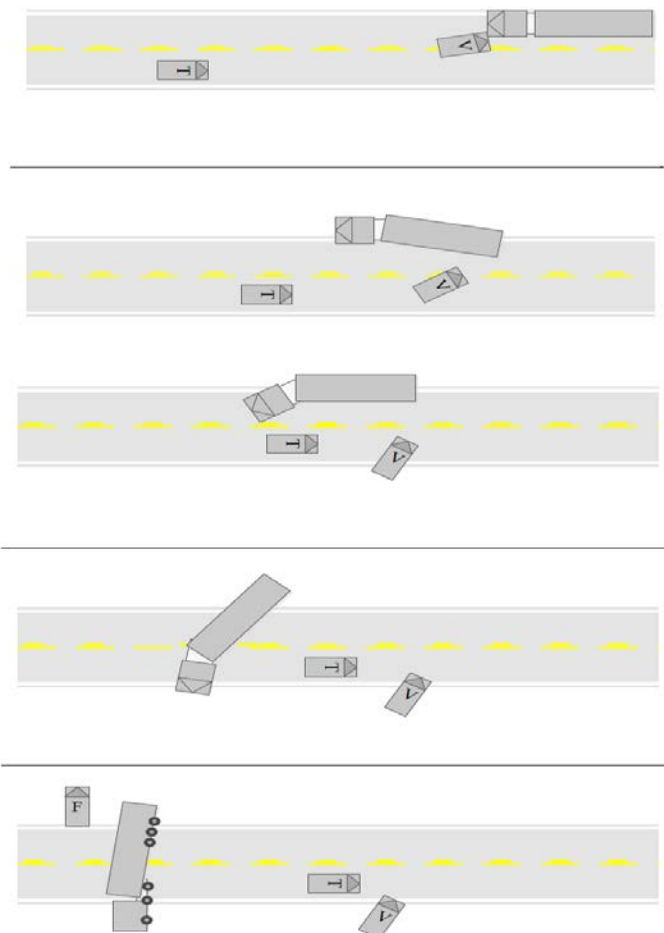
Fig 1. The accident occurs

Location of accident vehicle, as gasoline and diesel take on fire

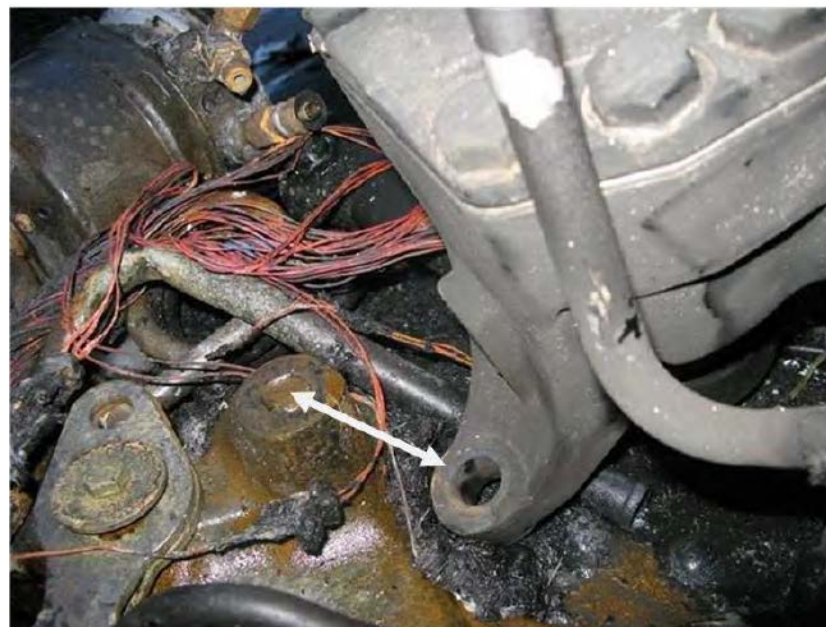
The van got into the lane for north-bound traffic and collided front to front with the tanker. As a result of the impact, the steering worm on the tanker broke loose from the frame, and the driver of the tanker was unable to steer. The tanker went off the road on its side of the road, but quickly returned to the road before overturning to the right and lying on its side, blocking the road. The tanker rapidly caught fire.

Figur 2: Viser at styresnekken har løsnet fra sine opprinnelige festepunkter i rammen. Foto: Statens vegvesen
