TMF management and accidents in the UNECE region, including in a transboundary context

Pavel Danihelka

TAILINGS 2018, Astana

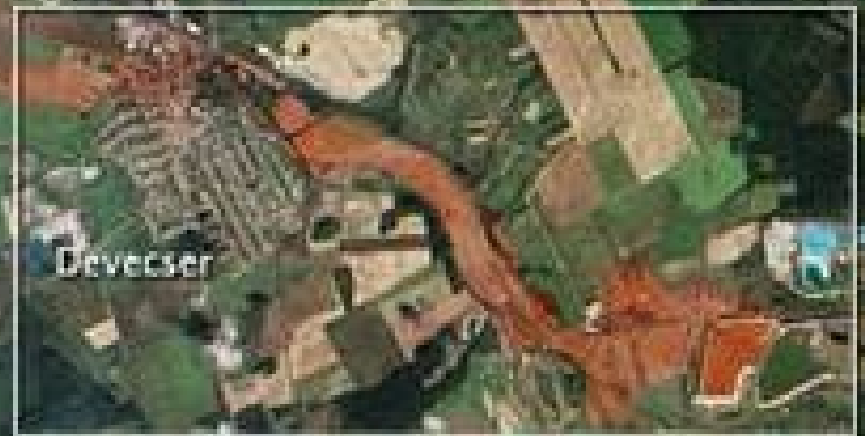
Kolontár (Ajka), Hungary

after

6 October 2010

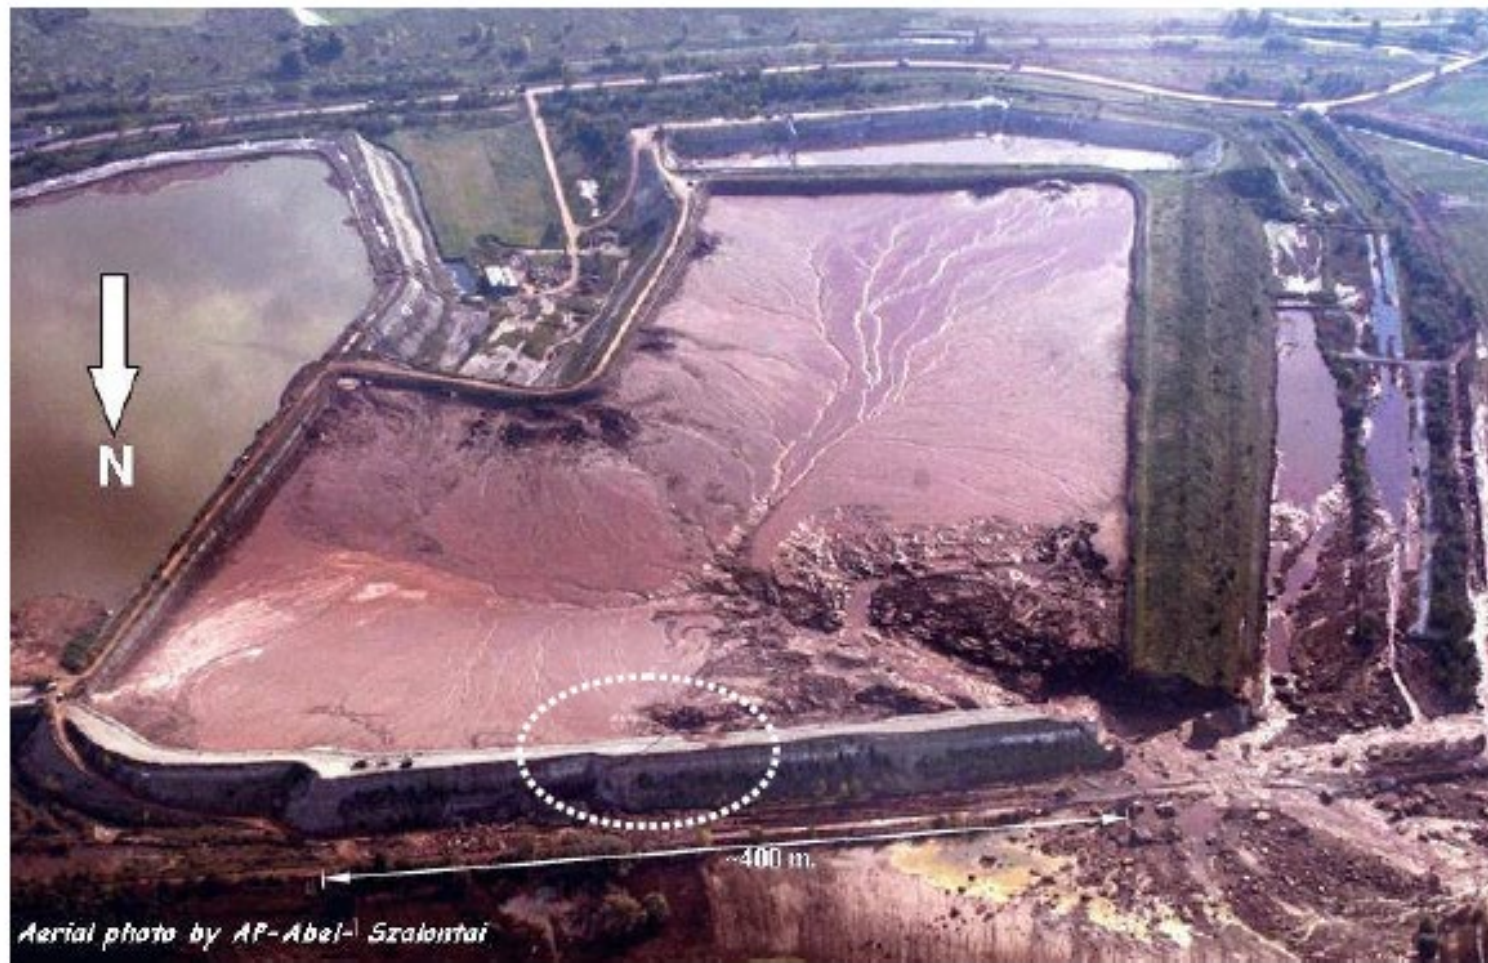
Post-Failure Aerial View of the Ajka Tailings Pond (Oct. 2010)

Apparently,
about 10% of the tailings solids were washed-out by scouring effect of the run-away water.

Please note the "vortex in the tailings" and the "diagonal fracture" on the North Dike
(for their relevance in the triggering mechanism of the failure).

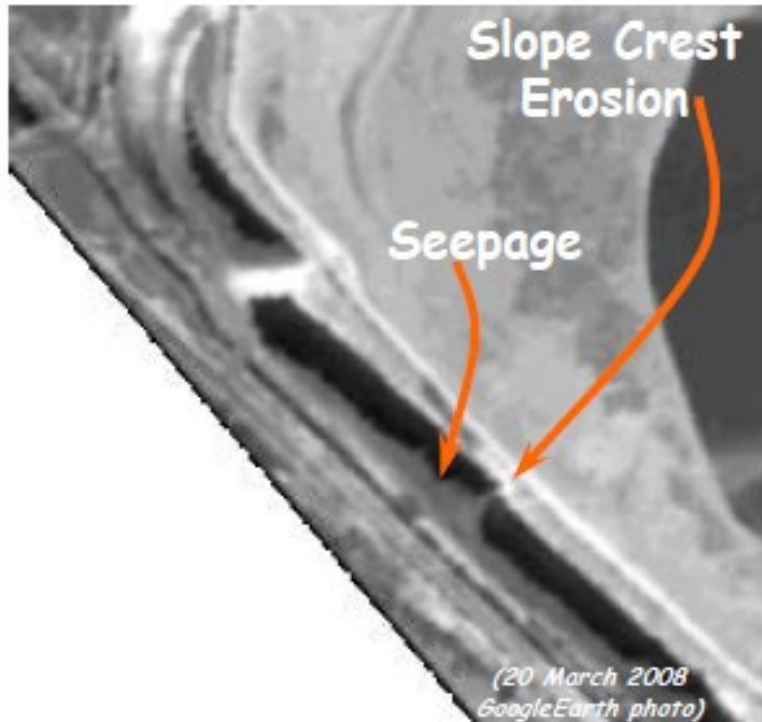
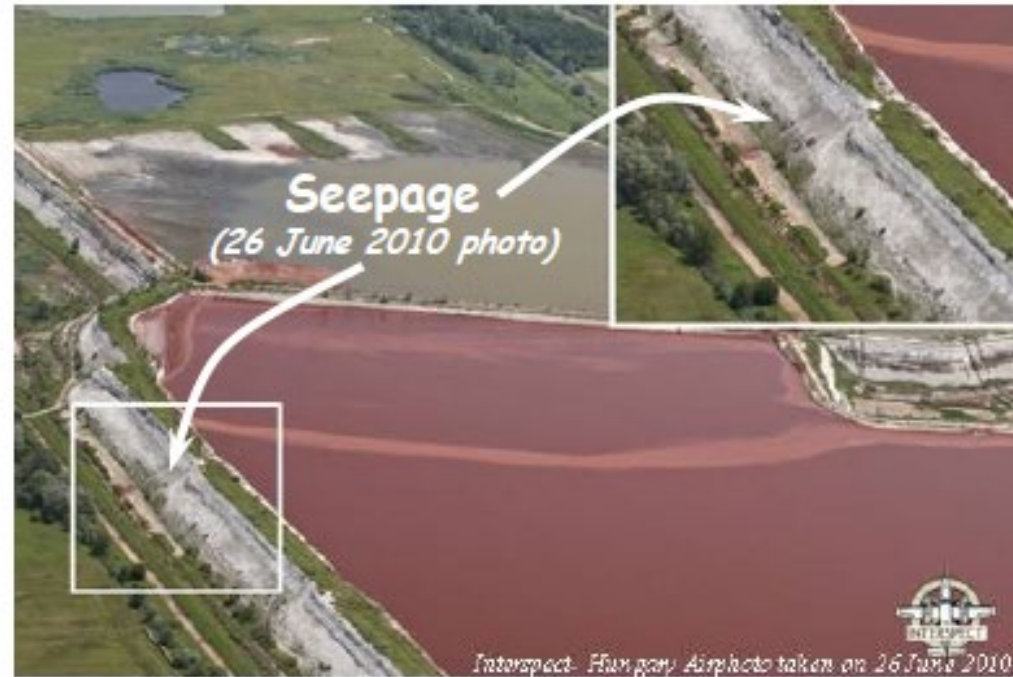
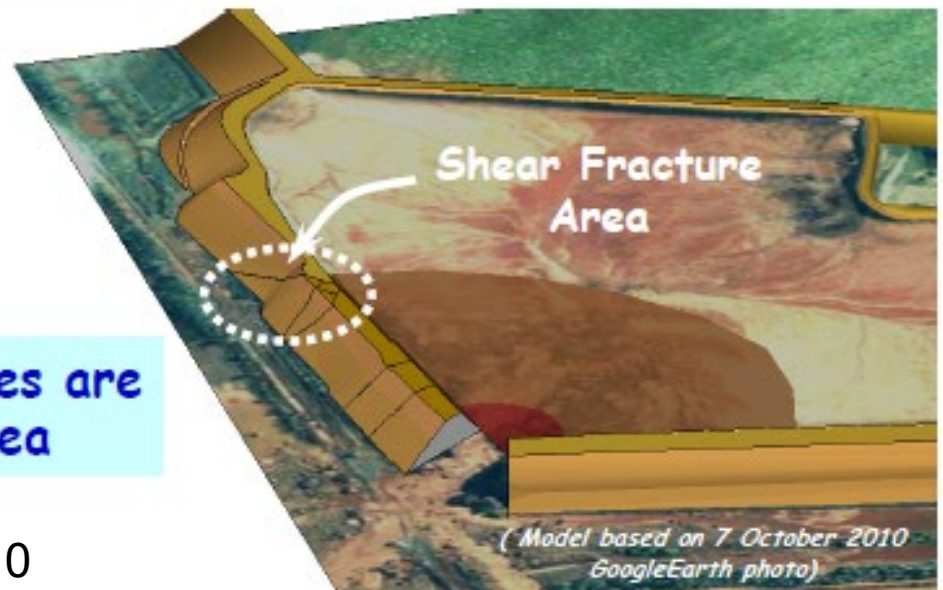
EARLY WARNING SIGNS OF THE FAILURE

Post-Failure Shear Fractures are
Located at the Seepage Area

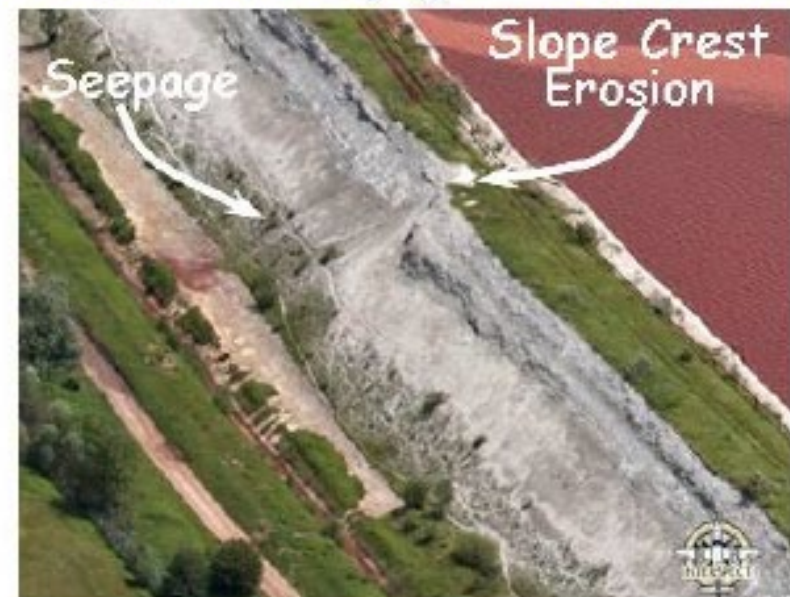
Pre-failure Seepage and Crest Erosion Marks on the North Dike of AJKA Pond

(26 June 2010)

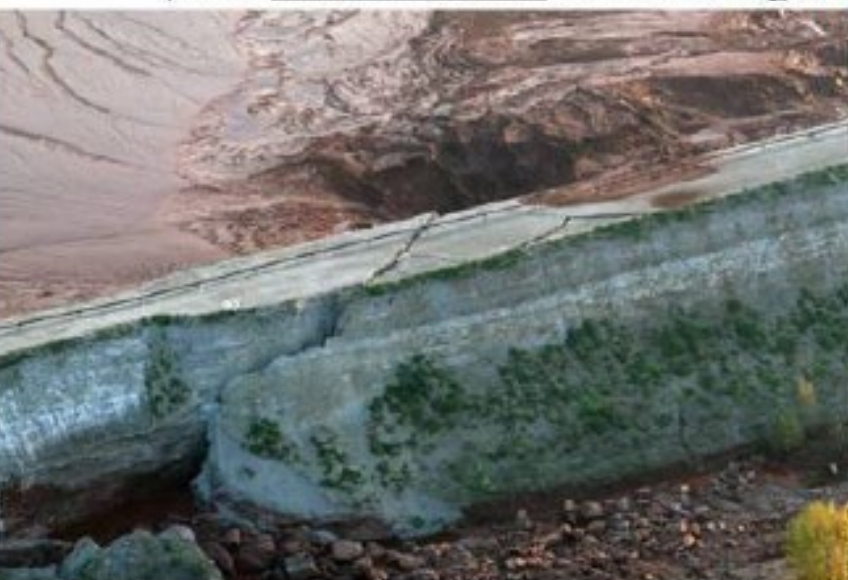
Post-failure Shear Fractures on the North Dike

(Note the vortex cone in the tailings revealing discharge through the shear fracture)

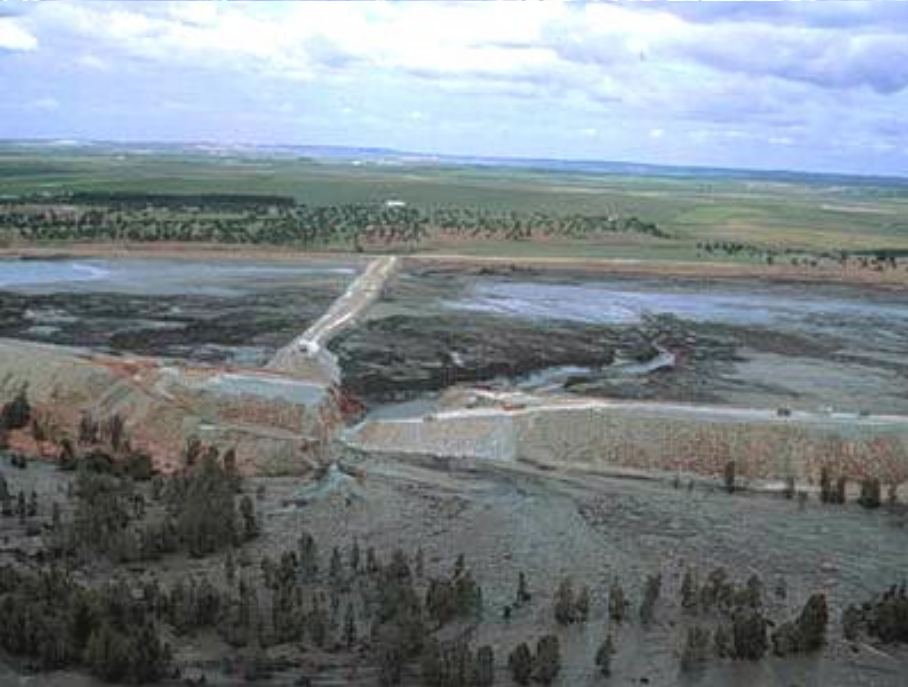
Case study: LOS FRAILES

April 25, 1998

tailings dam failure of the Los Frailes lead-zinc mine at Aznalcóllar near Seville, Spain,

released 4-5 million cubic meters of toxic tailings slurries and liquid into nearby Río Agrio, a tributary to Río Guadiamar.

The slurry wave covered several thousand hectares of farmland, and it threatens the Doñana National Park, a UN World Heritage Area.

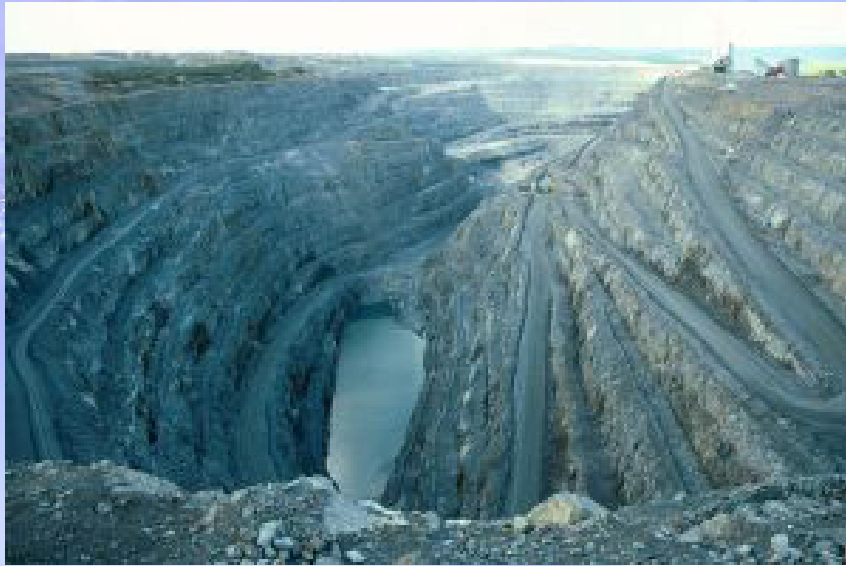
AITIK

On September 8, 2000, the tailings dam of Boliden's Aitik copper mine near Gällivare in northern Sweden failed over a length of 120 meters. This resulted in the spill of 2.5 million cubic meters of liquid into an adjacent settling pond. Boliden subsequently released 1.5 million cubic meters of water from the settling pond into the environment to secure the stability of the settling pond.

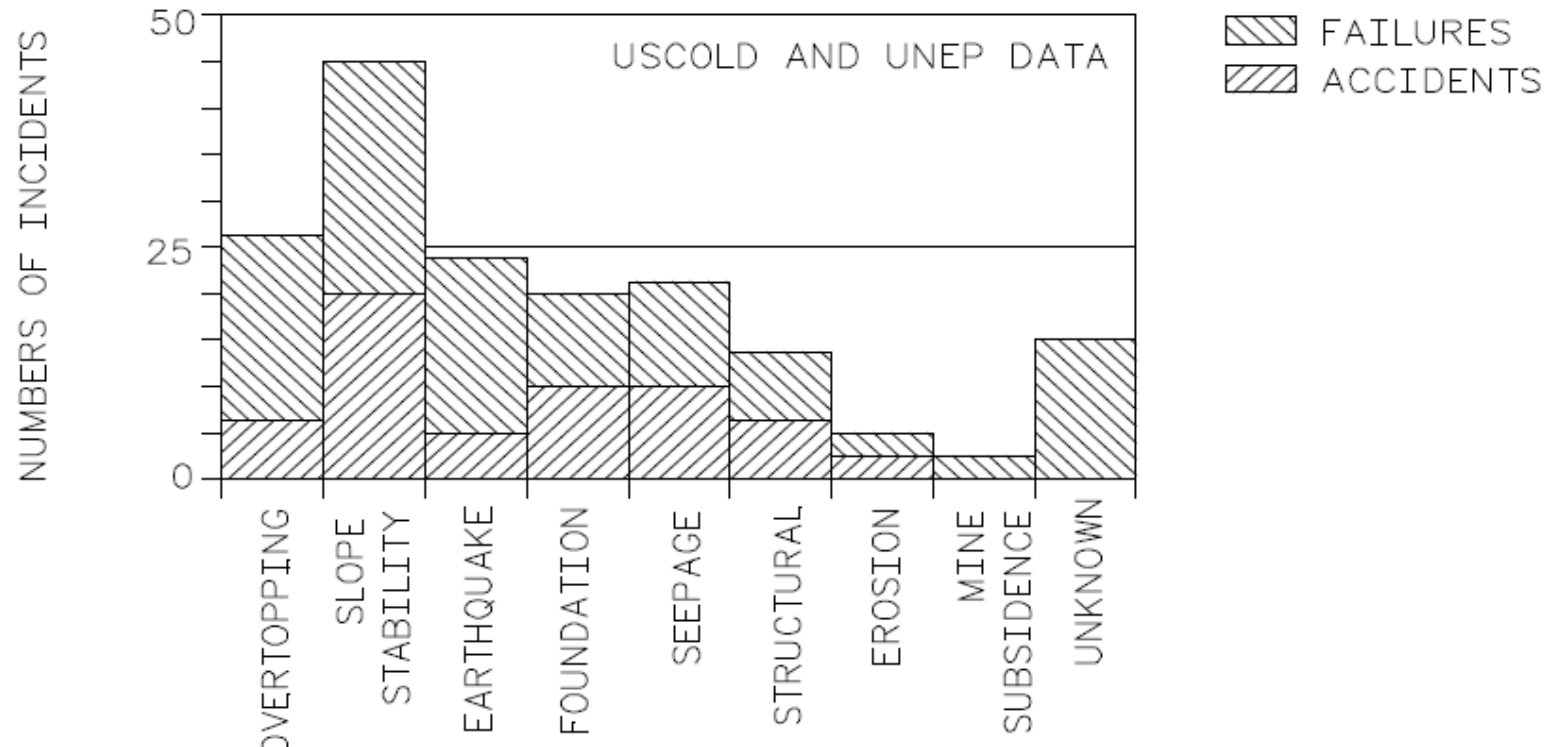
Distribution of causes of tailing dams accidents

Tailings dam incident cause comparison with incident type for active dams.
