Needs and challenges in managing tailings by operators in Central Asia (Republic of Kyrgyzstan)

Kyrgyz Chemical and Metallurgical Plant
(KCMP OJSC)

Information on tailing dumps of KCMP OJSC

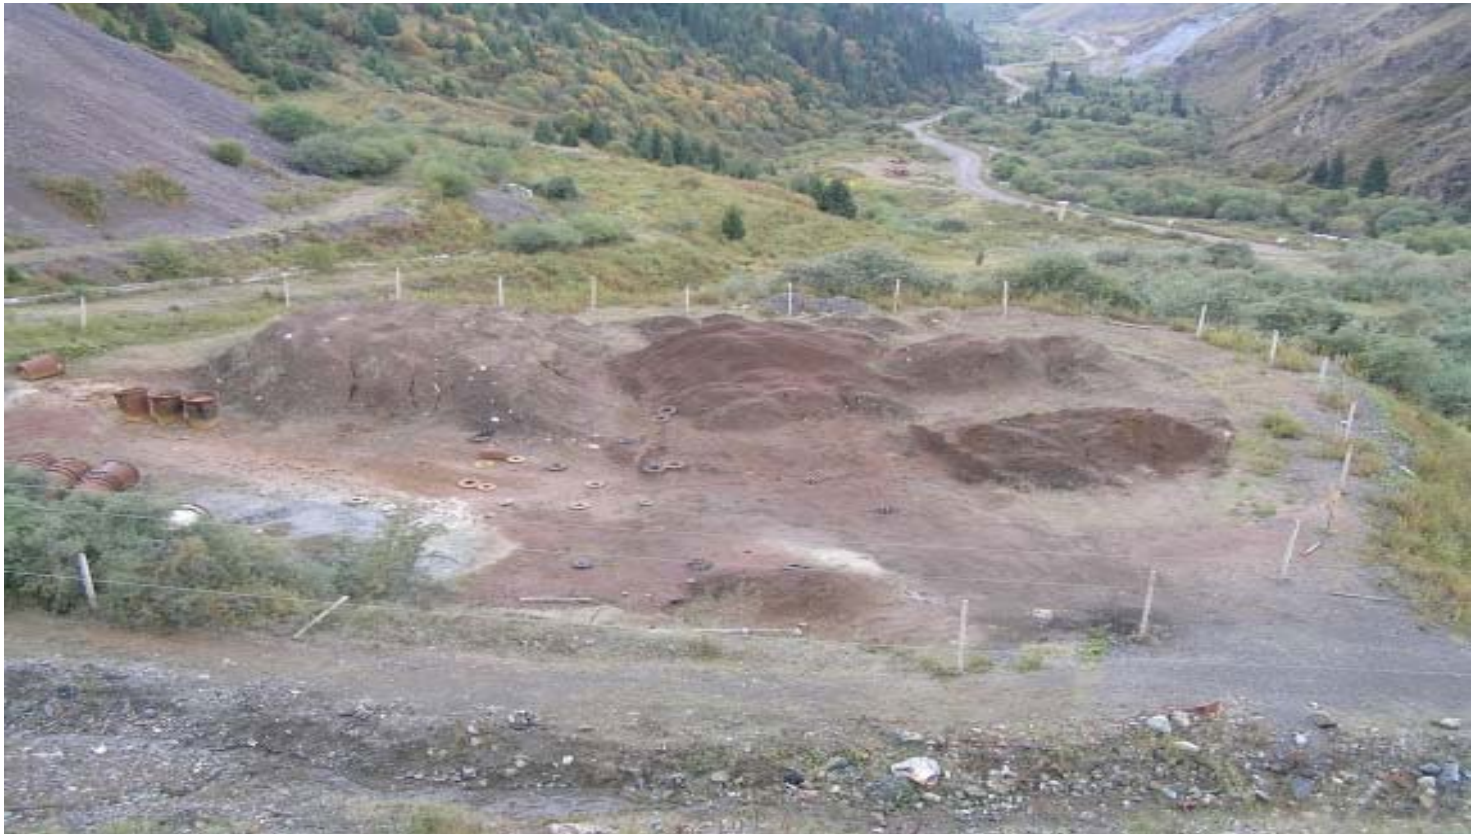
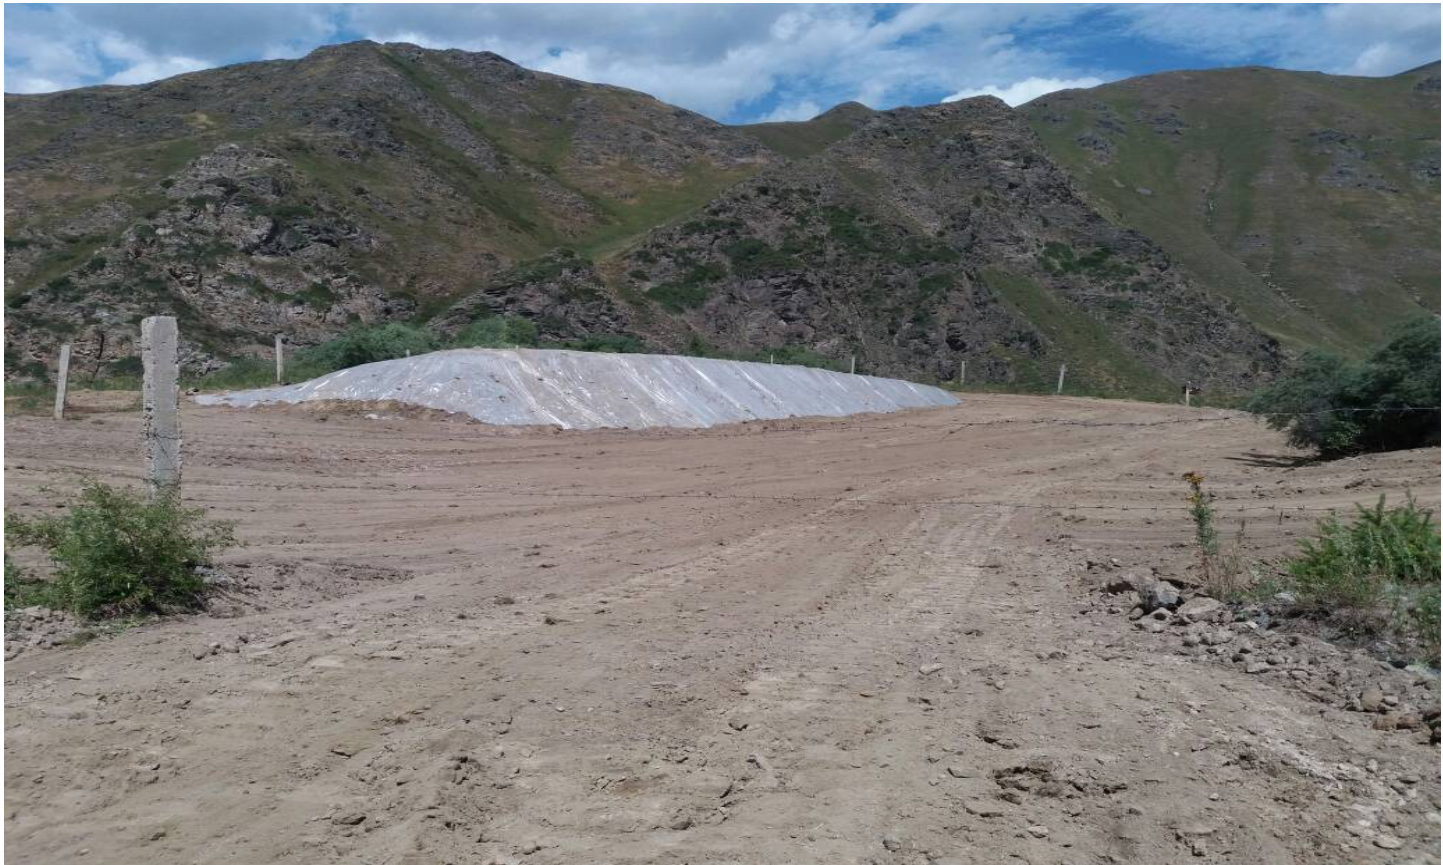
General view of tailing pond No. 1

Tailings storage facility No. 1 - was in operation from 1942-1955, geographically located directly under the processing plant of Ak-Tyuz, Keminsky district, at an altitude of 2140 m above sea level. The tailing area is 4 ha, the volume is estimated at 370 thousand m³.

In the tailings pond there is no antifiltration layer on the bed, hence there is the possibility of groundwater pollution due to sediment infiltration.

Also, the tailing dump is subjected to water erosion - under the influence of precipitation, despite the fact that it is preserved, melt and rain water from it pollutes the surrounding area, and the Kichi-Kemin river.

- According to tailing pond No. 1 - there is no antifiltration layer on the bed in the tailing pond, hence there is the possibility of groundwater pollution due to sediment infiltration. Also, the tailing dump is subjected to water erosion - under the influence of precipitation, despite the fact that it is preserved, melt and rain water from it pollutes the surrounding area, and the Kichi-Kemin river.

- Project development and transfer of the tail mass of Ak-Tyuz tailing pond No. 1 to the existing working tailing pond No. 2 or No. 4.
- Survey and assessment of the stability of dams at Ak-Tuz tailings No. 2,3 and the Bordun tailings of Orlovka.
- In case of instability of the dams, the development and implementation of measures aimed at ensuring the safety of tailings No. 2, 3 and Bordunsky.

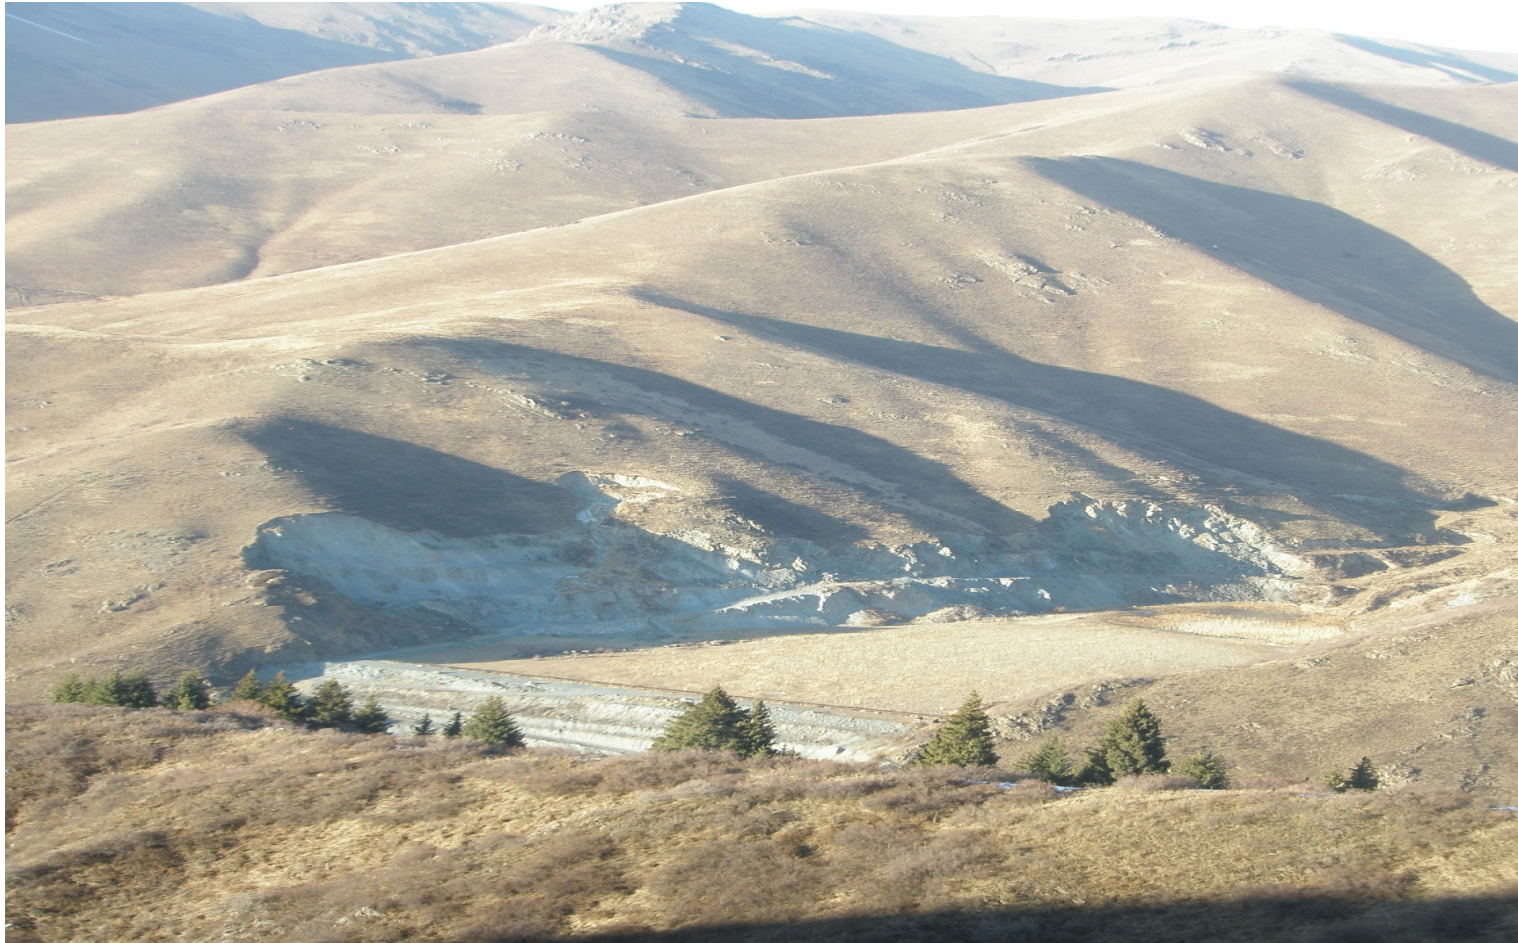
General view of tailing pond No. 2

- Tailings storage facility No. 2 - located on the right side of the Kichi-Kemin river valley, in Kulagan-Tash sai, at elevations of 2070-2150 m. The dam height is 72 m, the tailing area is 13 hectares.

- The tailing dump was operated from 1951 to 1972. Until 1964, the volume of waste disposed was 1,050,000 m³.
- In December 1964, as a result of an earthquake, a retaining dam broke and more than 600 thousand m³ of radioactive and toxic waste (60% of its accumulated volume) flowed from the tailing dump into the channel and valley of the Kichi-Kemin River. Tail flows containing elevated concentrations of thorium and heavy metals, in the form of radioactive mudflow, spread throughout the riverbed and valley. Kichi-Kemin at a distance of 40 km, up to its confluence with the Chu River in neighboring Kazakhstan. The waste laid on a site of 13 hectares contaminated agricultural land, settlements on the removal cone of the river. Kichi-Kemin with a total area of 3600 ha. The consequences of this cross-border disaster were eliminated for many years.

- According to archival data, the waste at tailing dump No. 2 contains the following metals (ppm): Pb 1200, Mo 90, REE 1600, Th 500, Cu 300, Y 440 ppm. The total α -activity of the remaining tail mass is estimated at 1600 Ci.

- The tailing dump has not been recultivated; a technological road has been laid along the lower slope and ledges of the dam.

- For tailing ponds No. 2 and 3 and the Bordun tailing pond - as experience in the construction and operation of tailing ponds under the difficult mountainous conditions of Kyrgyzstan shows, alluvial-type dams are less stable in comparison with bulk dams. Under adverse external weather conditions (heavy rainfall, mudflows), an earthquake there is a risk of breaking dams, which can lead to the ingress of tailings, including elevated concentrations of thorium and heavy metals, in the form of radioactive mudflow along the channel and the river valley. Kichi-Kemin n. Ak-Tuz, the Berkut river of the city of Orlovka, until they get into the Chu river, which is a transboundary river with neighboring Kazakhstan.

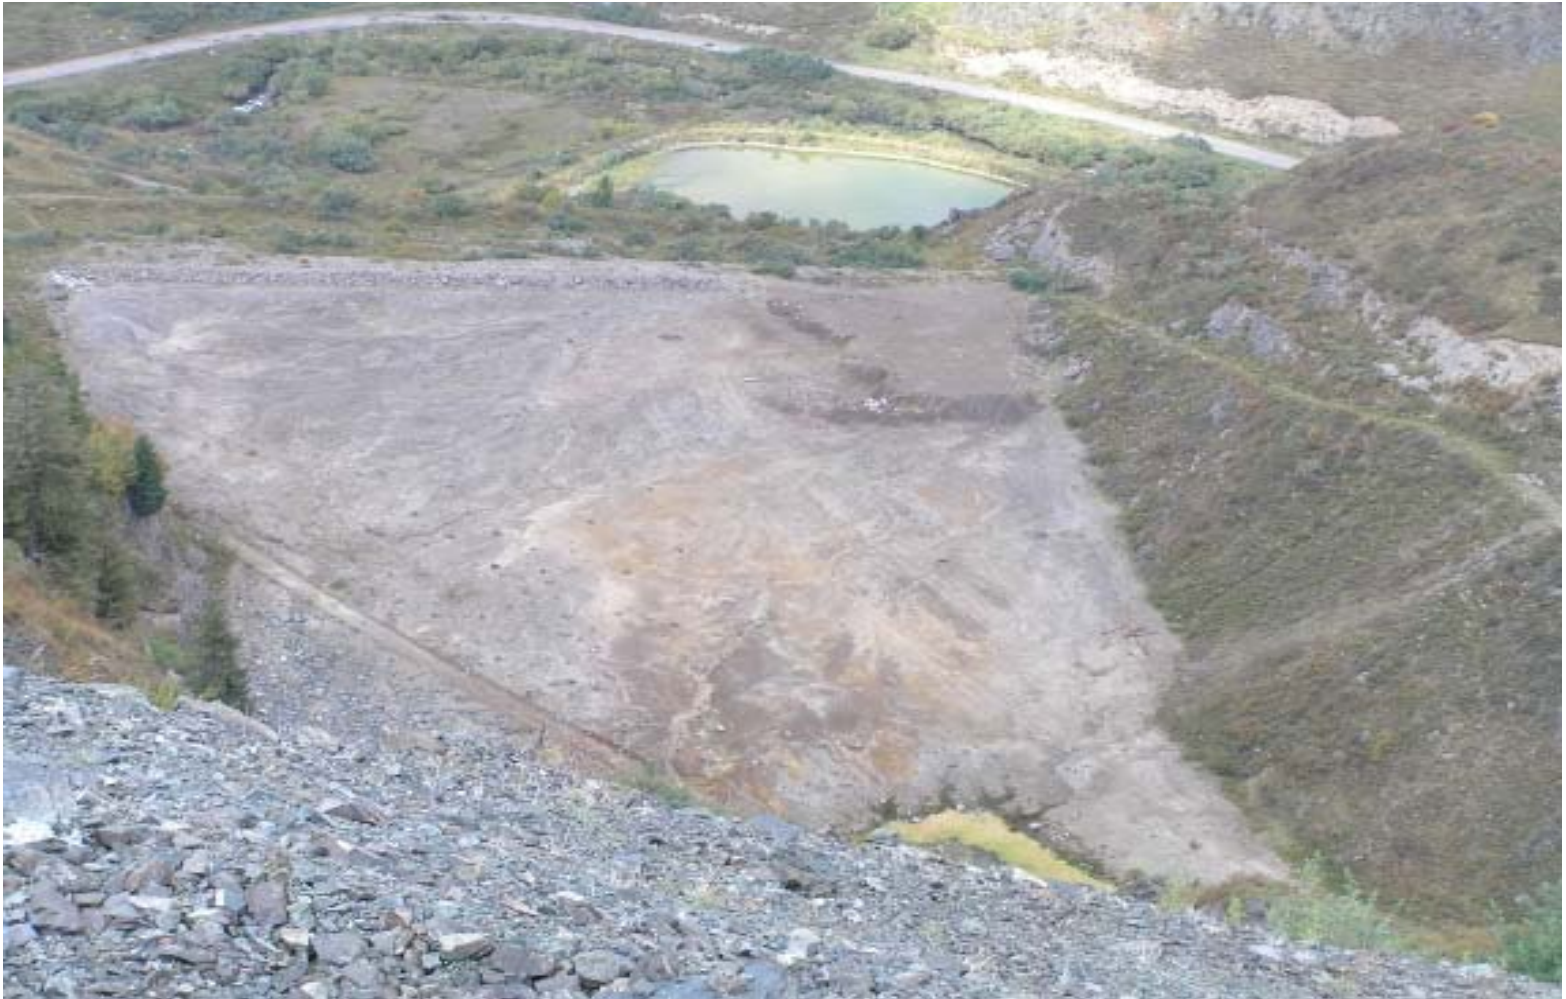
Data on tailing pond No. 3

- Tailings storage facility No. 3 is located on the left bank of the Kichi-Kemin river valley, in the estuary of the Kutesai stream, directly under the dumps of the empty rock of the Kutesai -2 quarry, at an altitude of 2200 m
- The height of the dam is 81 m, the tailing area is 3 ha. It stores about 1.05 million m³ of waste. The dose rate of gamma radiation on the surface of the tailings reaches 80 μ R / hour. The total α -activity of tail materials is estimated at 2100 Ci.
- The tailing dump was operated between 1965 and 1978, and in 1979 it was mothballed, but no protective layer was laid.
- Water and wind erosion take place on the surface of the tailing dump. Concerned over the tailing dump. In the event that this dump begins to collapse in the event of a strong earthquake, a waste discharge from the tailing dump into the Kichi-Kemin River is possible.

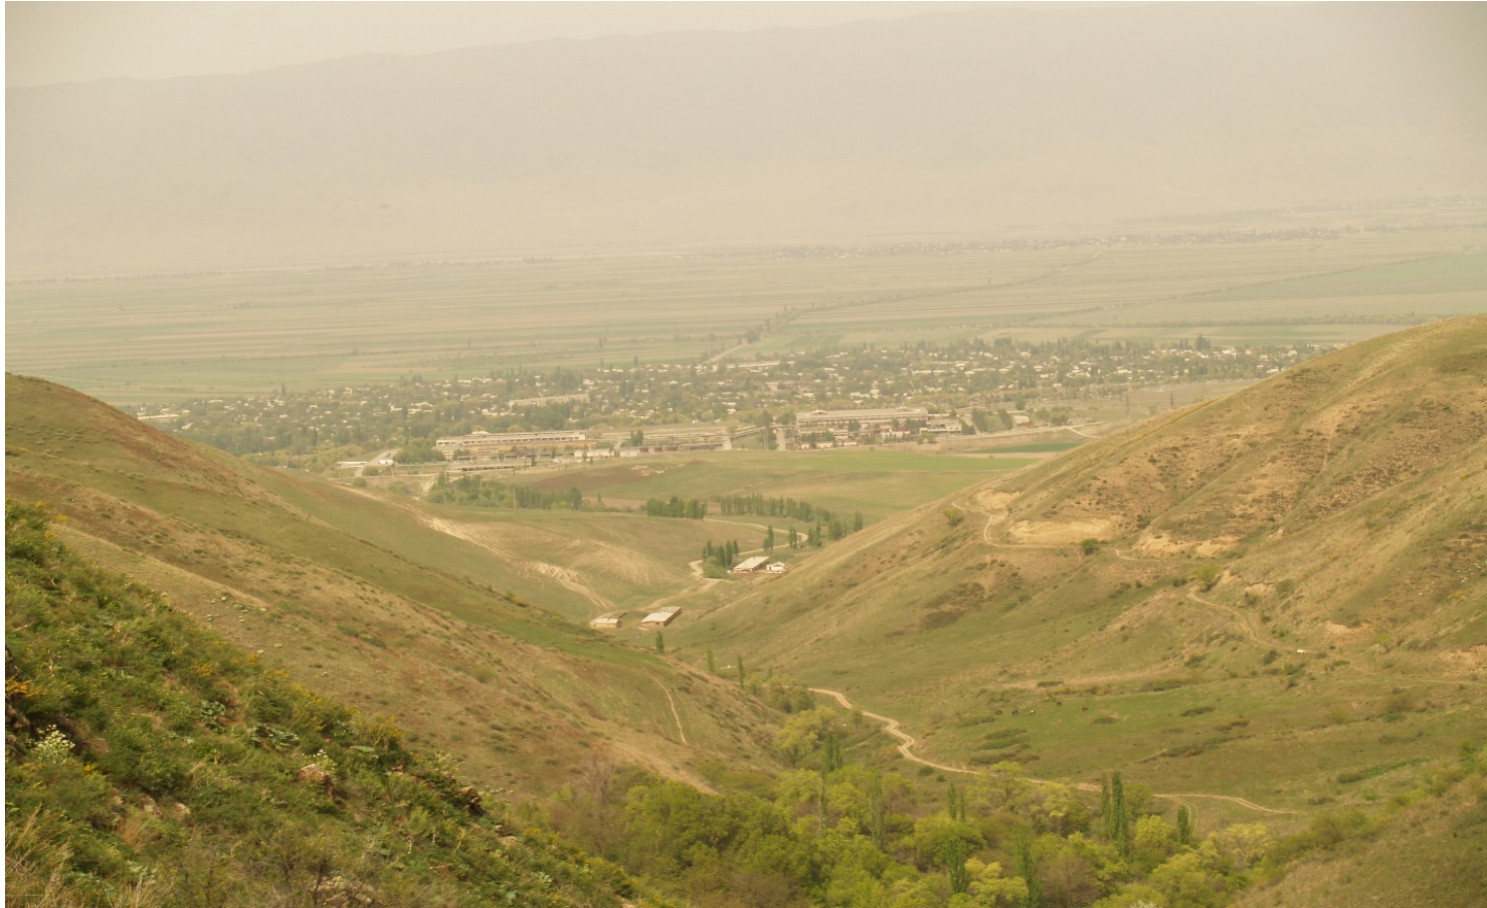
The surface of the Bordun tailing dump and the city of Orlovka below its dam

- At present, drainage channels have been laid on both sides of the tailing dump for the removal of storm and flood waters of the Burkut stream and its tributaries. The canals are concrete trays, on the eastern side, for the most part blocked, on the western - passing into a steel pipe with the subsequent discharge of water into the lower tail of the tailings dam.
