# REPORT

## from the on-site training and results of the application of the Checklists B.1 and B.2 of the tailings management facilities (TMF) Methodology

*held during an introduction workshop, on-site training and evaluation workshop (Kokshetau, Kazakhstan, 11–13 June 2019) under the UNECE projects on improving mining/tailings safety in Kazakhstan, Tajikistan and beyond in Central Asia*

*based on the safety evaluation of the TMF of LLC «Altyntau Kokshetau» (Kokshetau, Republic of Kazakhstan)*

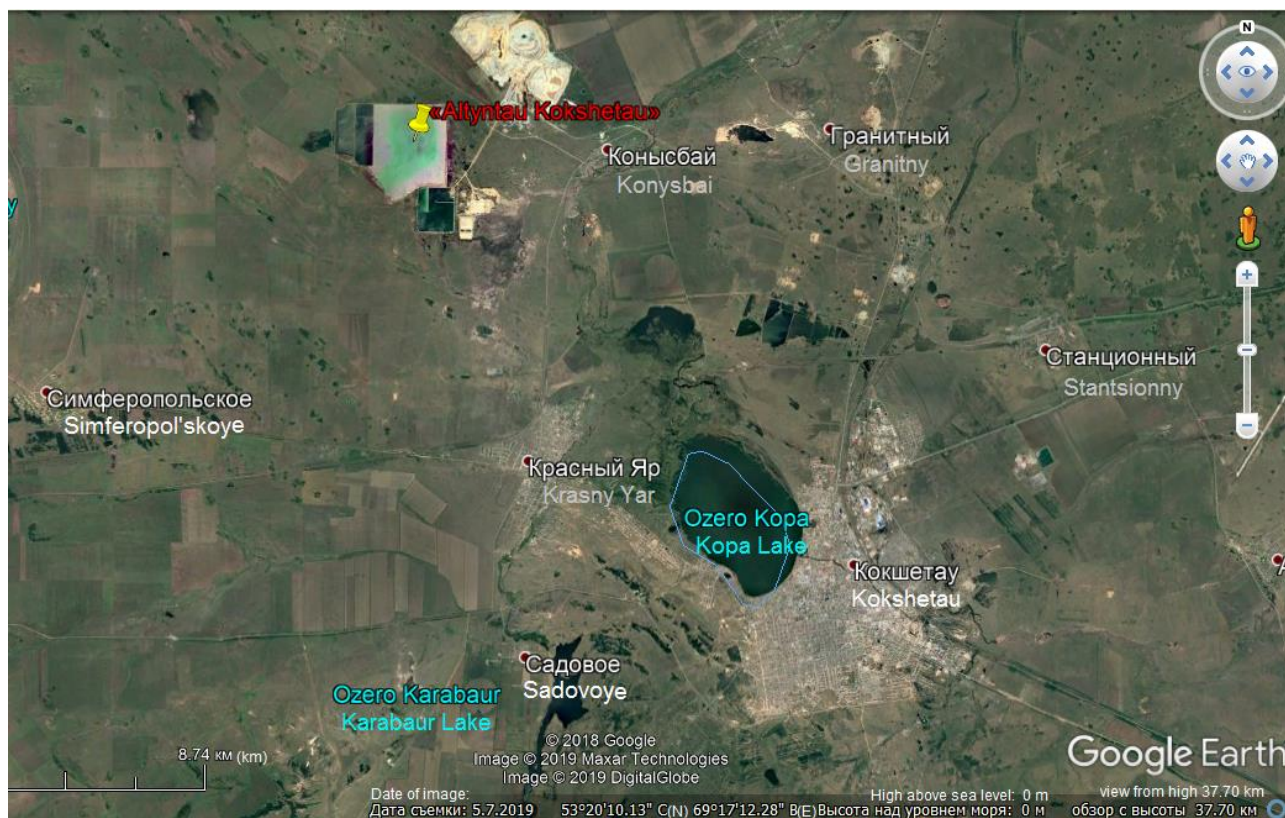
Figure 1: TMF location on-site (a) and its elements visited by training participants (b): 1-2 – upstream side of the enclosing dams; 3 – the bottom-line of the dam, observation wells; 4 – enclosing dam of the settling pond; 5 – pumping station for recycling water supply; 6 – drainage channel and enclosing dam of the settling pond. Red lines are the routes of inspecting the TMF by training participants.

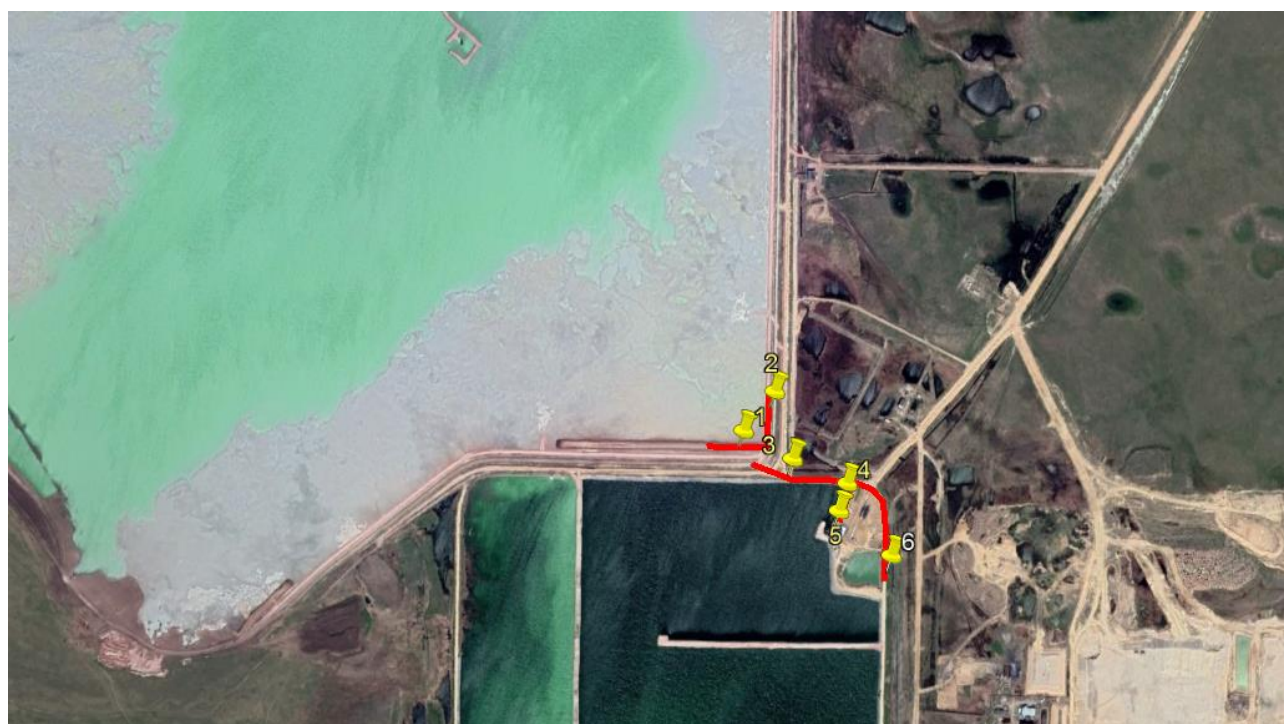
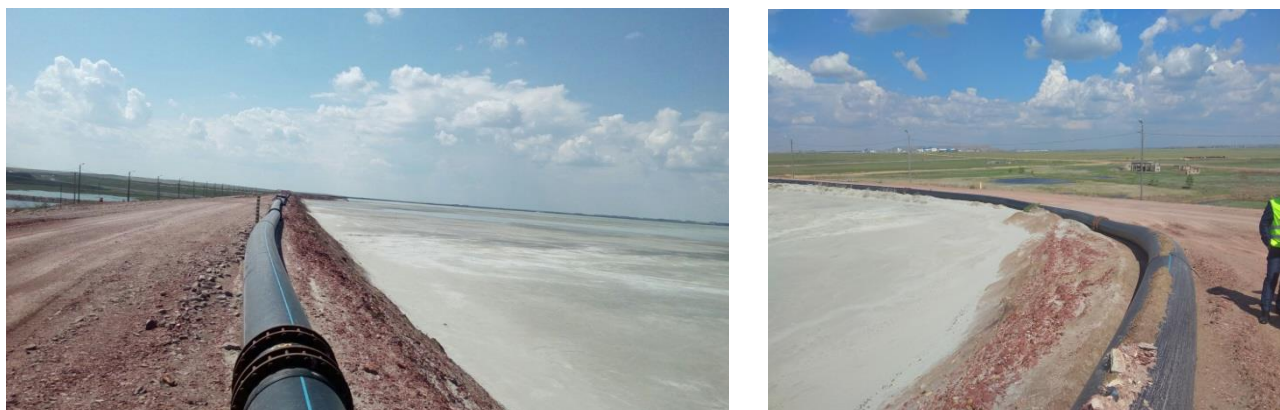
Figure 2: Views to the flotation TMF from the point 1 (see Fig. 1,b) to the west (a) and north-east (b)

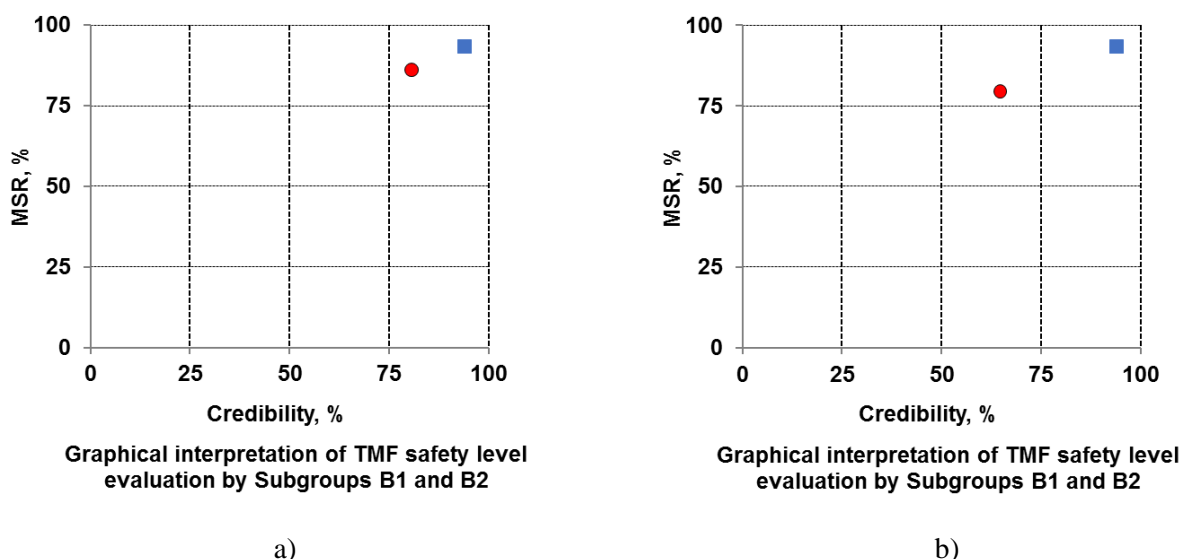
The overall evaluation results (Table 1, Fig. 3) showed, on the whole, a relatively high level of compliance of this TMF with the safety requirements defined in the UNECE Safety Guidelines and Good Practices for TMFs [1]. As a result of the visual check, both groups rated the TMF safety level as follows: the parameter “Meeting safety requirements” at 79.4-86.1% and “Credibility” at 64.7-80.6%. The same parameters for the Subgroup B.2 were evaluated at 91.5% and 91.9%, respectively.

Figure 3: Overall TMF safety evaluation obtained by Group 1 (a) and Group 2 (b) of training participants. **Red circle** shows the visual check result; **blue square** the result of document check. MSR = Meeting safety requirements.

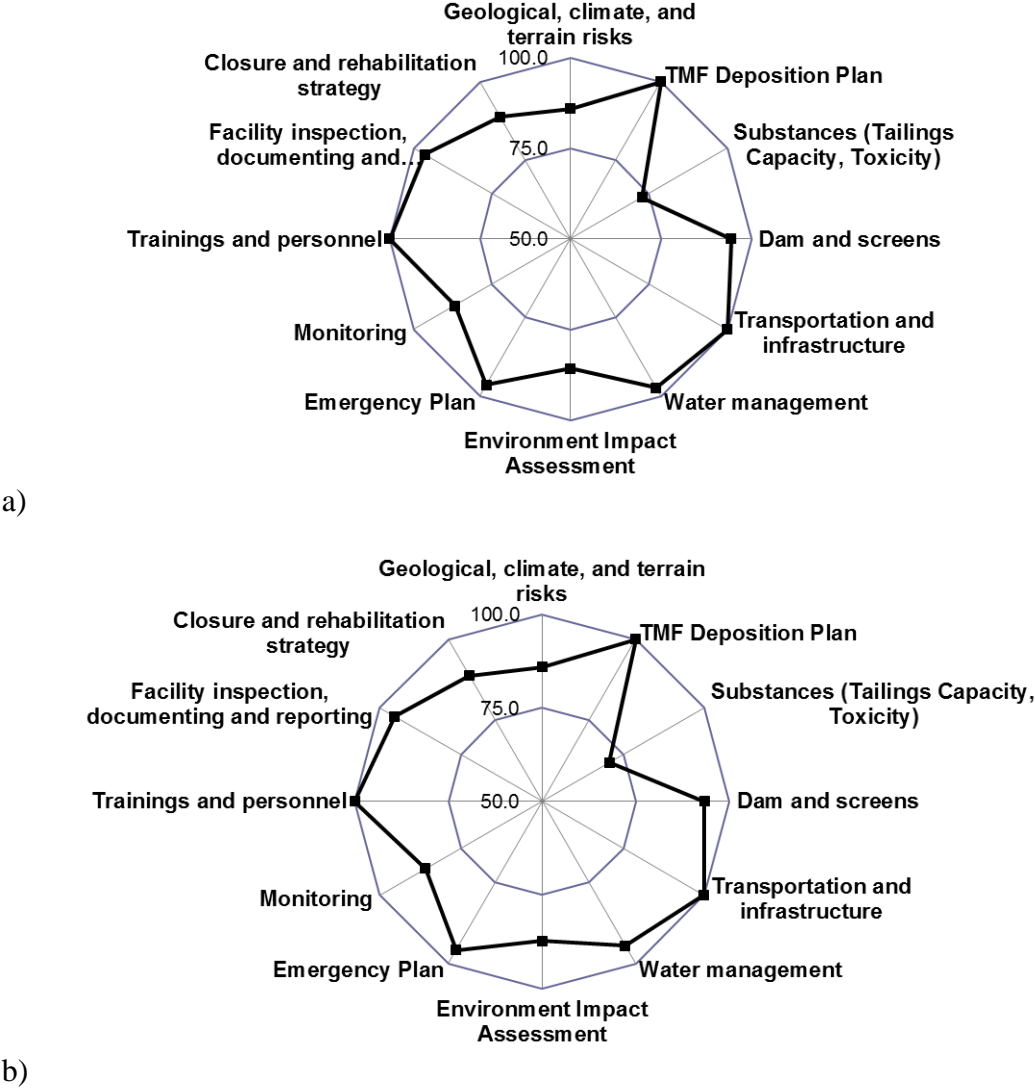
The categorical evaluation (Fig. 4) revealed those aspects of the TMF operation with the lowest safety performance, which should be addressed first by the appropriate safety improving measures; they include neutralization of toxic effects of substances contained in tailings; water management; Environmental Impact Assessment; monitoring; closure and rehabilitation strategy.

Figure 4: Categorical evaluation of TMF safety obtained by Group 1 (a) and Group 2 (b)
