REPORT

Road 2020/07

REPORT ON A HEAD-ON COLLISION BETWEEN A PASSENGER CAR AND A VAN ON THE E39 AT AUSTEFJORDEN, VOLDA, MØRE OG ROMSDAL ON 20 OCTOBER 2019

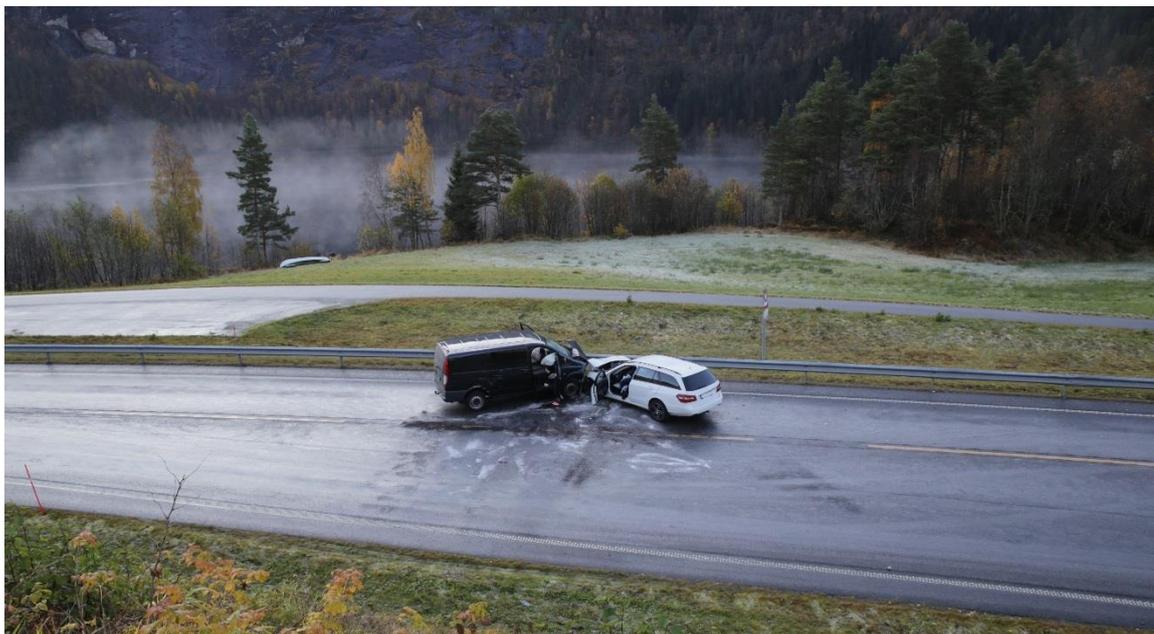
Figure 2: Final positions - northbound van and southbound passenger car photographed at 11:48.
Photo: The police

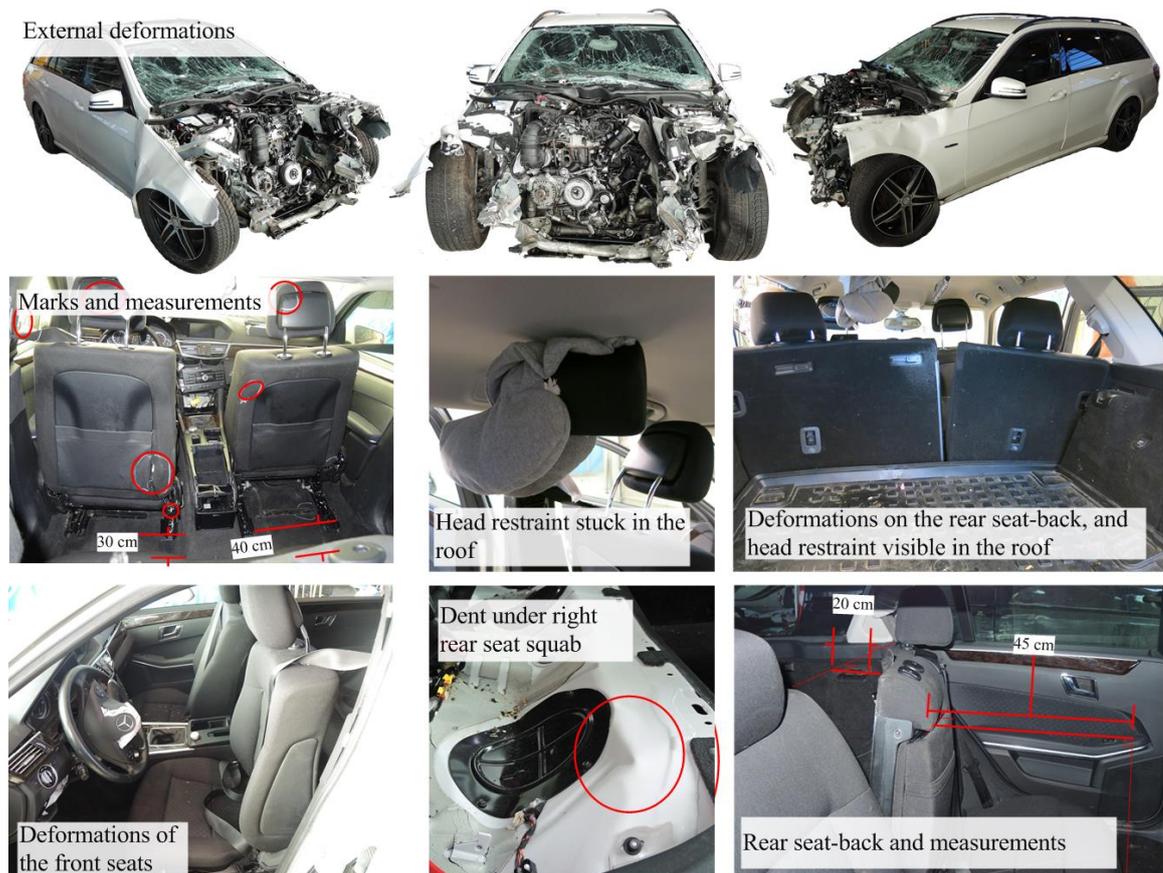
The front of the estate car had external deformations and had crumpled by approx. 73 cm on average across its whole width. The passenger compartment was intact and all doors could be opened and closed. The windscreen was the only broken window. The driver's seat was originally 30 cm away from the back seat and was displaced forward and upward, but was still firmly attached to its front anchorage. The right passenger seat was originally 40 cm away from the back seat and was loose and displaced further forward. The rear seat-back consisted of two parts, and the larger part (the 60 part) was displaced approx. 20 cm forward from the normal position at the middle rear seat. The distance between the rear seat-back, and the forward part of the rear seat squab, was approx. 45 cm. The NSIA removed the upholstery from the rear seat-back and examined it in detail, see Section 1.13.4. There were scorch marks on the right rear seat squab, and a dent under the rear seat squab, see Figure 4.

The middle head restraint was stuck in the roof, pins first, immediately behind the driver's seat, but was not ripped or damaged. At the middle of the rear side of the seat-back was what appeared to be a spot of paint, but this is not related to the accident.

Figure 4: External/internal deformations, marks and points of impact in the estate car
Illustration/photo: NSIA

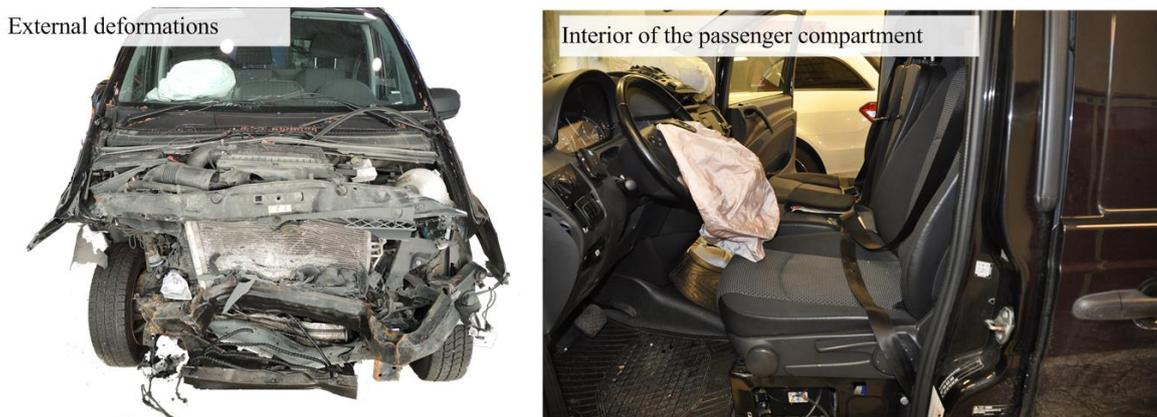
Externally, the crumple zones in the front of the van had crumpled by approx. 40 cm. The right impact cushion had completely crumpled. There was little deformation internally,

and a full partition separated the load in the cargo space from the passenger compartment. Pretensioners and force limiters were activated on both seat belts.

Figure 5: External deformations on the van and the interior of the passenger compartment.
Illustration/photo: NSIA

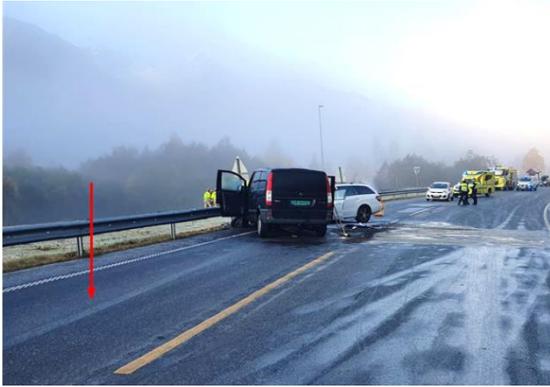
Figure 6: Temporary traces left by the van on the roadway, photographed at 10:04. Photo: The police

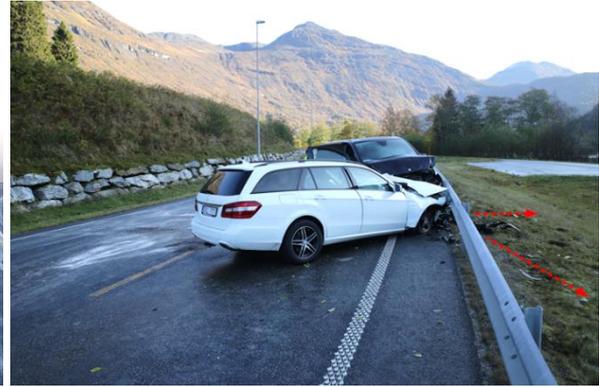
Figure 7: Spread of plastic covers and remnants from the head-on collision Photo: The police

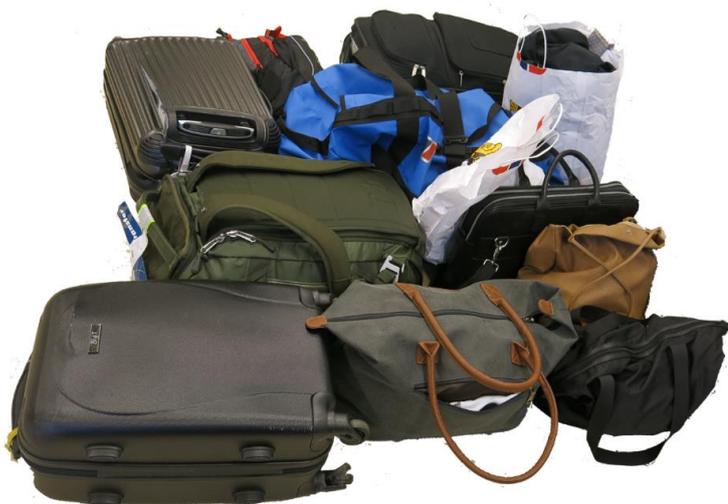
Two suitcases and one bag had external damage after the collision. All luggage, except for the 2.9 kg rucksack that was loaded last, remained in the boot following the collision. The rucksack was lying on the floor behind the right passenger seat after the collision.

The compartment cover beam, which can be fitted with a net stretching up to the roof and a fabric cover that can be drawn over the luggage, was not in place at the time of the accident. This is analysed in Section 2.5.3.3.

Figure 8: Luggage that was placed in the estate car's boot. Photo: NSIA

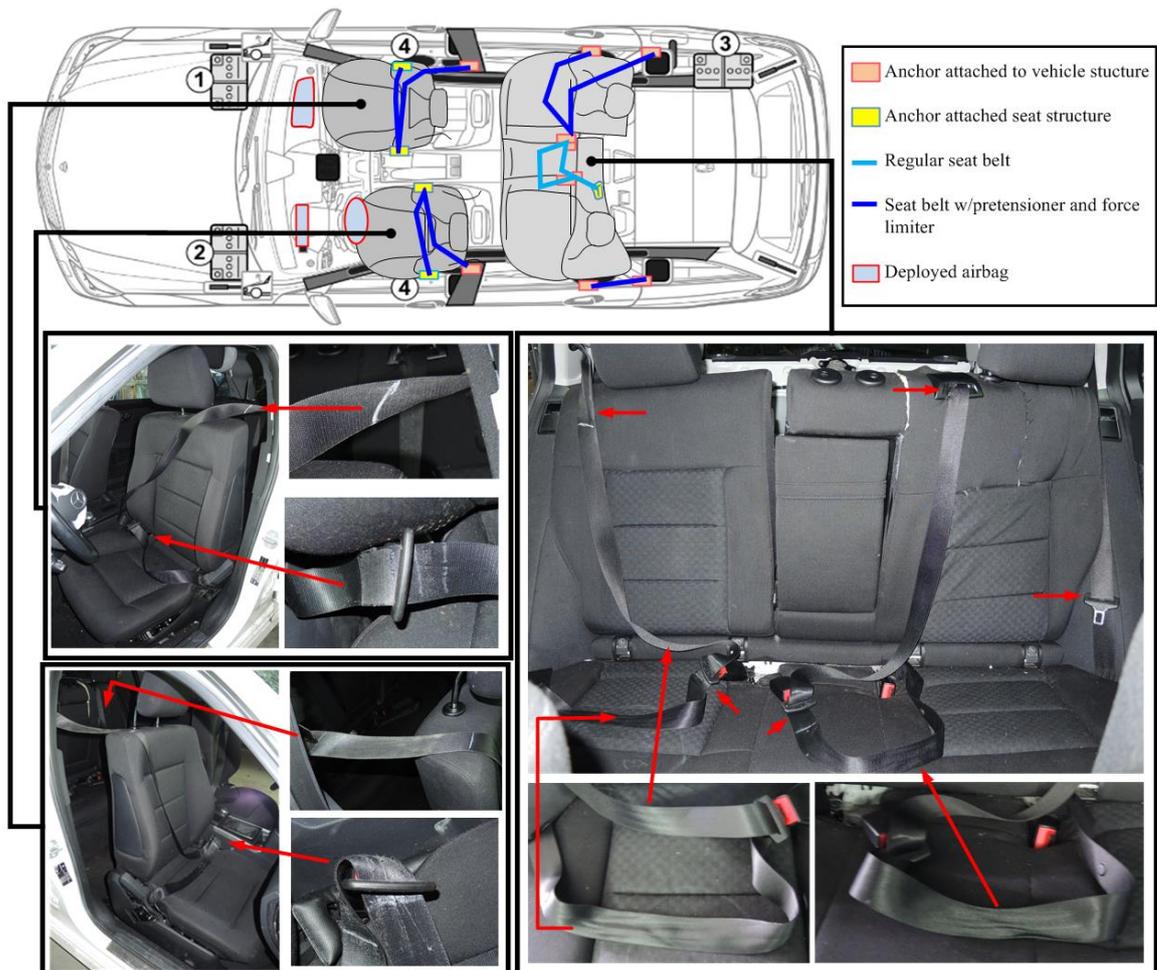
Seat	Lap belt	Shoulder belt	Pretensioner/force limiter
Driver's seat	Scorch mark by buckle	Scorch mark by B pillar	Activated / 10 cm extraction with jamming
Right front	Scorch mark by buckle	Scorch mark by B pillar	Activated / 24 cm extraction
Left rear seat	Not in use	Not in use	Activated (fastened)
Middle rear seat	Wave pattern along 20 cm, internal scorch mark	Small rip at top towards the retractor	Not available
Right rear seat	Wave pattern along 25 cm, internal scorch marks	Weak wave pattern at bottom, scorch mark by C pillar	Activated / 20 cm extraction

Figure 13: Scorch marks, extractions and wave patterns on the seat belts after collision.

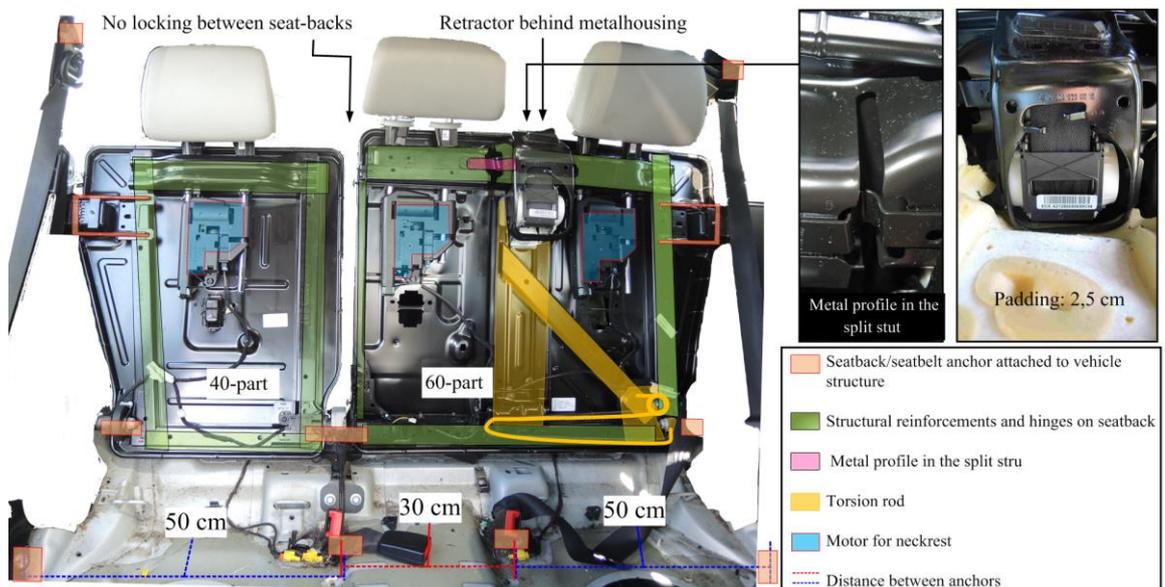
The 60-part's framework was constructed in two parts, where the framework from the outer edge towards the retractor had special reinforcement, marked yellow in Figure 14. The lateral strut at the top of the 60-part was divided in two at the retractor, with a small, profiled metal part in the gap. The reinforcement consisted of a diagonal strut, fitted at the bottom of the outer edge of the left seat, where it was linked to a torsion rod. It then led diagonally up towards the retractor for the middle seat belt.

Figure 14: The rear seat structure and distances between the seat belt anchor points. Illustration: NSIA

The retractor was installed on the front edge of the upper part of the rear seat-back. The shoulder part of the seat belt moved with the upper part of the rear seat-back when it was deformed forwards during the collision. This may also have affected the direction of travel. The NSIA considers the fractures in the upper part of the passenger's back to be related to the tightening of the shoulder belt in this situation. The NSIA also considers that the metal housing around the retractor on the front of the seat-back, beneath the thin upholstery – as shown in Figure 14 – may have contributed to her injuries.

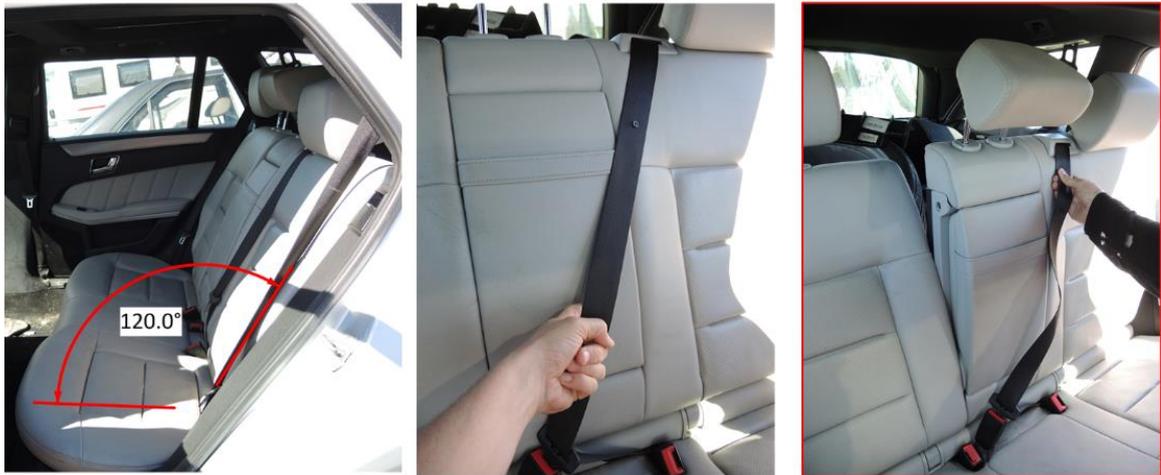
In the locked position, the rear seat-back was at an angle of approx. 120 degrees to the floor. When the middle seat was pushed forward with the belt locked, the length of the belt increased because of the difference between the seat-back rotation point and the positioning of the anchor points, as shown in Figure 15.

Figure 15: Rear seat-back angle and extension of locked seat belt's length when the seat-back is moved forwards. Illustration: NSIA

In the context of this test, the alternative middle rear seat belt anchorages present different problems in relation to deformation of the rear seat-back. When the shoulder belt anchorage is in the roof, the rear seat-back must be strong enough for a deformation not to jam the passenger between the shoulder belt and the rear seat-back. When the shoulder belt anchorage is integrated into the rear seat-back, the movement of a secured passenger's body will be determined by the movement of the rear seat-back and the configuration of the belt, described in Figure 15.

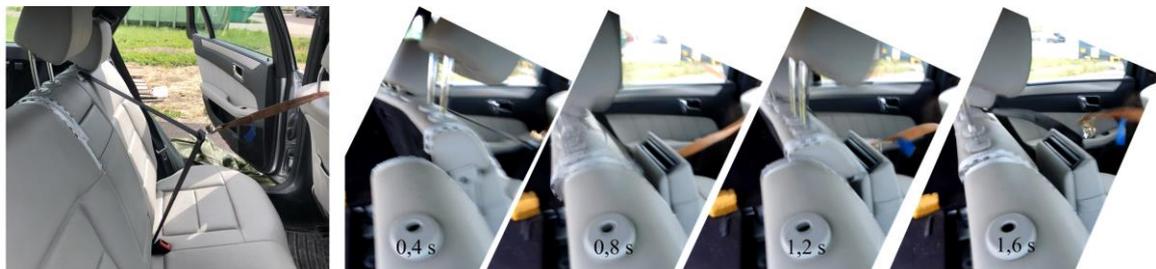
The experiment was filmed. It is very clear from the recording that the seat-back bent forward when the load was applied to the shoulder belt. When the pressure on the stop was released, the seat-back sprang back, but before it came to rest it rocked to and fro before it reverted to a roughly upright position, see Figure 16.

Figure 16: Set-up of the pulling experiment and sequence of oscillations from the video. The whole experiment lasted for around 2 seconds. Illustration: NSIA

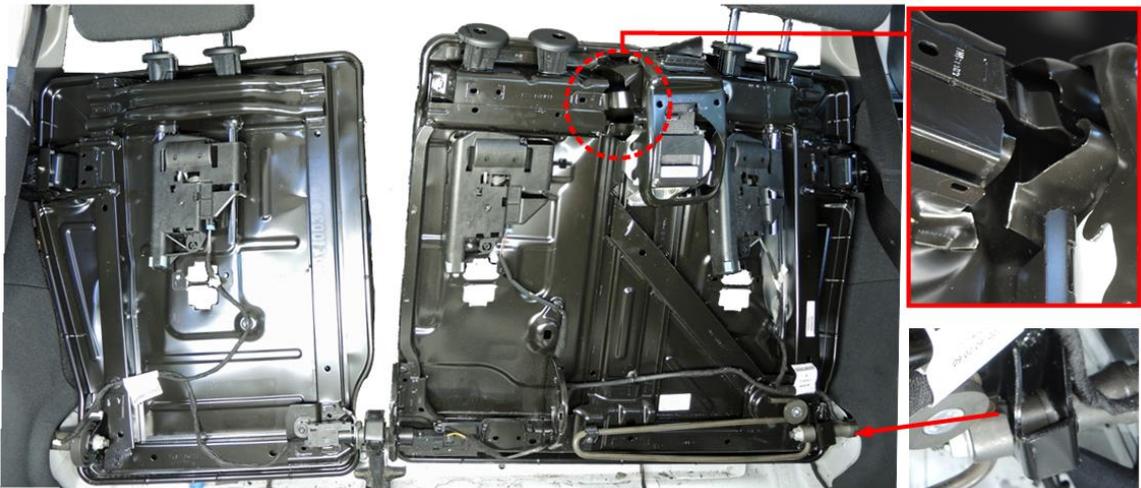
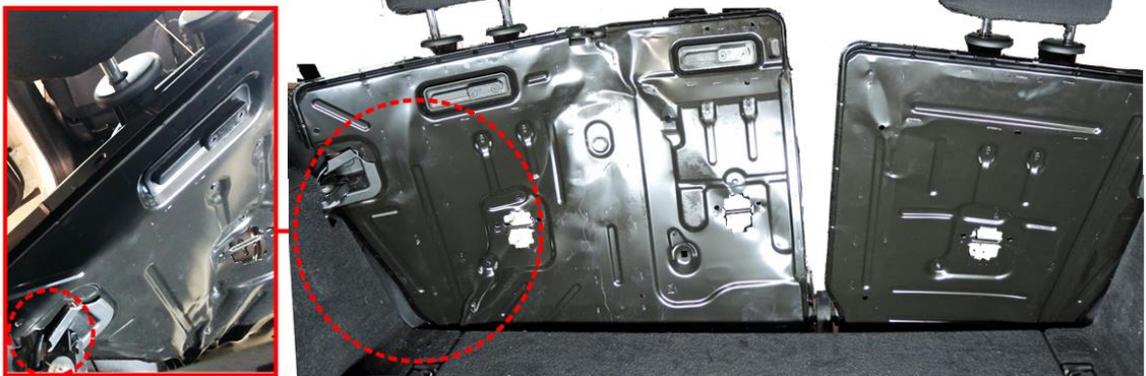
The NSIA removed the upholstery from the rear seat-back of the estate car involved in the accident in order to examine deformations, twisting and metal fractures. Both parts of the seat-back were deformed, but the 60-part was most deformed.

The 60-part was at its most deformed from the retractor in the middle and out towards the C pillar. Fractures were found in the strut at the top, by the retractor, and the small metal profile in the gap was completely stretched out, see Figure 17. Twisting and stretching was found at all three anchor points that attached the seat-back to the body of the vehicle, especially by the buckle against the C pillar.

Figure 17: Deformations, twisting and metal fractures on the seat-back's 60-part. Illustration: NSIA

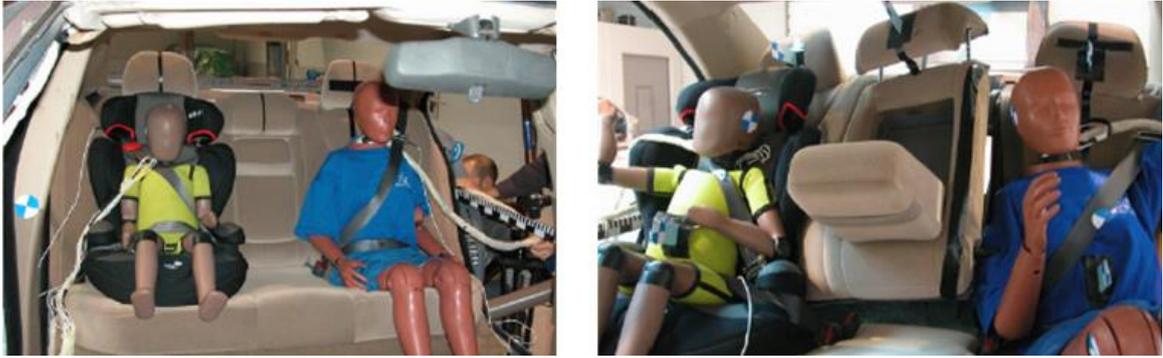
Figure 20: The back seat in one of the test cars, before and after the ANEC test. Photo: ANEC

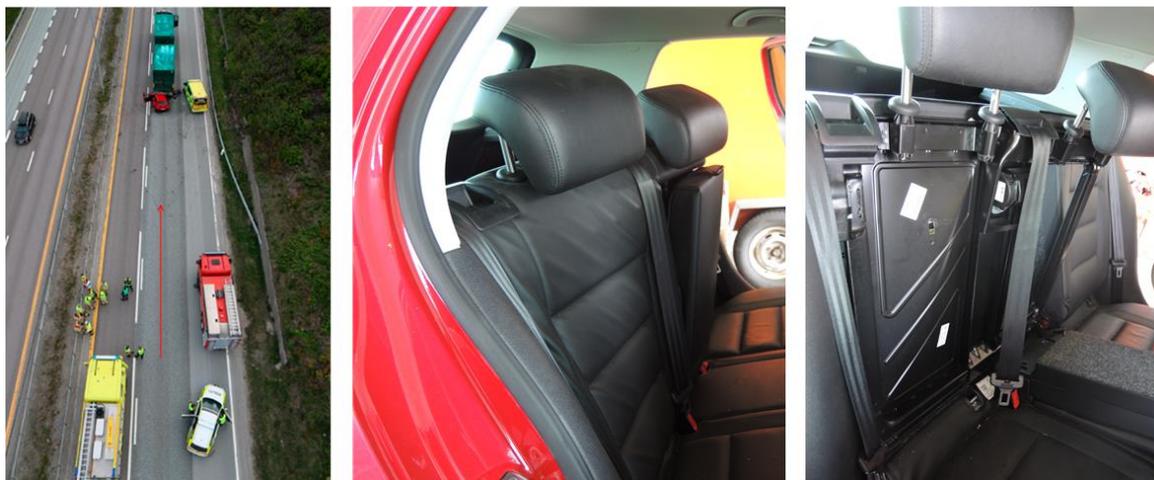
While this investigation was being conducted, observations were made concerning the rear seat of a passenger car in another ongoing investigation. The accident involved a passenger car colliding with a stationary HGV at a speed of approx. 80 km/h (SHK, 2020). There were no persons in the back seat, but the rear seat structure gave way in the collision. The only item that could have been in the boot before the accident, was a 4-litre container of washer fluid that was lying in the passenger compartment after the collision. The seat cover in the rear seat was removed and the NSIA found that the retractor integrated into the rear seat-back had been displaced approx. 15 cm forwards.

Figure 21: Deformed rear seat structure from the accident involving a collision with a stationary HGV (SHK, 2020). Source: NSIA
