## Description of the Tous Dam break case study (Spain)

F. ALCRUDO, *Area de Mecánica de Fluidos, CPS-Universidad de Zaragoza, 50.018-Zaragoza, Spain*

J. MULET, *Area de Mecánica de Fluidos, CPS-Universidad de Zaragoza, 50.018-Zaragoza, Spain*

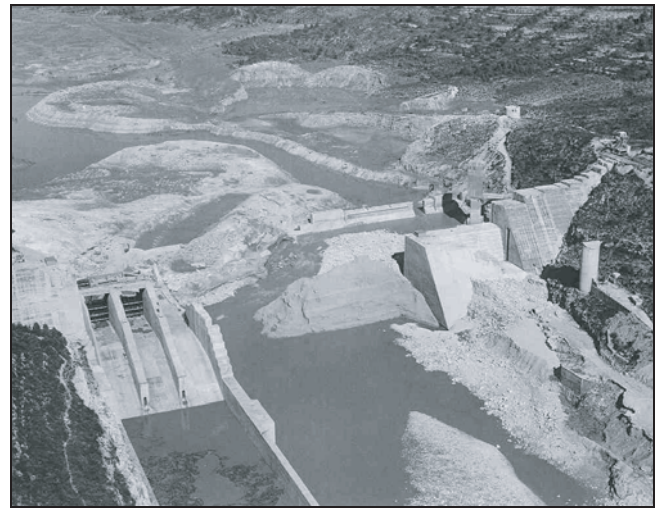
Dam failure was a progressive process as it usually happens with loose material dams. However it can be said that collapse took place at about 19:15 h, when a significant part of the dam fell, including the leftmost gate and rig, and was swept away by the stream. A picture of the remains of Tous Dam can be seen in Fig. 1. The outflow hydrograph is discussed in Section 3.

Figure 1 The remains of Tous Dam after the failure looking upstream (from Estrela, 1999).

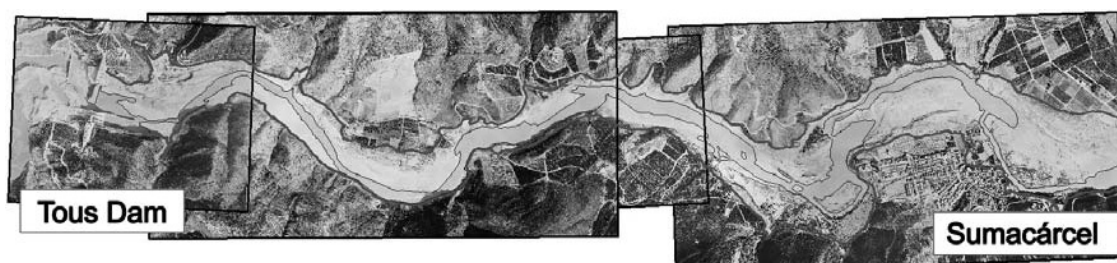
Figure 2 Aerial view of the Júcar River reach from Tous Dam (left) to Sumacárcel (right) about one week after the flood.

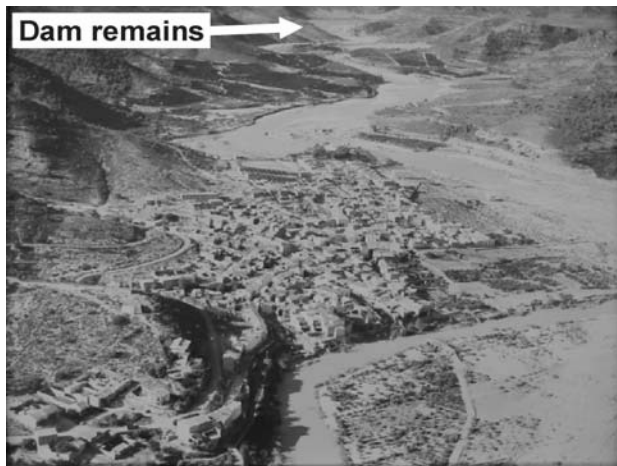
Figure 4 The town of Sumacárcel after the flood, looking upstream.

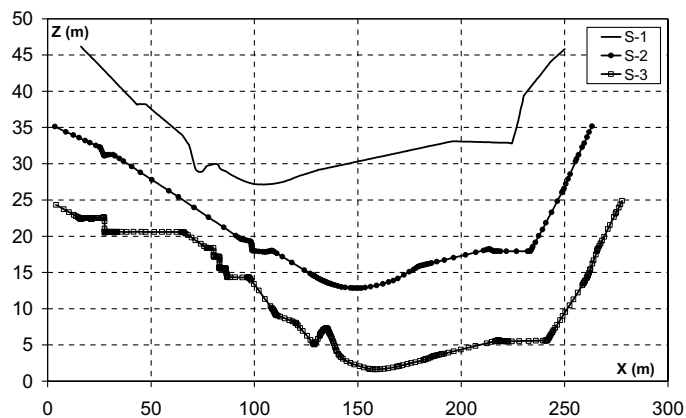
The peak outflow figure obtained by the method above was also cross checked with the high water marks measured at three consecutive actual river cross sections 1.3 km downstream of Tous Dam. An iterative procedure based upon the application of the (steady) energy equation to the three selected cross sections yields an average value of the Manning roughness and the corresponding peak discharge. The uncertainty in water level records taken from the river banks leads to a peak outflow interval between  $14,000$  and  $17,000 \text{ m}^3\text{s}^{-1}$  by this method. The

Figure 5 The three consecutive cross sections of Júcar River used for peak outflow estimation. Left of figure corresponds to left bank.

proposed peak discharge of  $15,000 \text{ m}^3\text{s}^{-1}$  obtained by means of the physical and mathematical models falls in between those figures. The details of the calculations can be found in the original reports (CEDEX, 1984, 1989a). The three consecutive river cross sections used in the computations can be seen in Fig. 5.

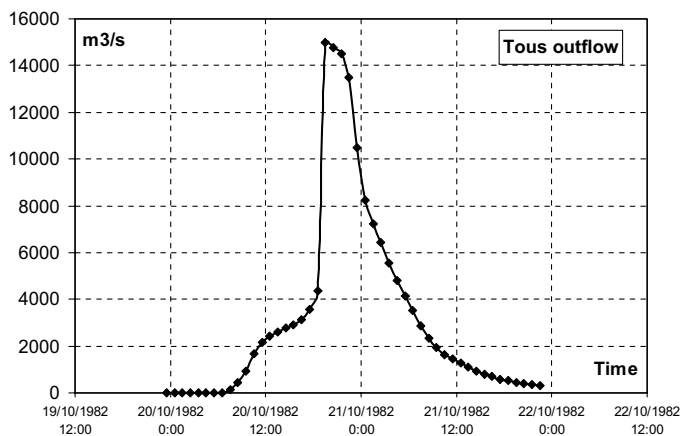
Hence, the outflow hydrograph proposed for modelling is the one shown in Fig. 6 that has been advanced in time by half an hour with respect to the original CEDEX curve. The numeric data are provided in a Microsoft Excel file named *Outflow.xls* in the accompanying data set.

The area below the curve of Fig. 6 yields  $550 \times 10^6 \text{ m}^3$  for the total amount of water that passed through the dam during the event.

Figure 6 Tous Dam outflow hydrograph.

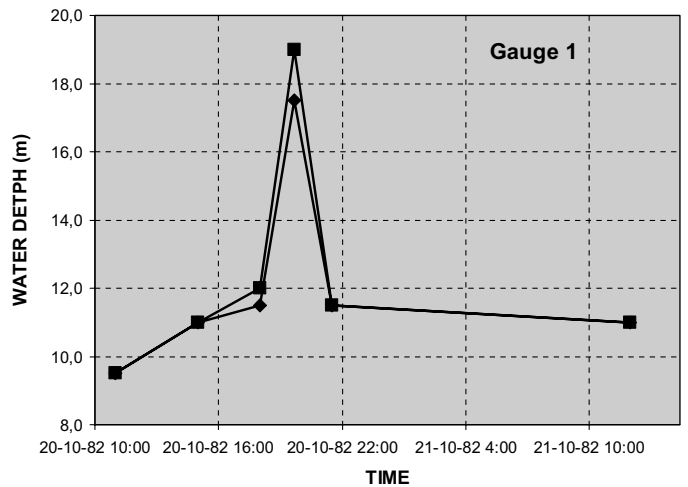
Figure 8 depicts water depth evolution at gauging point number 1 (bridge) according to two different sources. The corresponding river cross section is displayed in Fig. 9. As can be seen from both figures water largely overflowed the river banks flooding the town. According to witnesses and statements quoted in the reports, the town was already flooded before the dam break due to the intense rain and river flow. At about 18:00 on October 20

Figure 8 Estimation of water depth evolution at Gauge 1 (riverbed at the bridge).

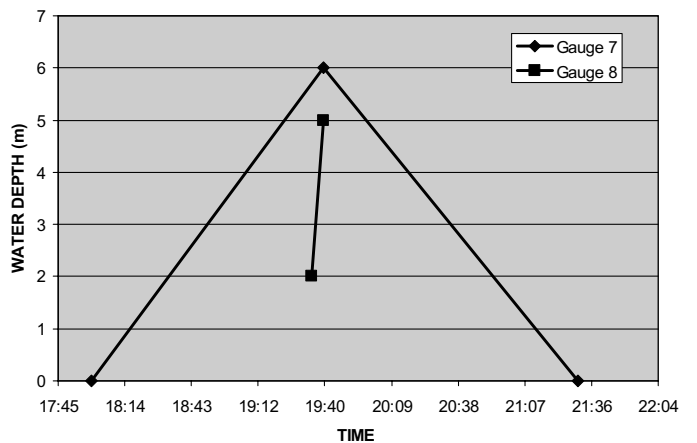
Figure 10 Estimated water depth evolution at Gauges 7 and 8.

Figure 10 shows estimated water depth evolution at gauges 7 and 8 according to a single source (local police officer).

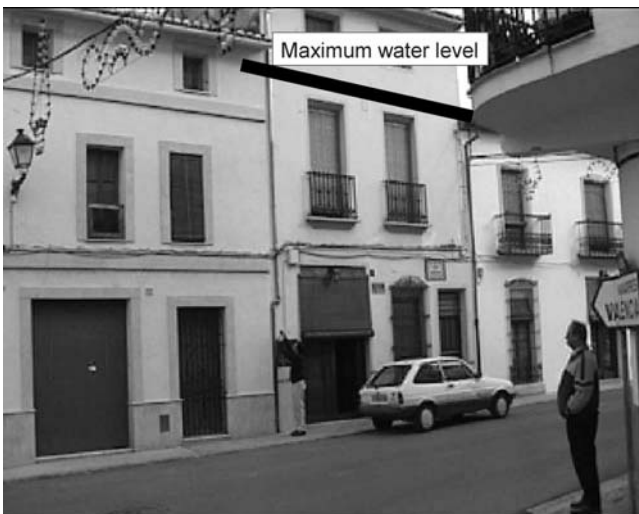
Figure 13 Probe 3. The man behind the car marks 2 m elevation above the ground.

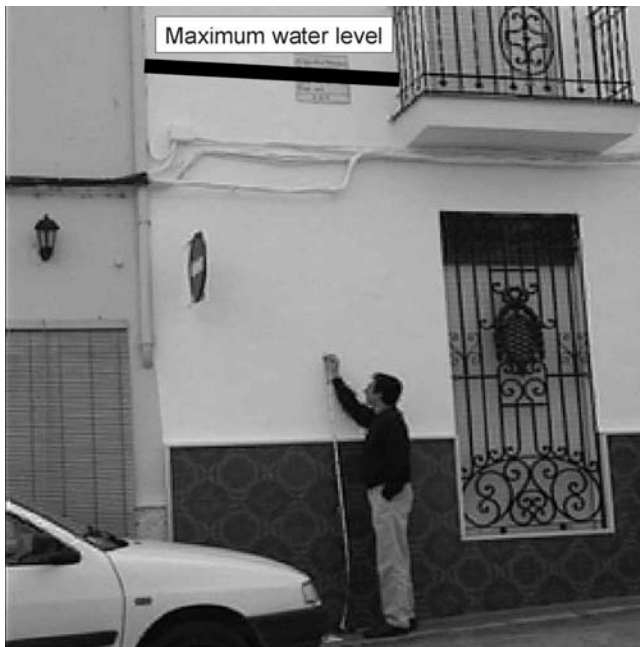
Figure 17 Probe 10. The man marks 2 m elevation above the ground.

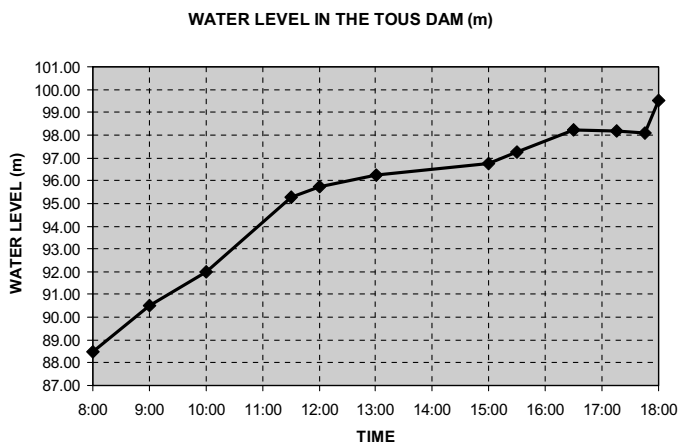
Figure 24 Water level recorded in Tous Dam during the event (from CEDEX, 1989a).

Figure 24 shows recorded water level in Tous reservoir until the dam failed by overtopping. As it has been mentioned before it appears that water elevation never exceeded 99.5 m (MSL). There is also evidence that the water elevation in the reservoir had dropped to 81 m at 23 : 30, October 20.
