Experiences and results of bus crash investigation - Stockholm

Informal document GRSG-123-14
(123rd GRSG, 28 March–1 April 2022)
Agenda item 2(a))

Klaratunneln 2019-03-10

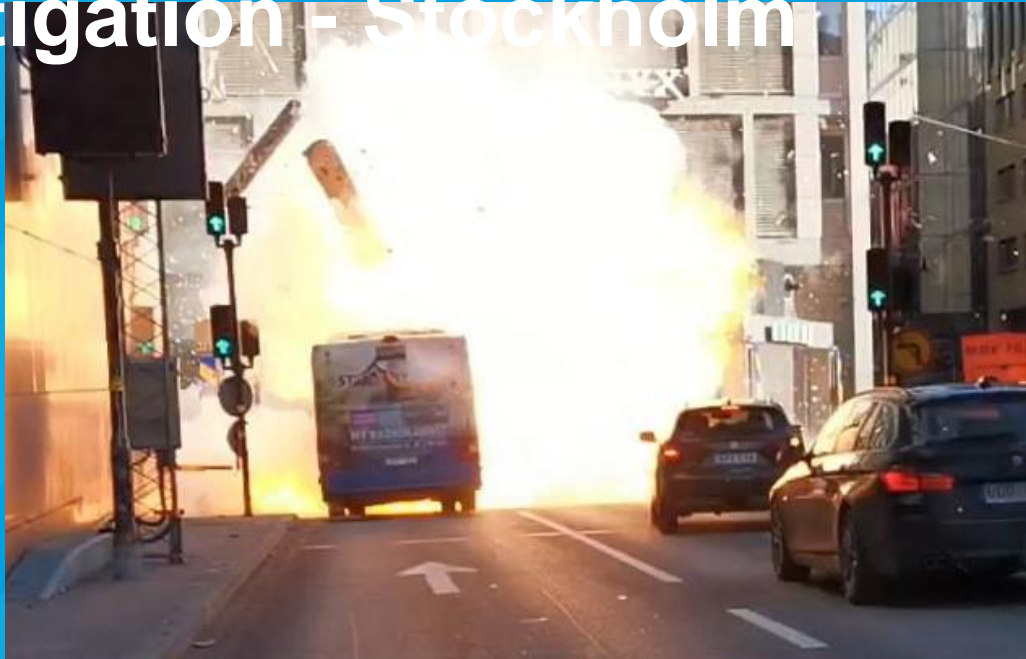
- M3 class 1 collided with a height restriction portal
- Year 2018, articulated, CNG propulsion system
- A gas-cylinder was penetrated and pushed down through the roof and filled the passenger compartment with gas
- The gas-cylinder then flew away and hit a house facade 13 m up
- The vehicle caught fire, ignition source unclear

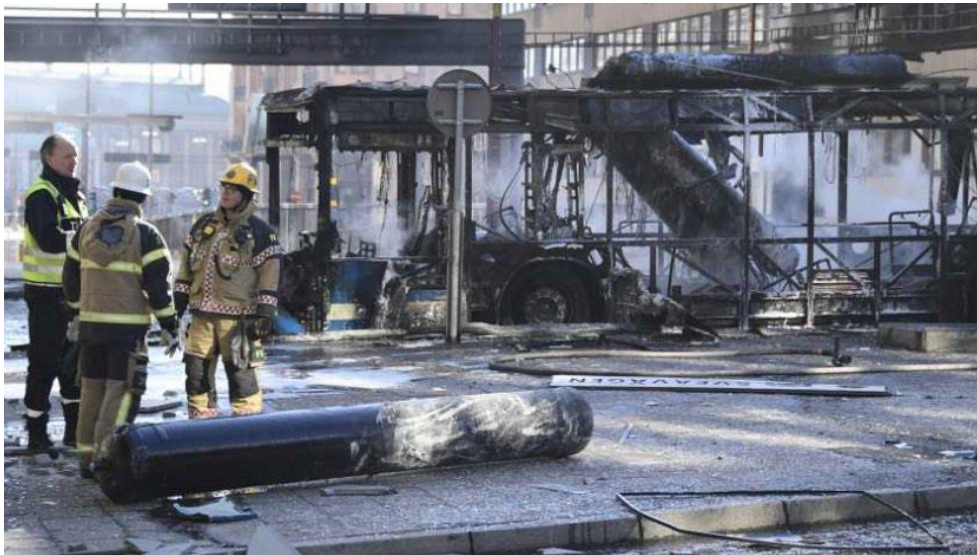
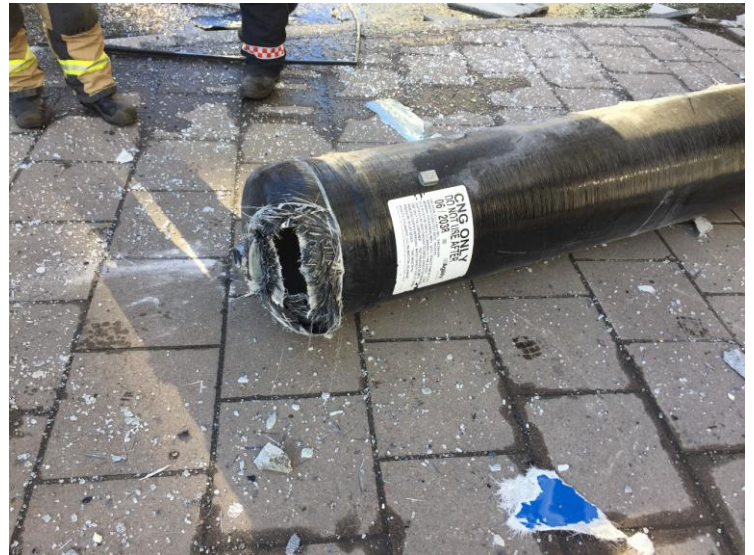
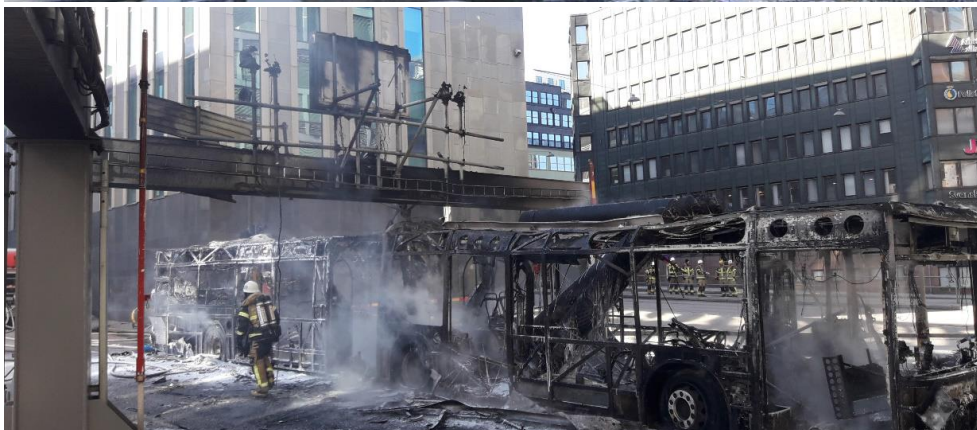
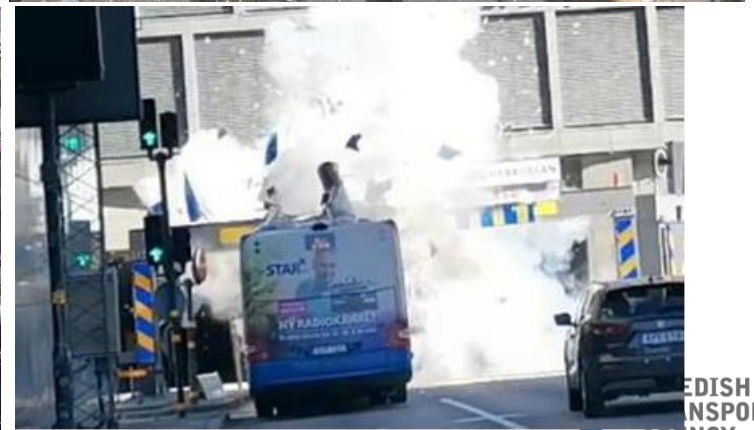
- Vehicle Height Information – improvement or ineffective?
- Support system – warning or active?
- Passenger compartment integrity – room for improvement?
- Protective structures or breakaway features?
