# **REPORT**

## **from the on-site training and results of the application of the Checklists B.1 and B.2 of the tailings management facilities (TMF) Methodology**

*based on the safety evaluation of the TMF of JV «Zarafshon»  
(Penjikent, Republic of Tajikistan)*

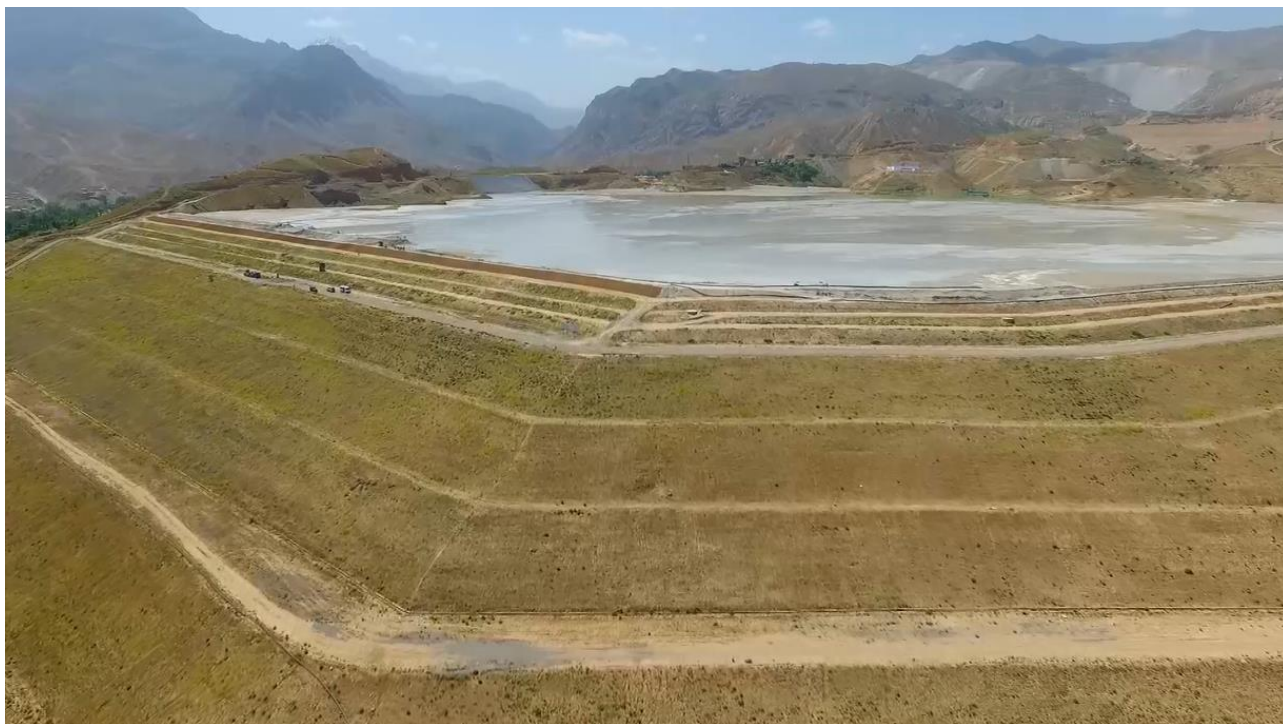
Figure 2: Views of the TMF from its northern side

The participants noted that almost all systems for ensuring the safe operation of the TMF are in satisfactory condition, maintained and operating without any evidence of accidents that might have occurred in the past. The dam's technical conditions are monitored regularly and, in general, sufficiently; however, the enterprise is introducing new control systems for individual parameters that were not previously recorded.
