## Committee of Experts on the Transport of Dangerous Goods and on the Globally Harmonized System of Classification and Labelling of Chemicals

#### Explosives and related matters: improvement of test series 8

## Recommendations on Test Series 8: Applicability of Test Series 8 (d)

### Transmitted by the Institute of Makers of Explosives (IME)

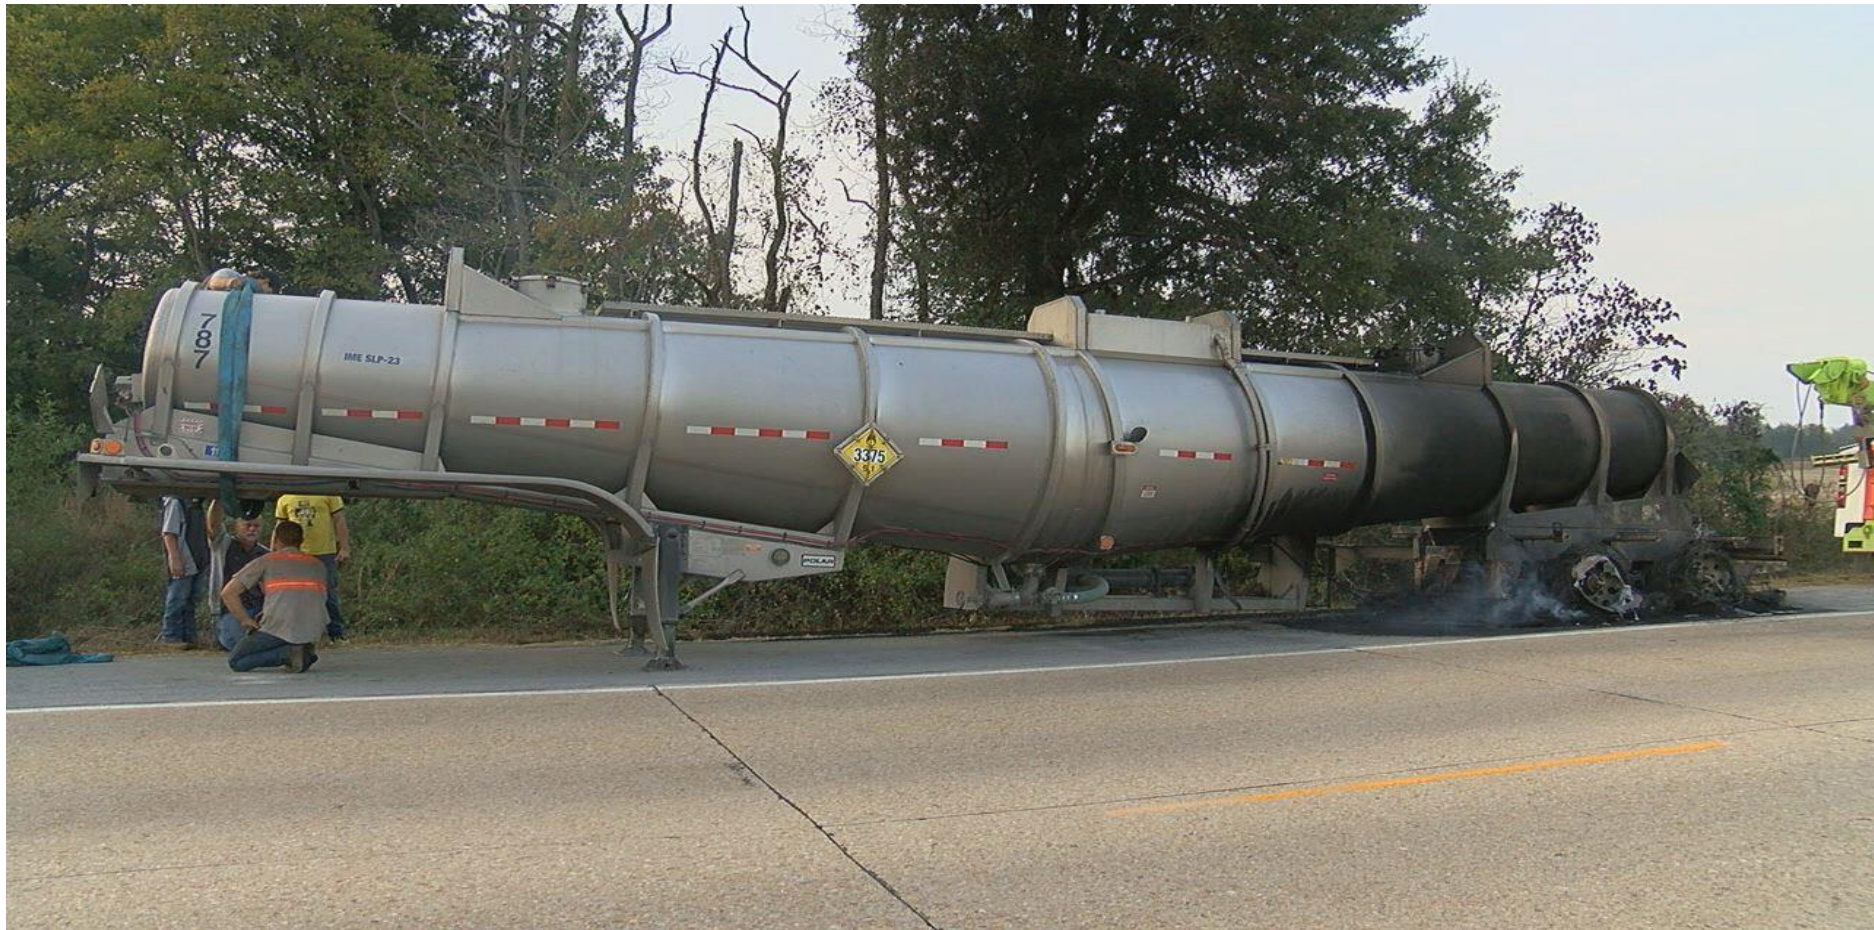
5. In the first event a transporter was carrying 44,000 lbs. of 5.1 emulsion, an ANE, on a highway in Arkansas when, for unknown reason(s), there was a fire in the axle area (Figures 1 to 3). The event occurred on 25 October 2016. Fire suppression was attempted unsuccessfully and eventually all 8 tires were engulfed in flames. Emergency Response procedures were activated, and the area was evacuated to a ½ mile radius. The fire was allowed to burn out. There were no injuries. All wheels burned on the tanker, and the aluminium fenders also melted. The double-walled stainless steel tank did not fail. The ANE, without any signs of heat damage, was recovered.

Figure 1. The tanker after the fire had died down

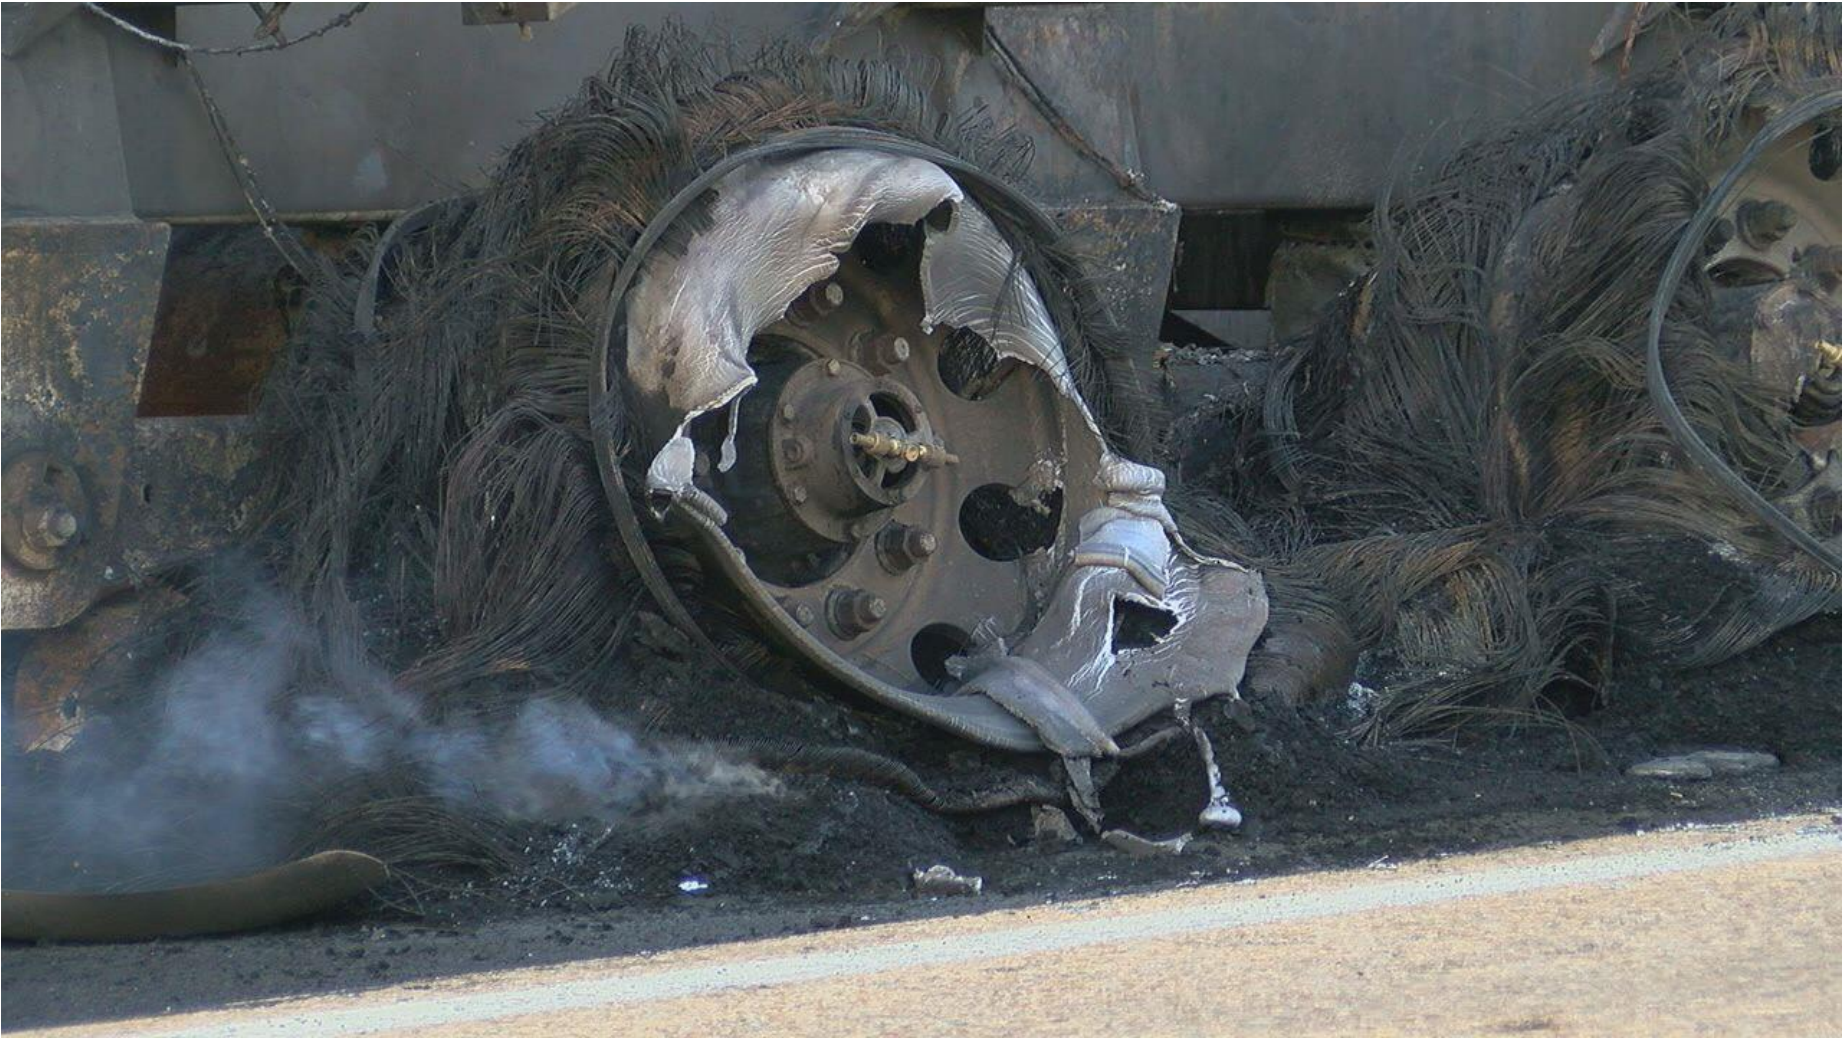
Figure 2. Closeup on the burnt tire area

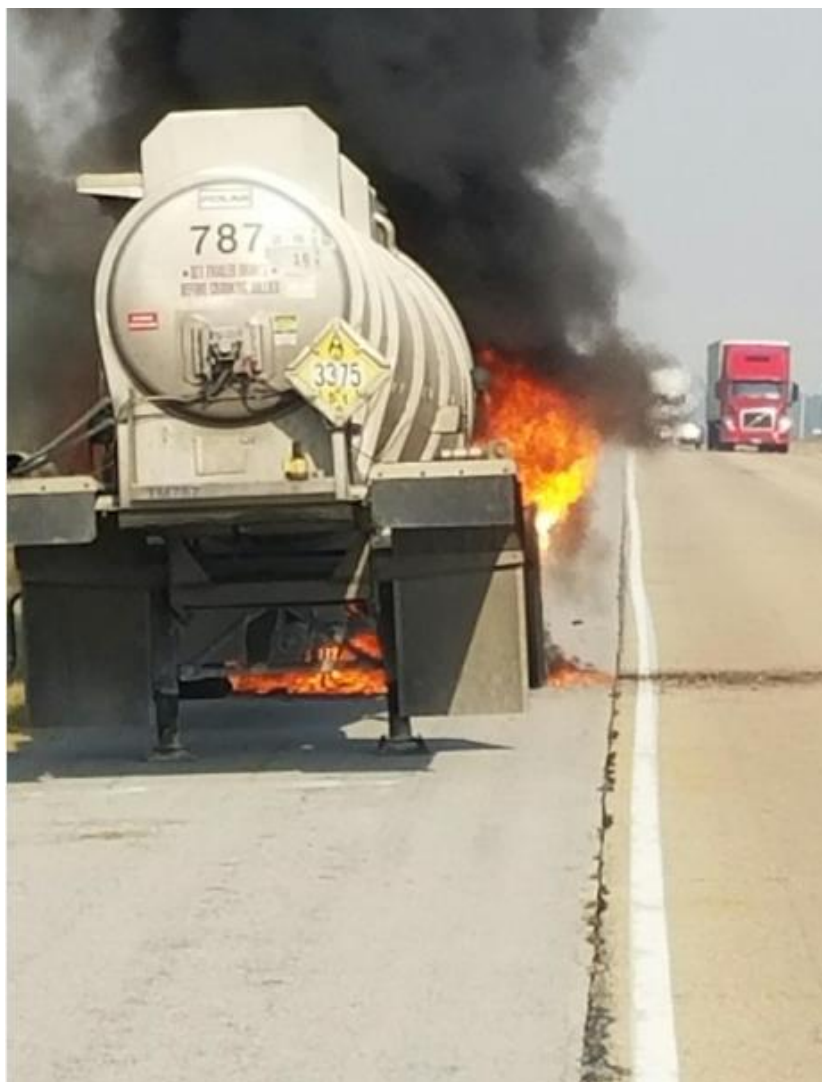
Figure 3. The tanker image captured while the fire was raging.

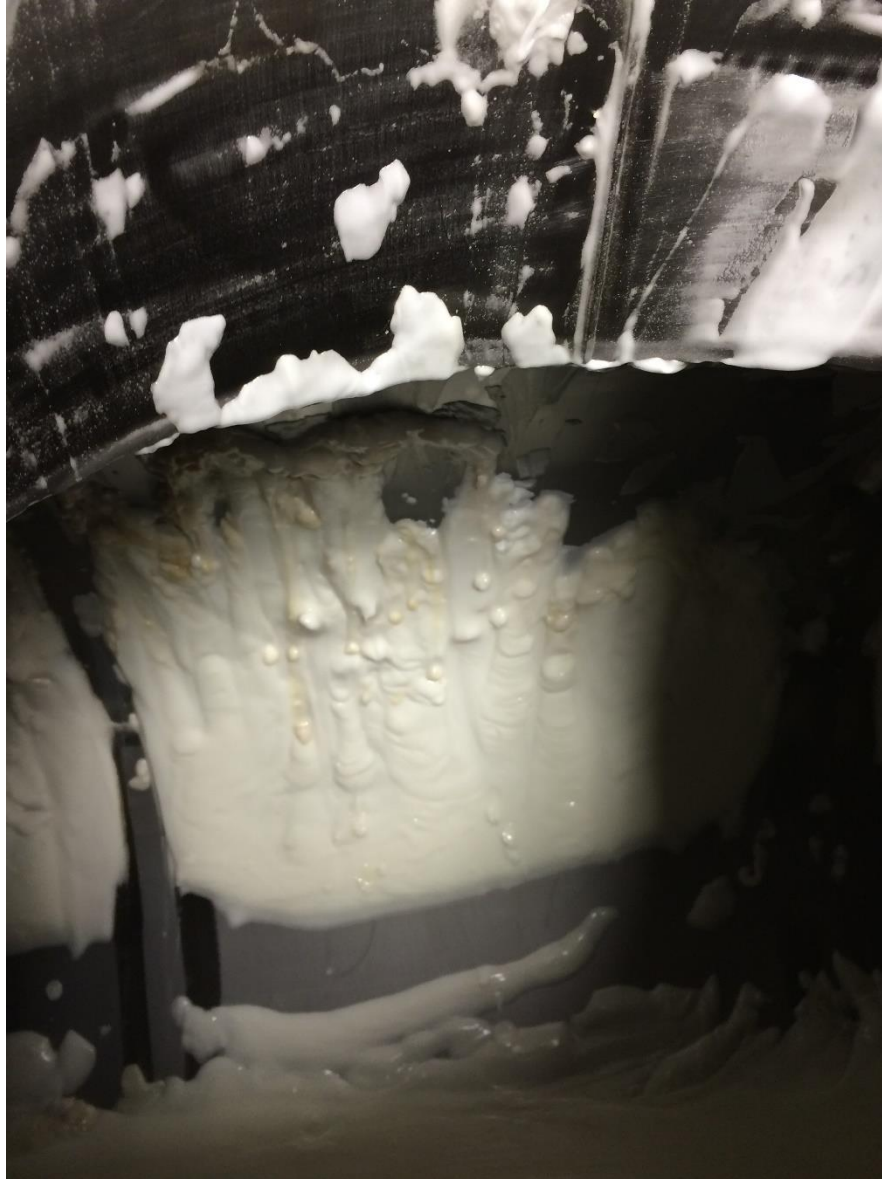
out with all personnel cleared for a one-mile area. The fire consumed all six tires on the passenger side of the trailer, the air hoses, lights and wiring, and melted the aluminum rims. Once the fire had burned out the emulsion was pumped out of the tank. (Figures 4 to 6).

Figure 4: Crust (on top) and residual sensitised emulsion in the heated area after almost all the product was pumped out of the tank

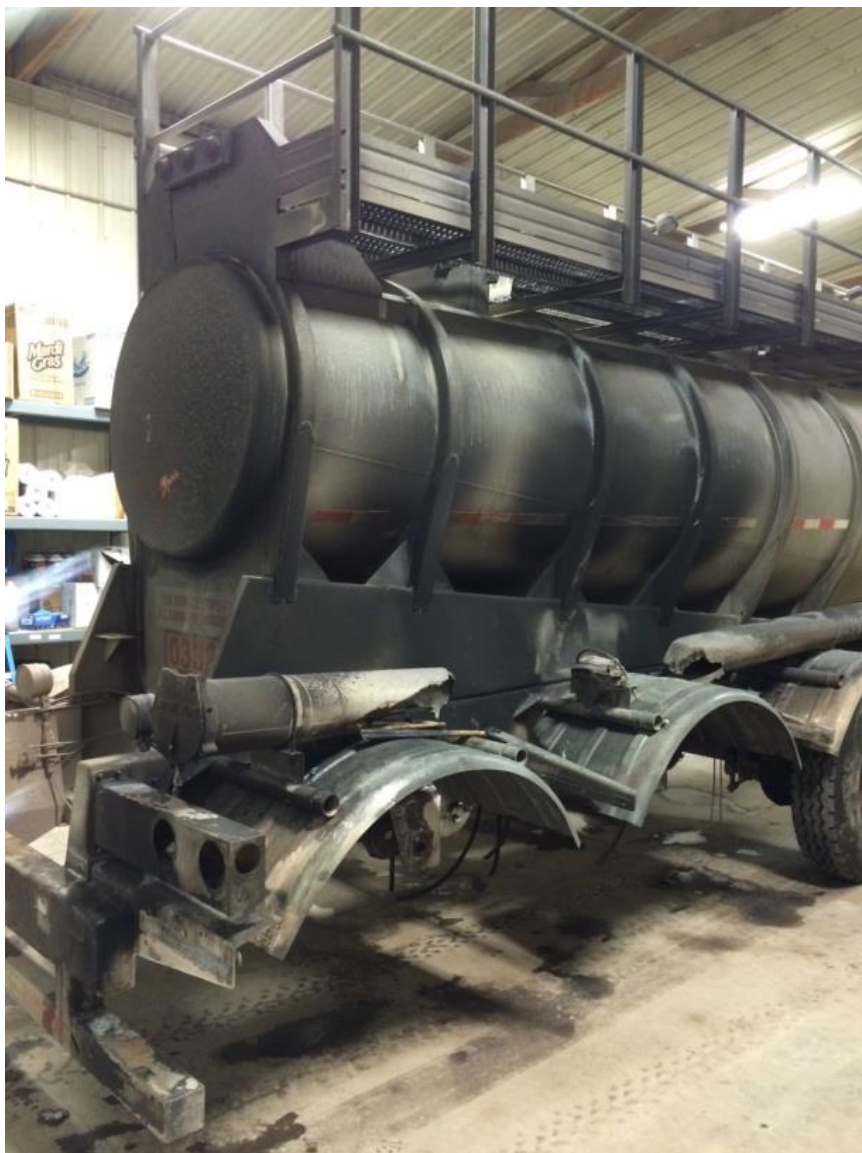
Figure 5: Tanker in the workshop showing heated-affected areas

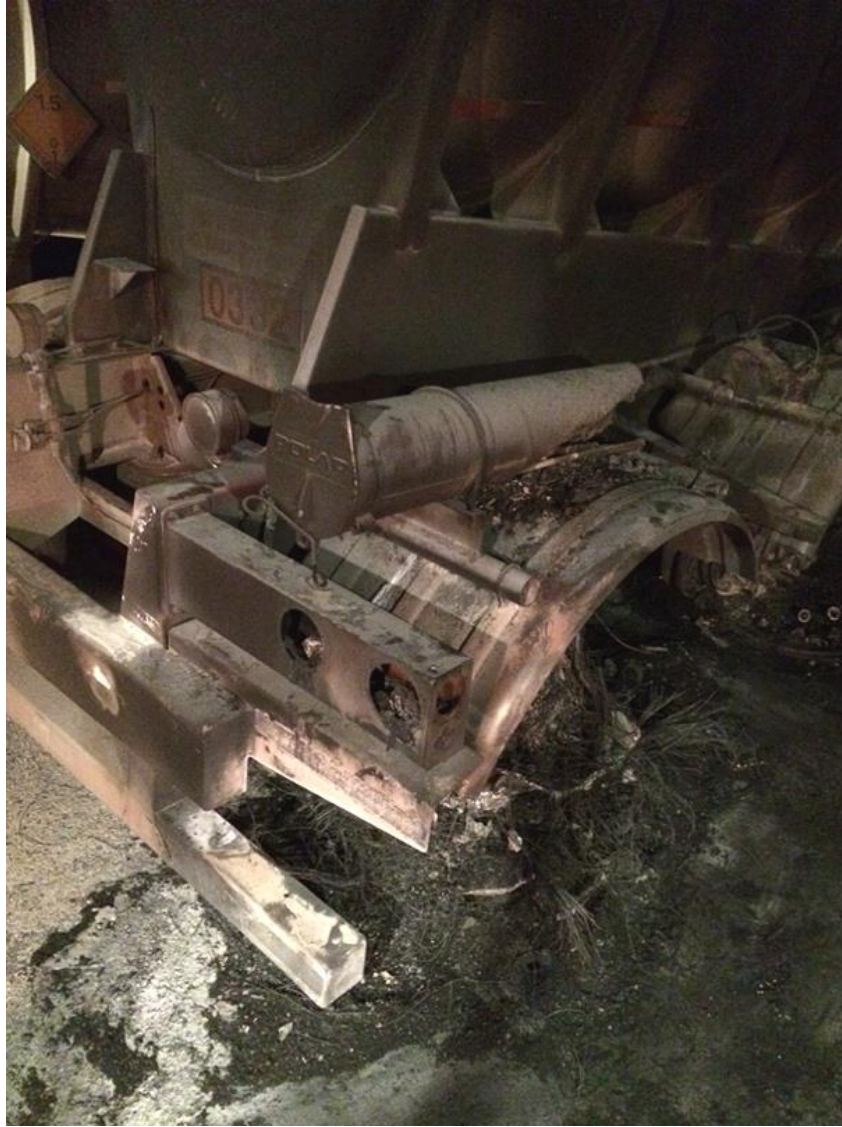
Figure 6: Burnt and melted tire area
