Technical meeting
to prepare for the on-site training in Tajikistan and to enhance capacity for governance and policy making on tailings safety in Central Asia

Recommendations for visual inspection of tailing dumps

Prof. Dmitry Pikarenia
Technical University
“Metinvest Polytechnic”
Mariupol, Ukraine

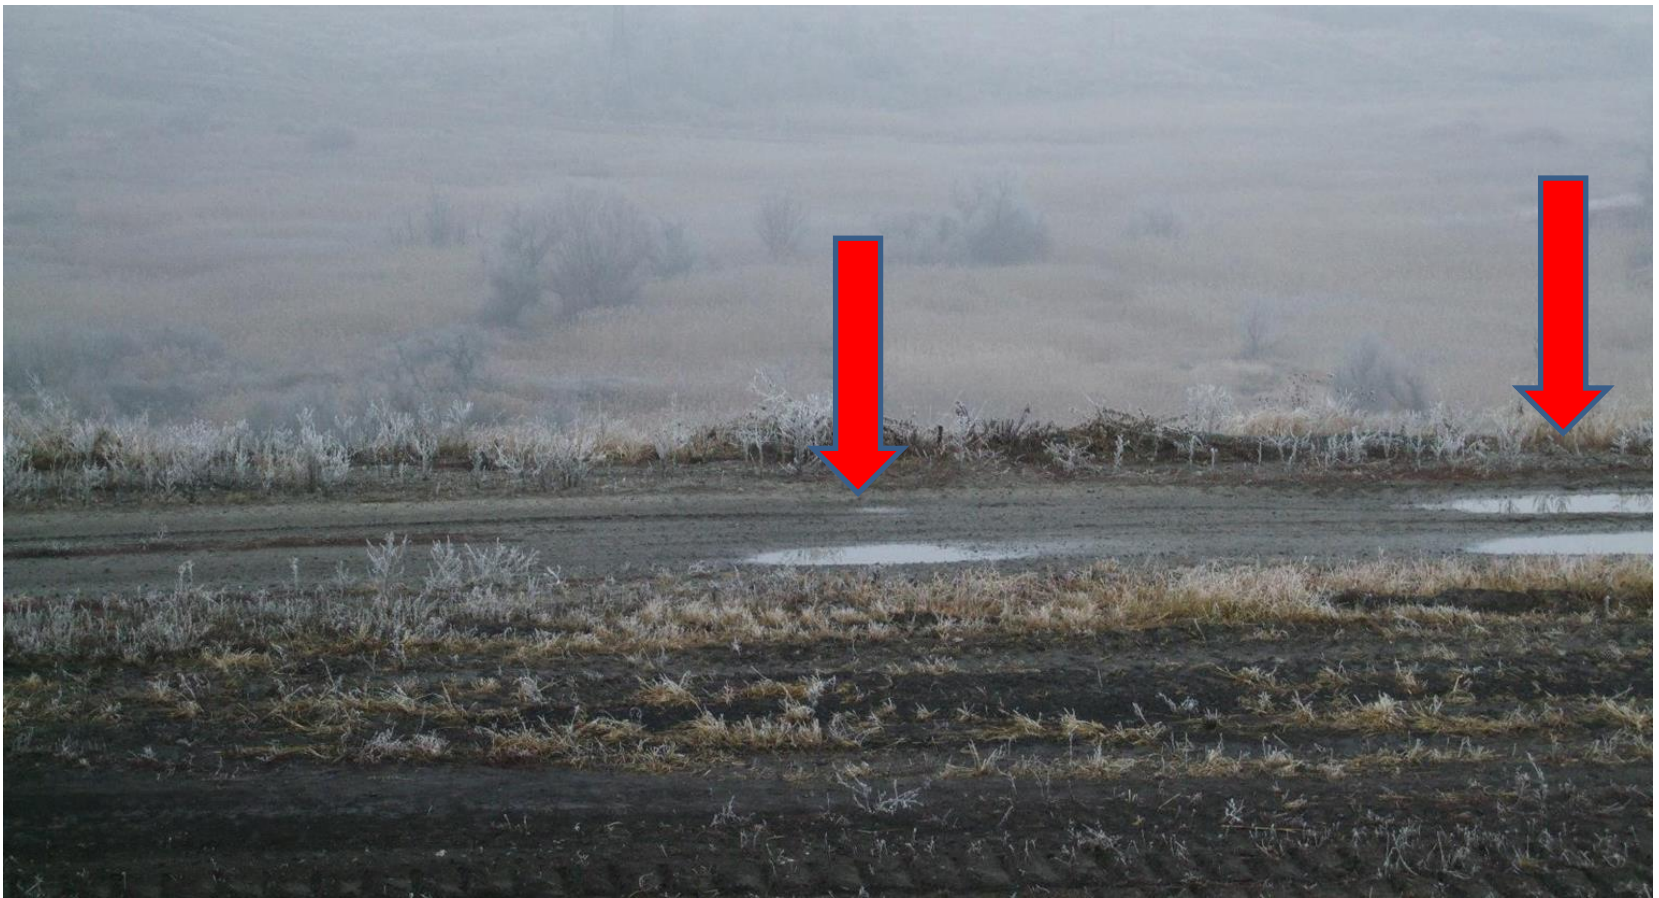
Excessive waterlogging of the dam, atmospheric precipitation is not absorbed.

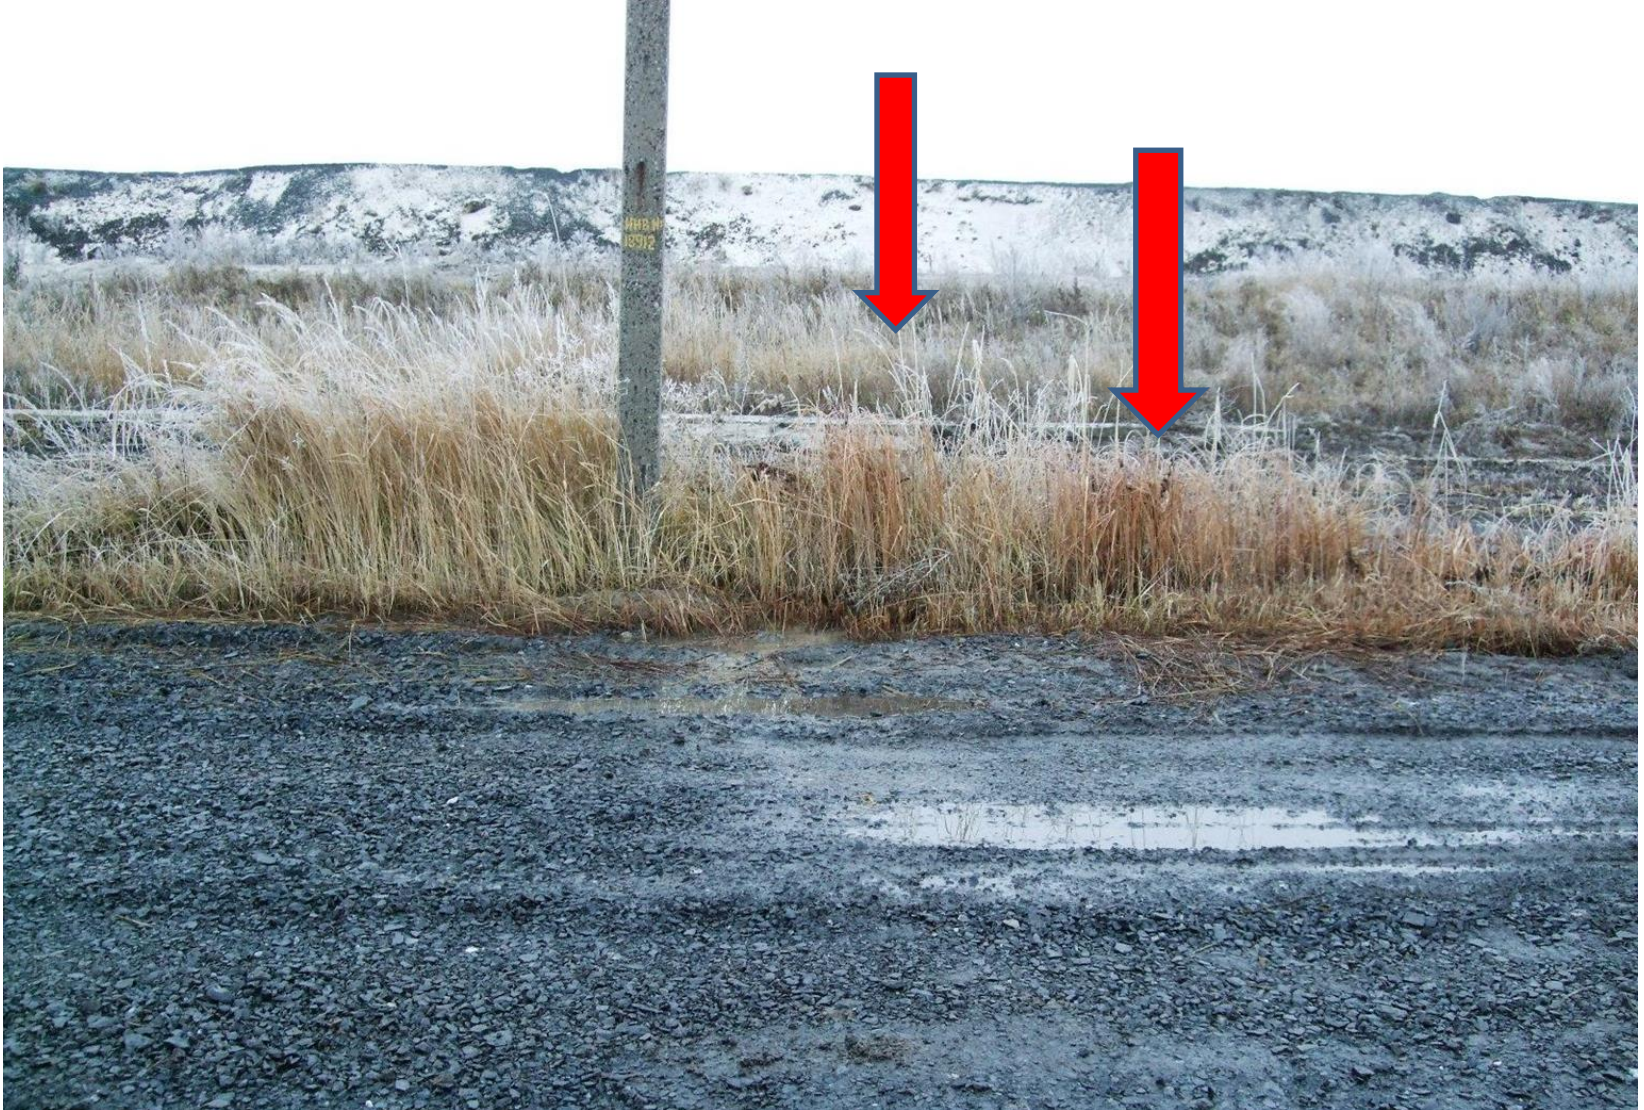
An implicit sign of filtration is the development of moisture-loving vegetation

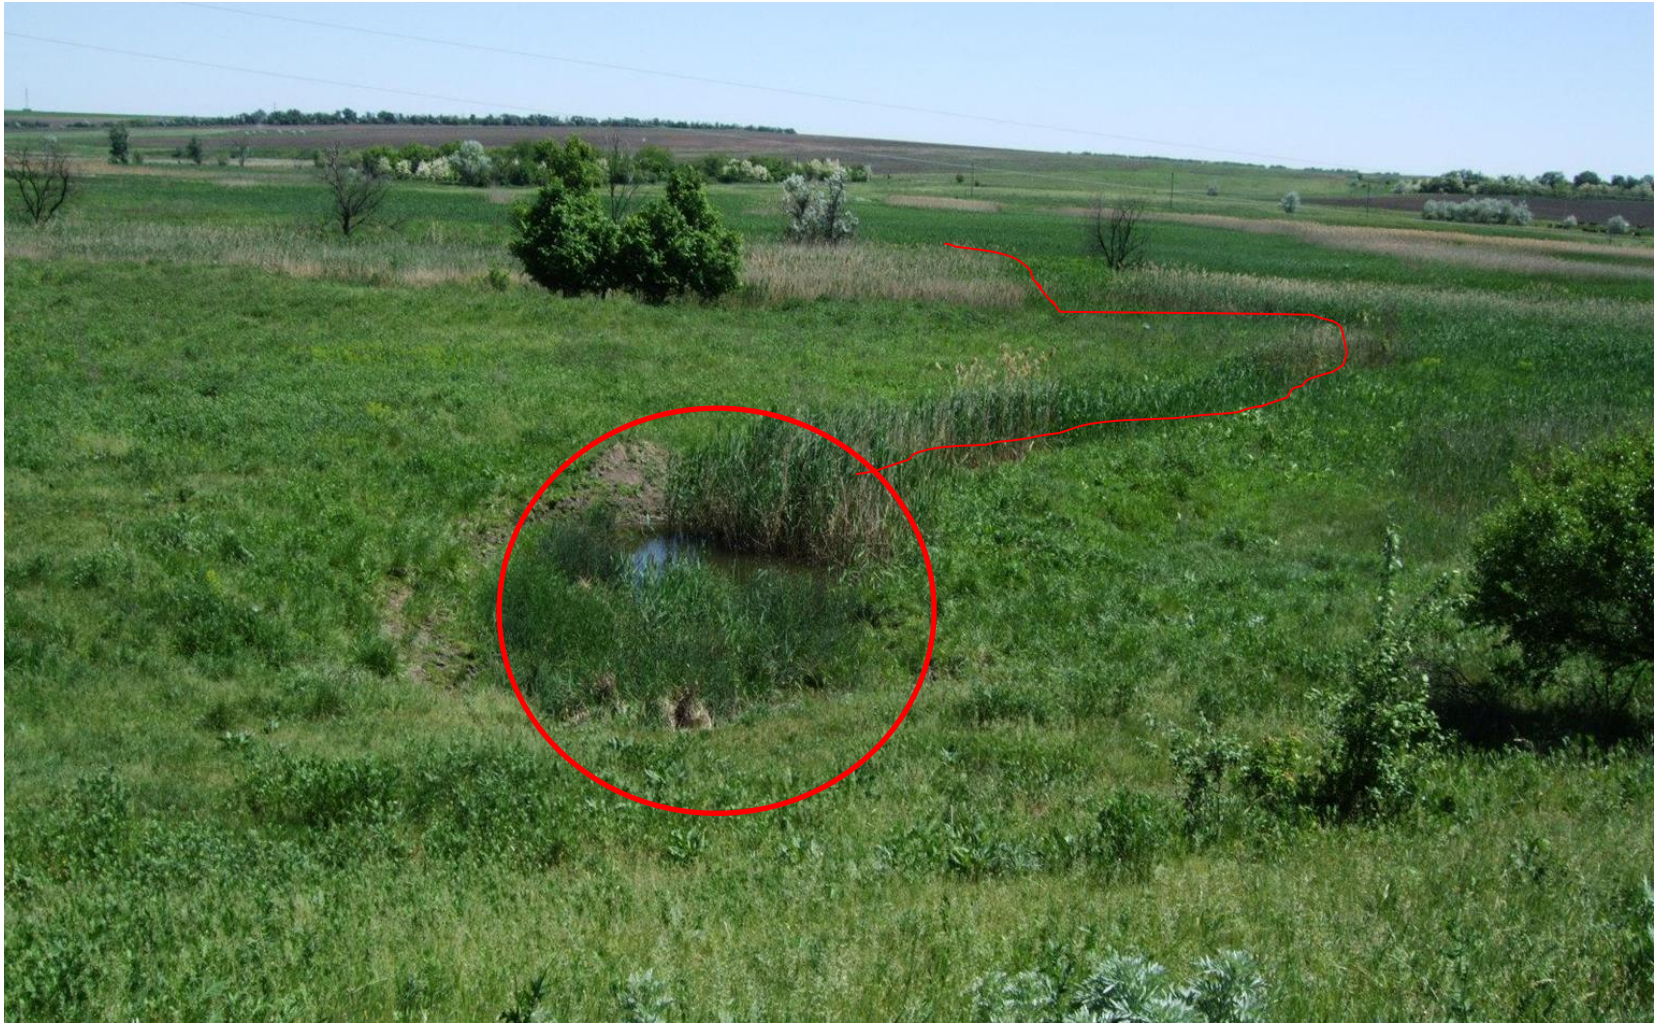
Filtration of water through a dam and outlet in the form of a spring.
(View from the dam)

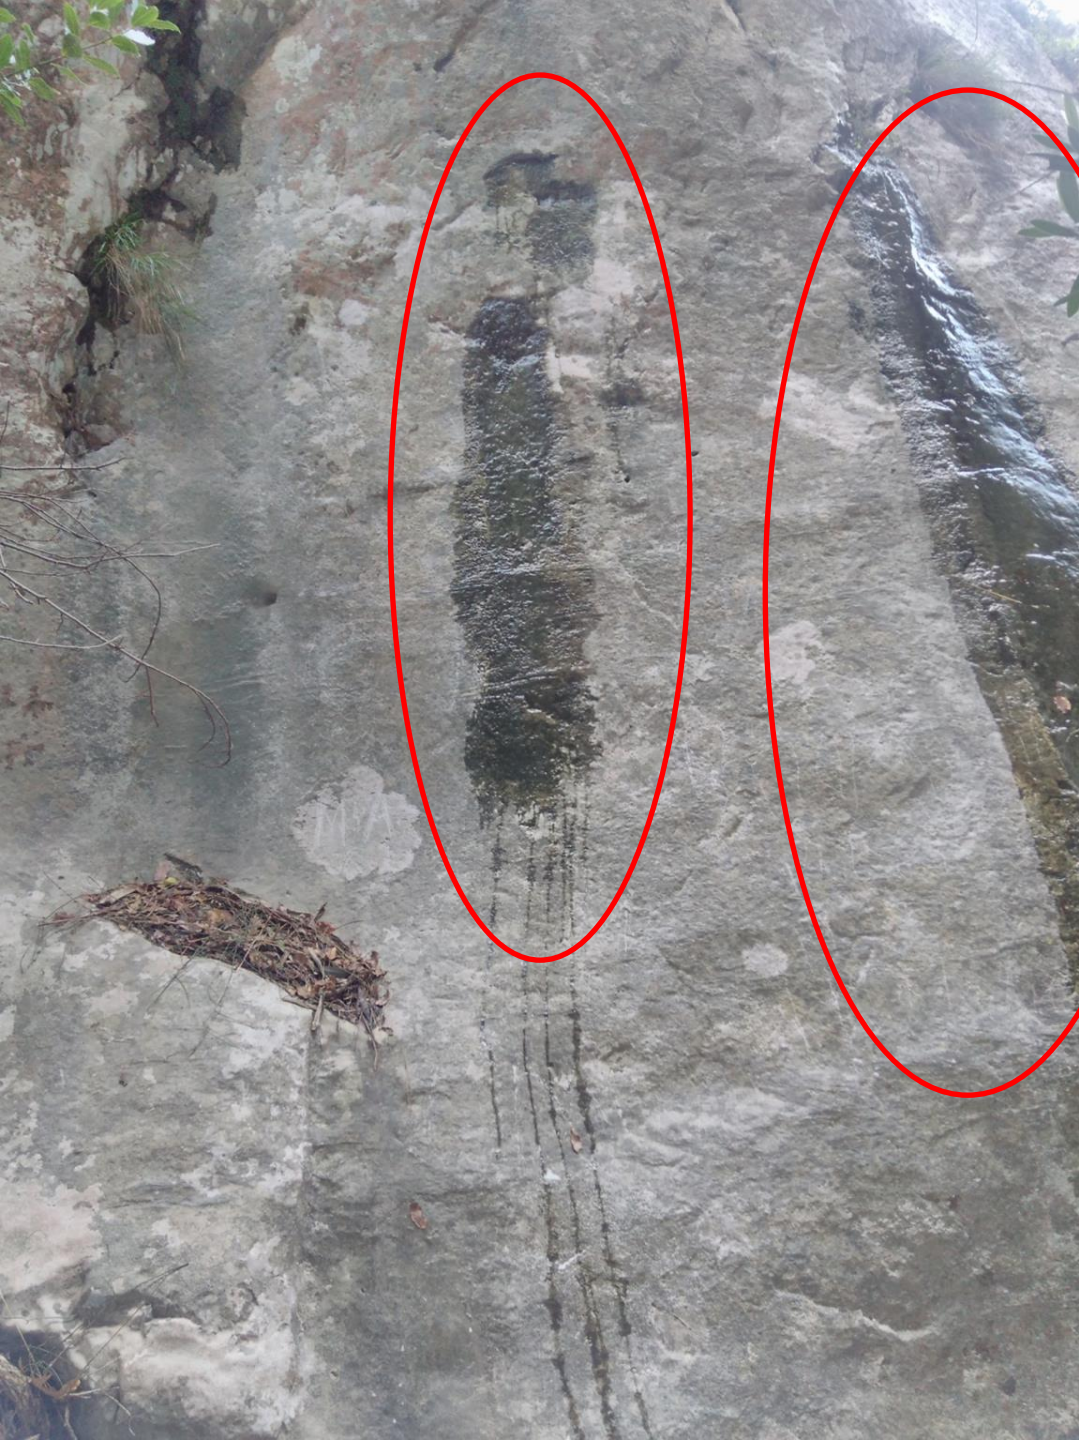
Concrete tailings dam.
Filtration of water
through
the pores in the monolith
("teardrop»)

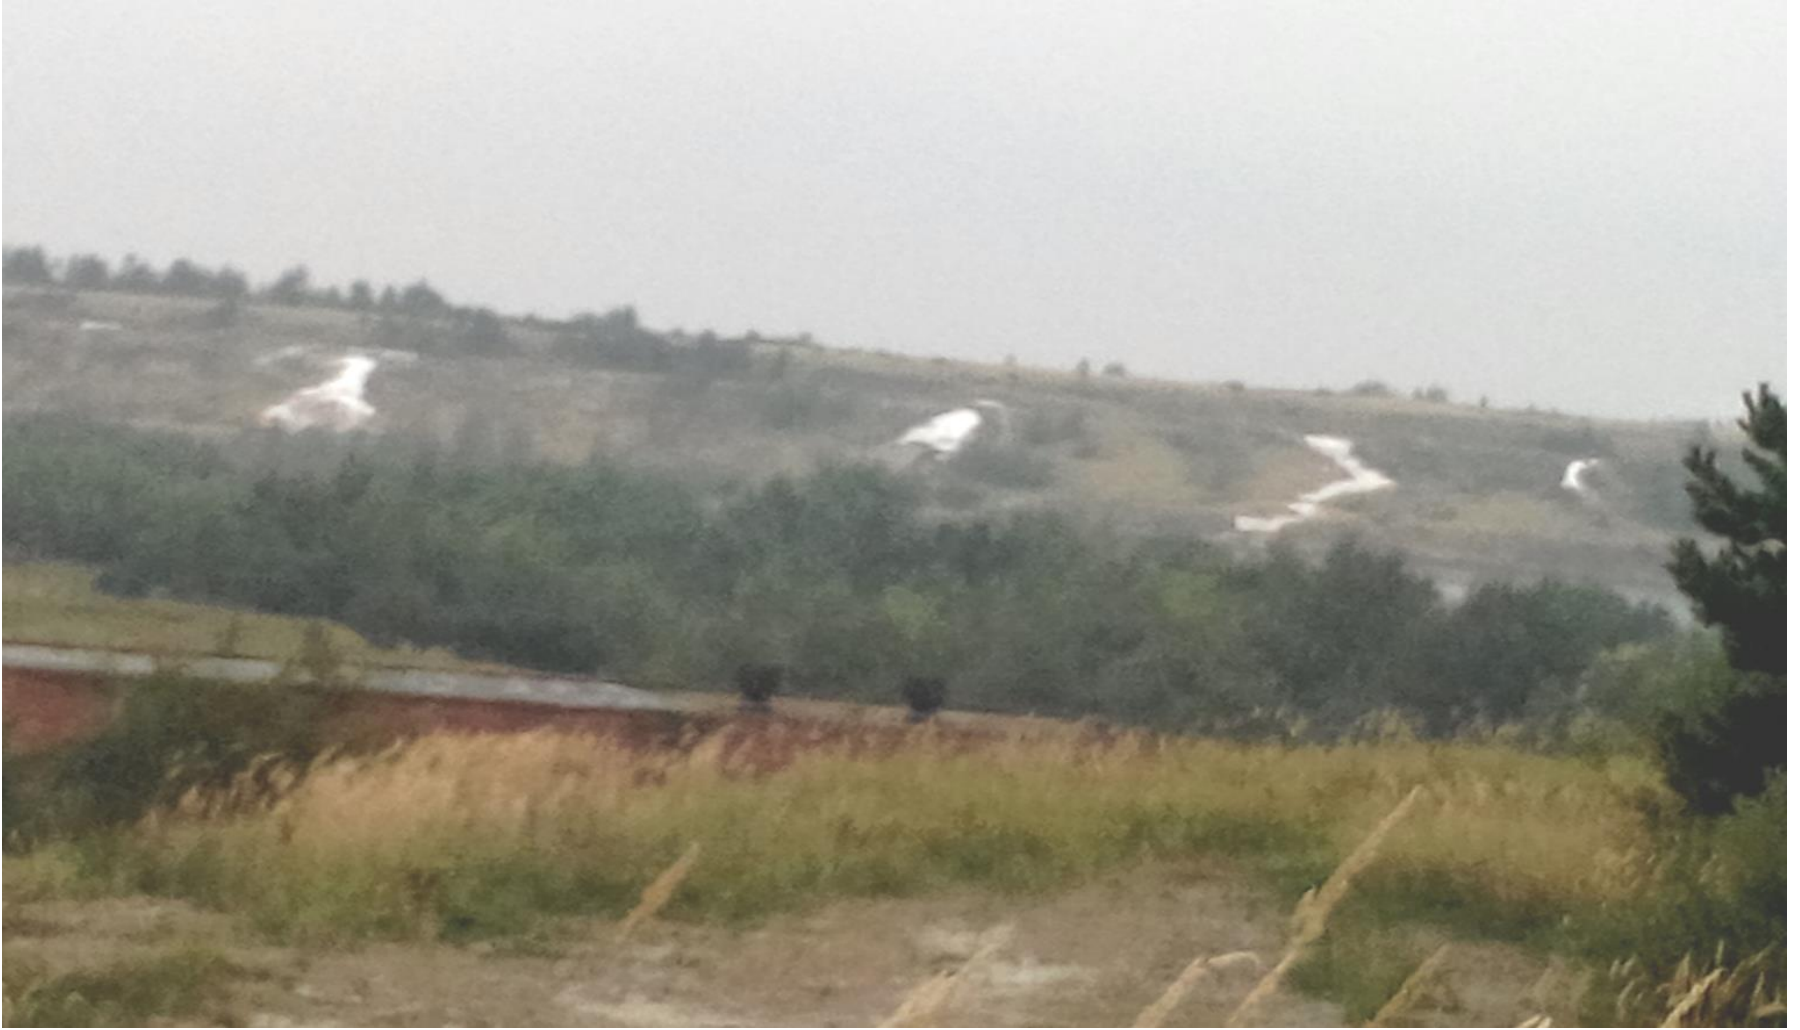
The outer slopes of the tailings dam.

Salt deposits as a result of filtration of solutions through the body of the dam

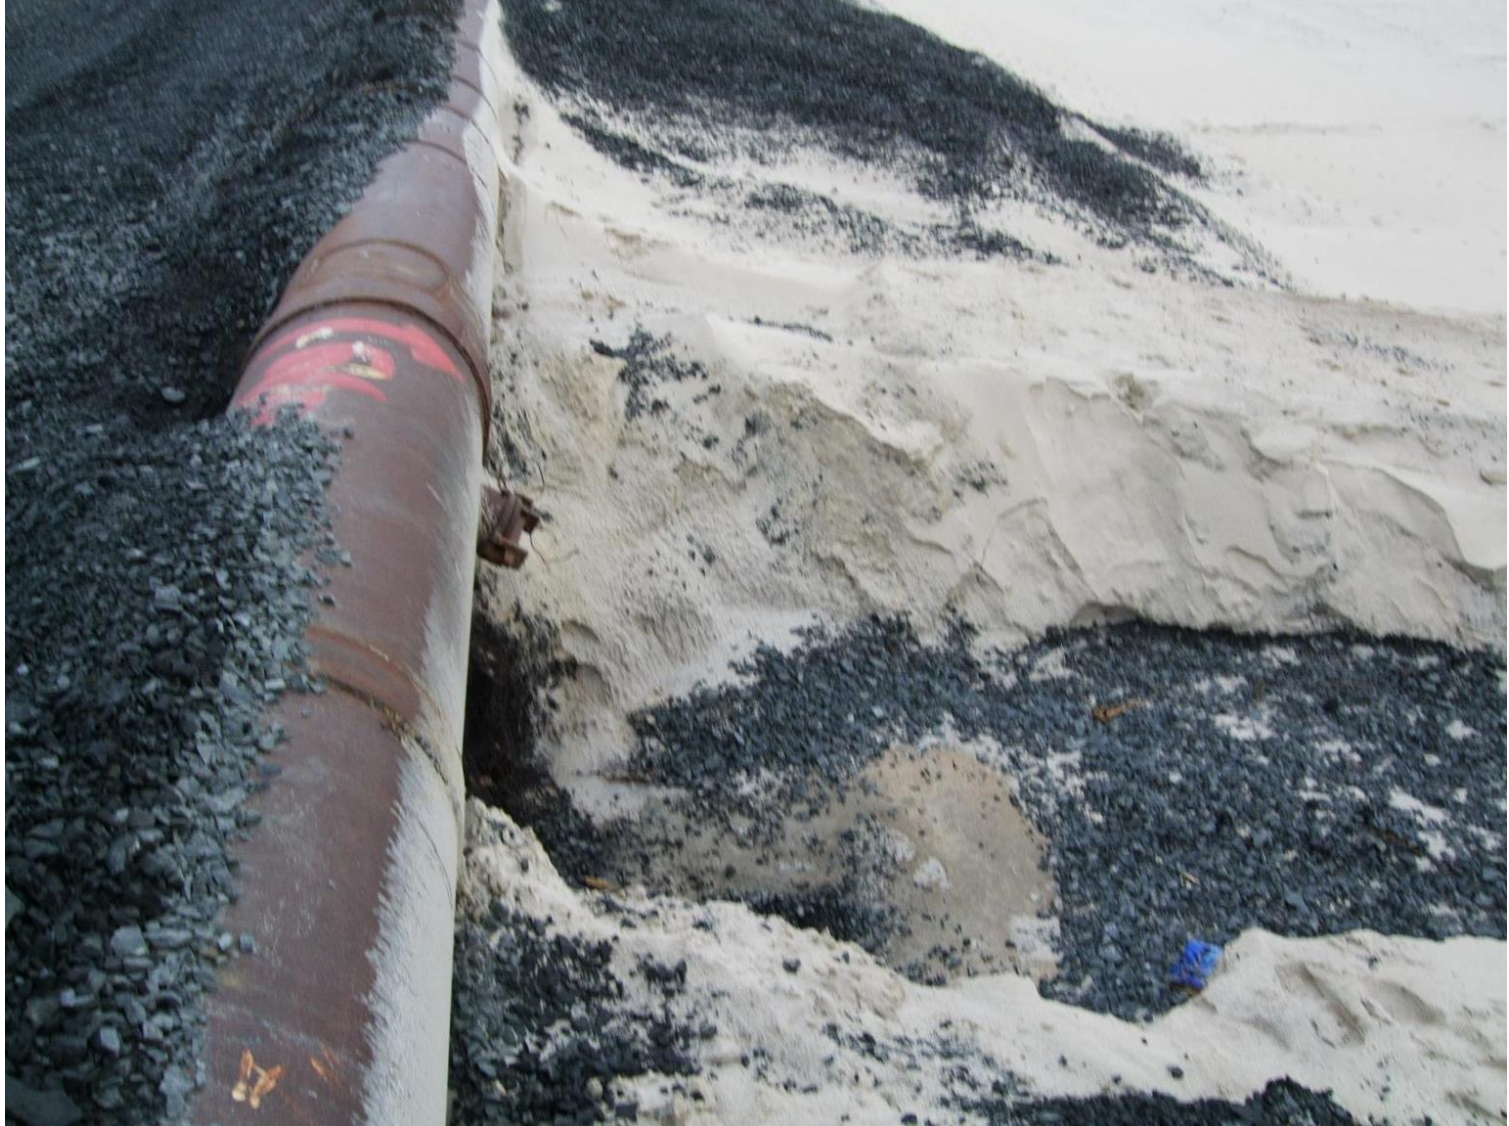
Internal slope of the tailings dam.
Erosion due to sludge pipe leaks

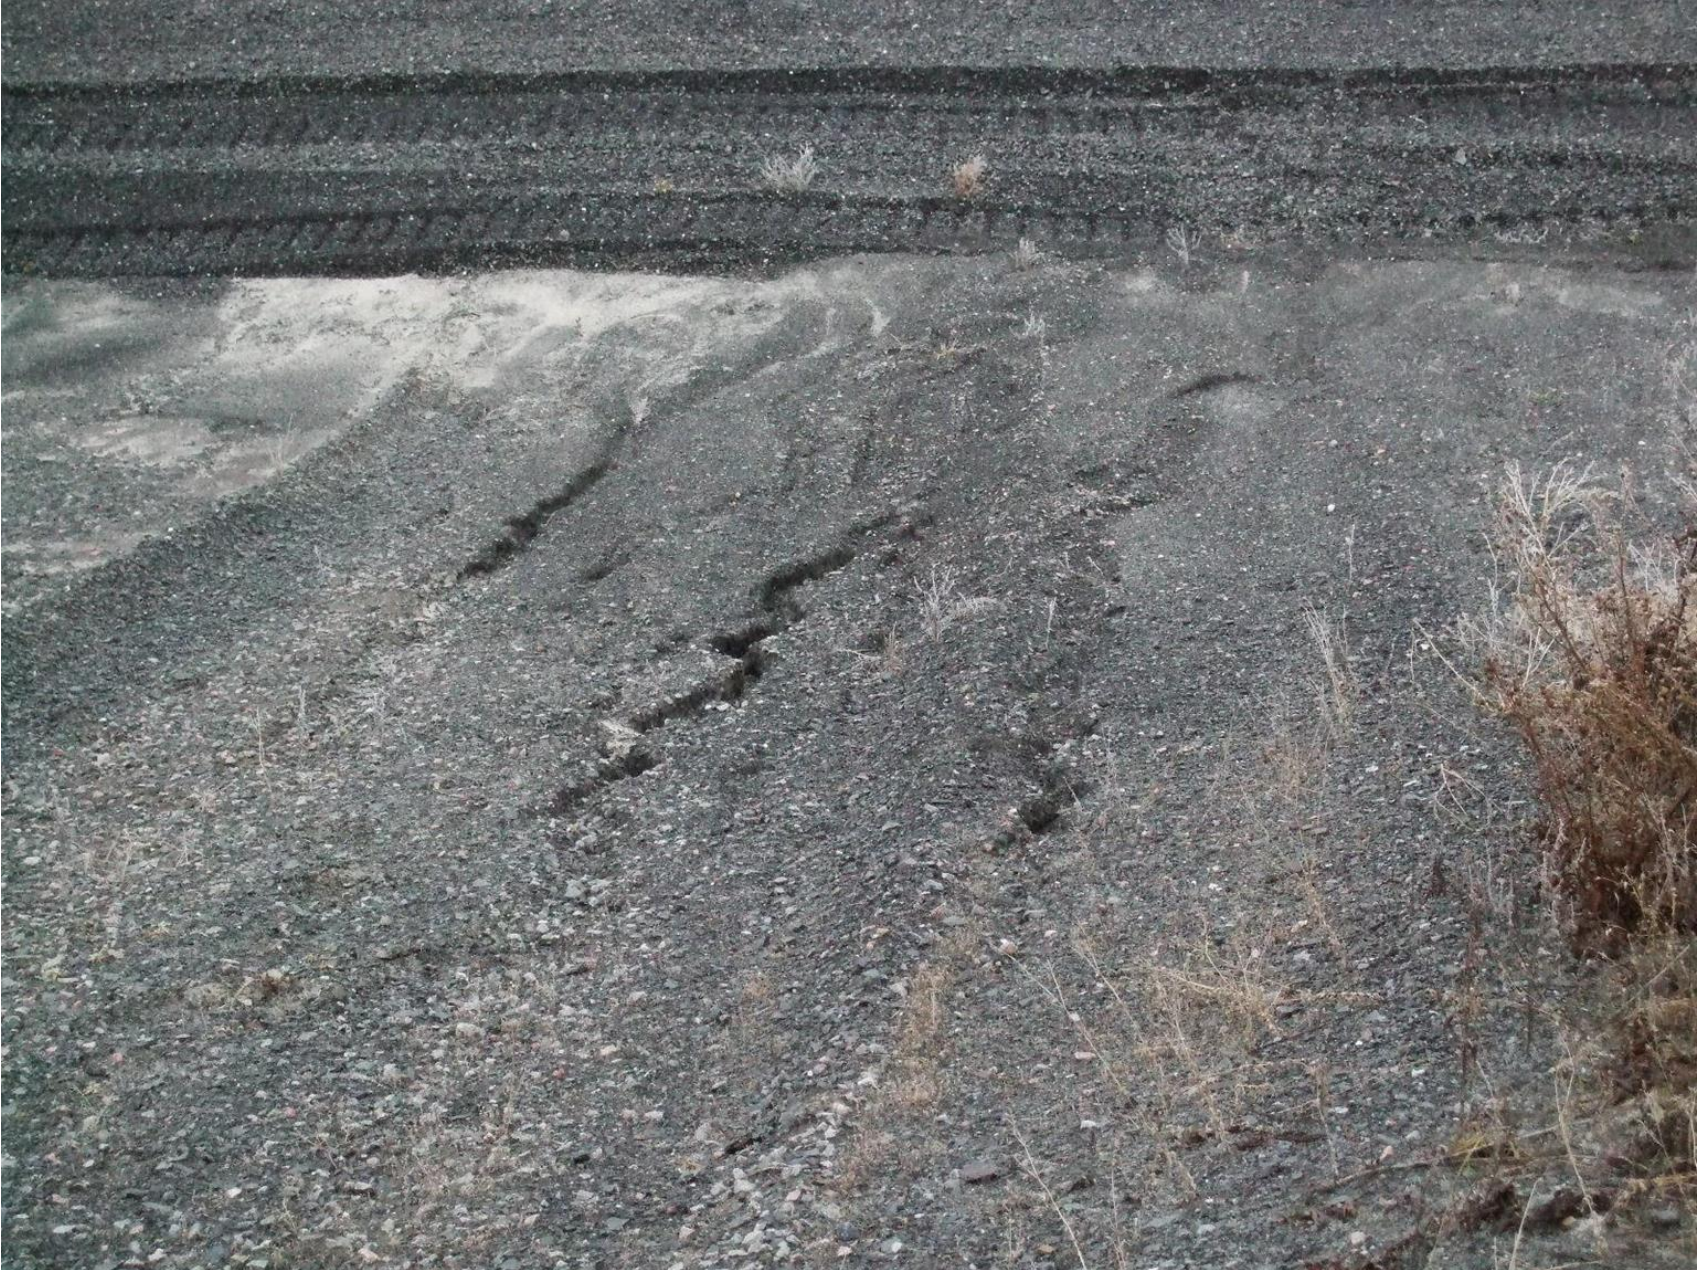
External slope of the tailings dam: rain washouts.
In these places, gullies may occur

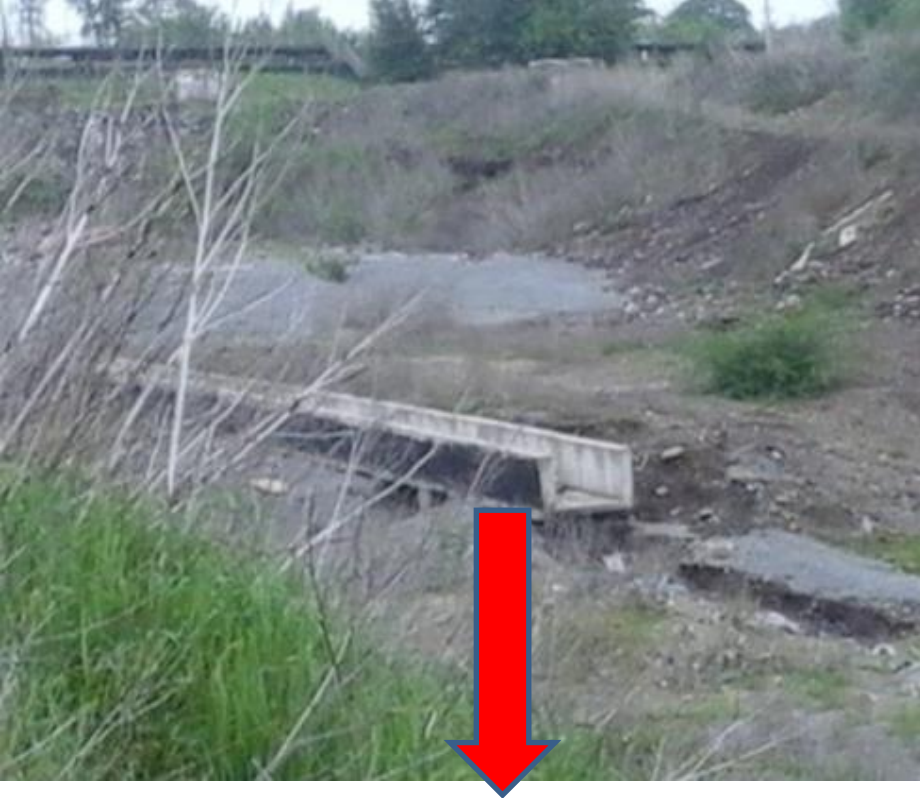
On mountain drainage ditches and chutes.

Bottom erosion of the talvega gulch or ravine caused by improper drainage of water from the territory of the tailings storage facility.

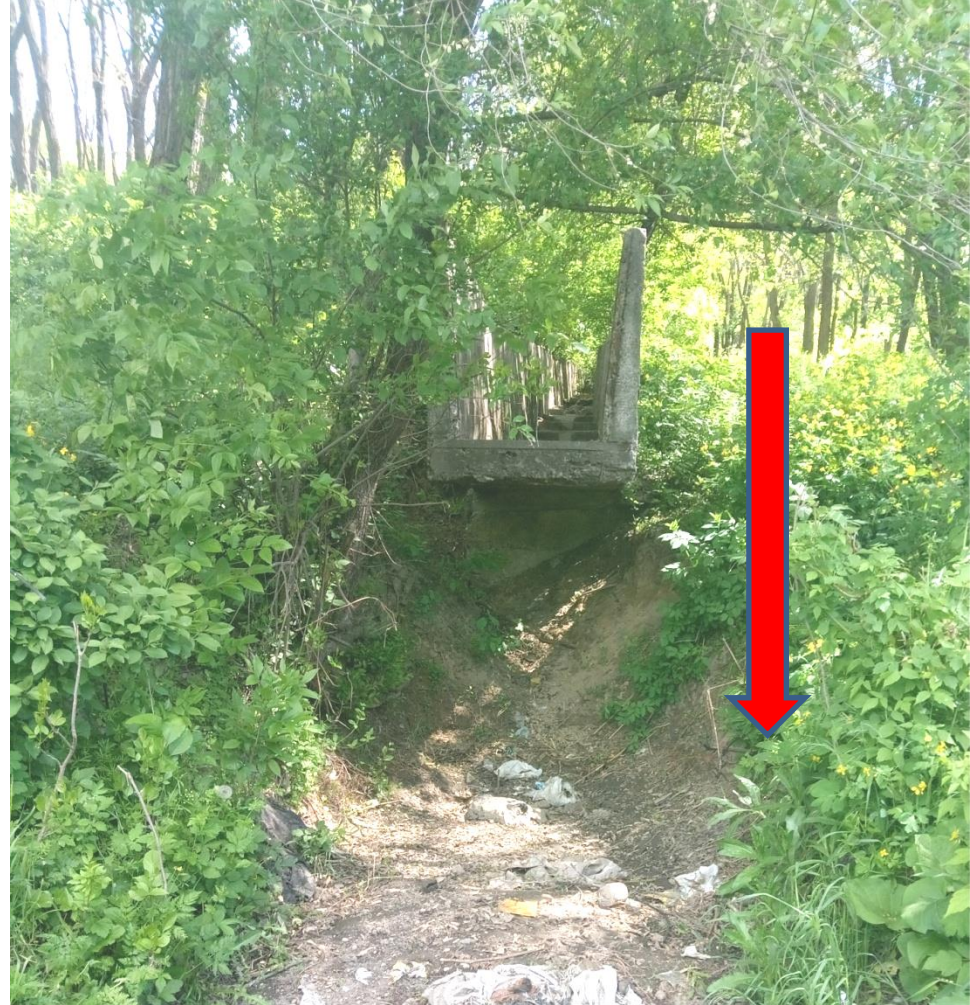
With further erosion, the drainage system will be destroyed

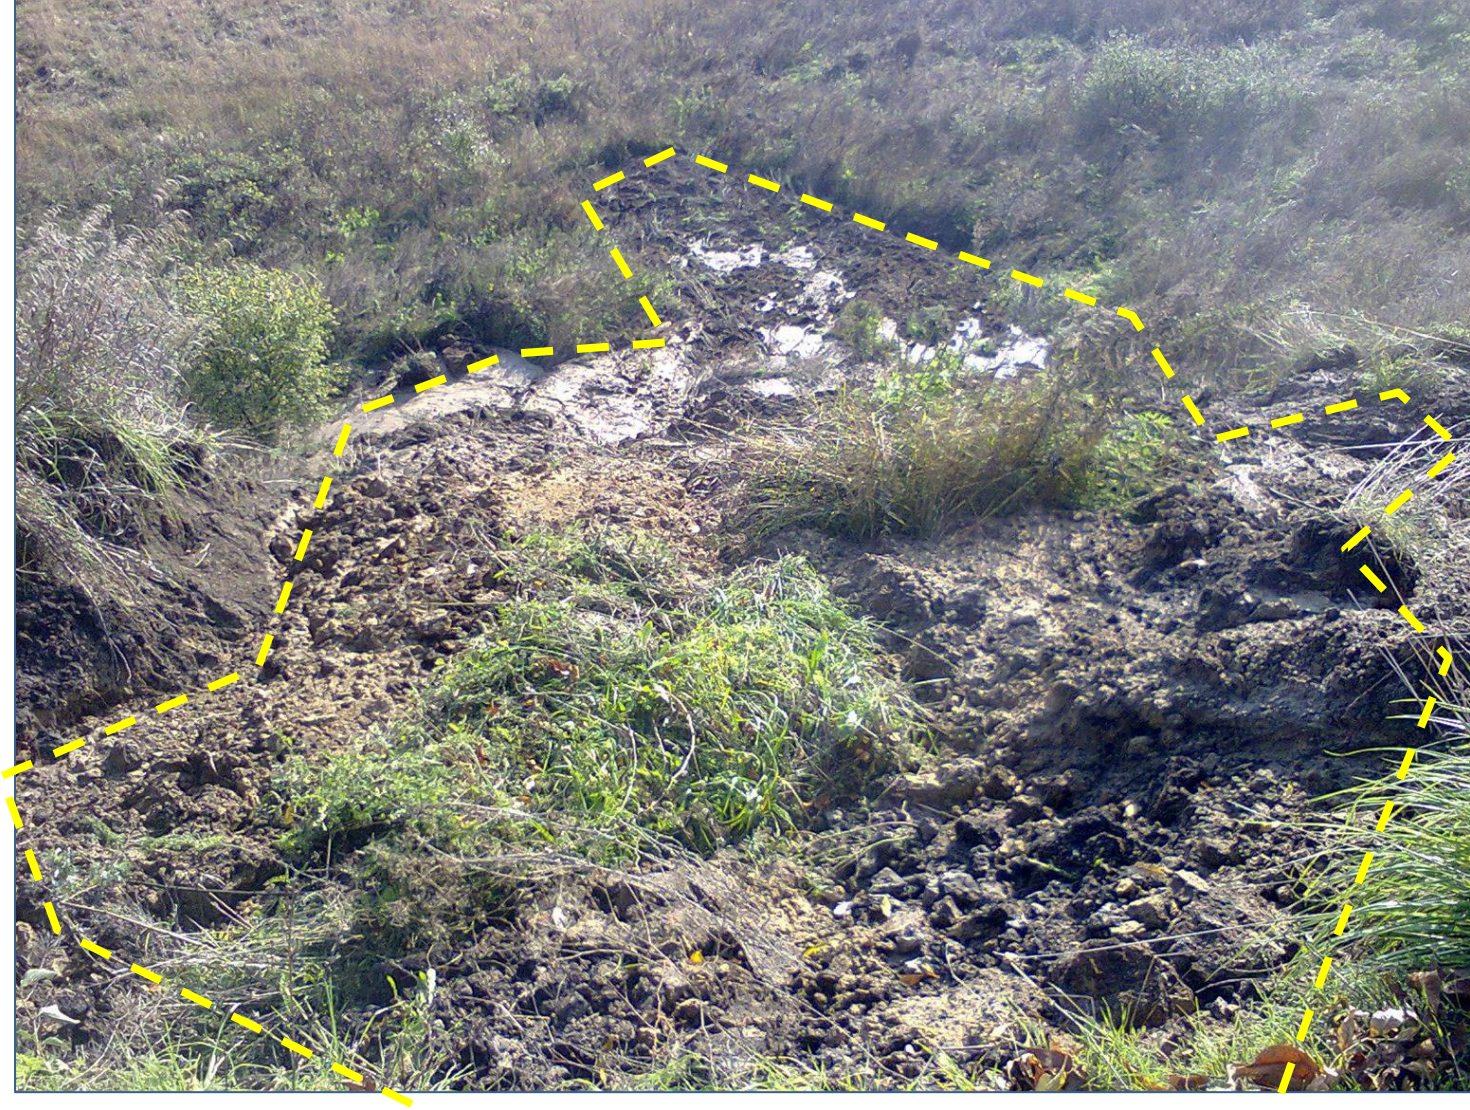
The outer slope of the dam.

A flowing landslide (oplyvina), indicating that it is heavily watered. (View from the dam)

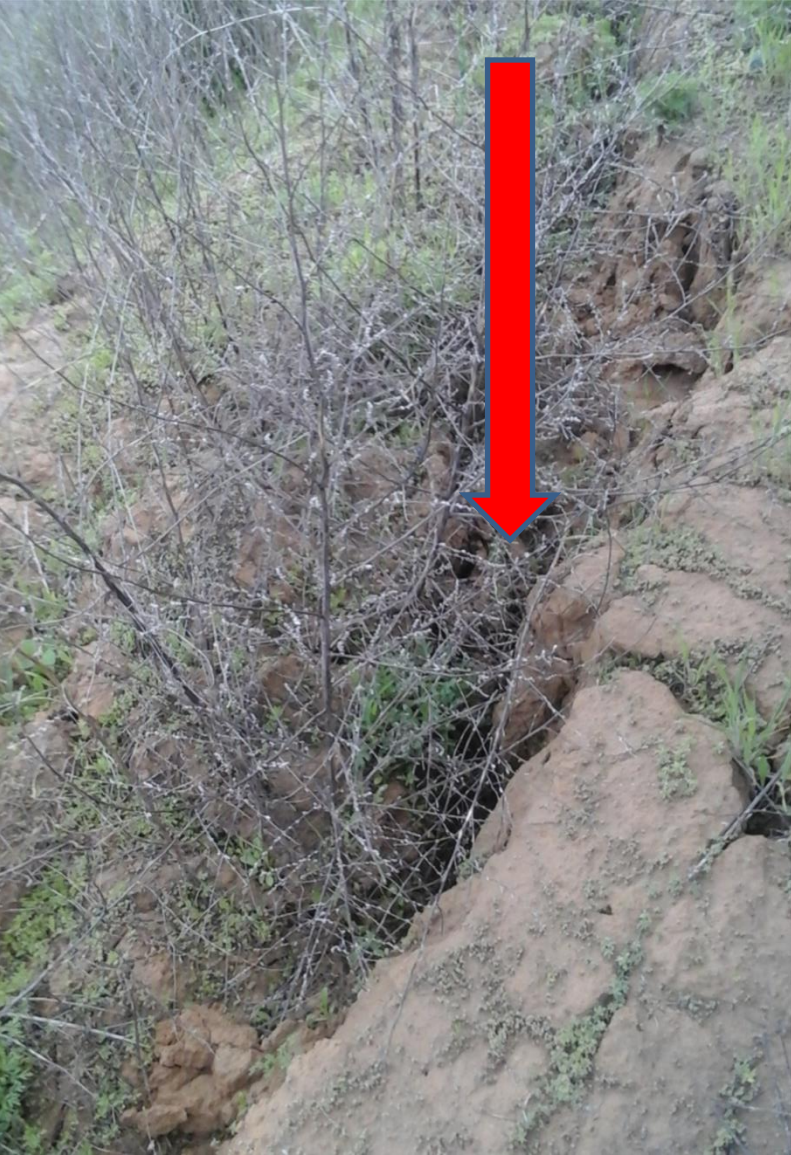
The outer side of the tailings dam.
Landslide Breakaway Crack

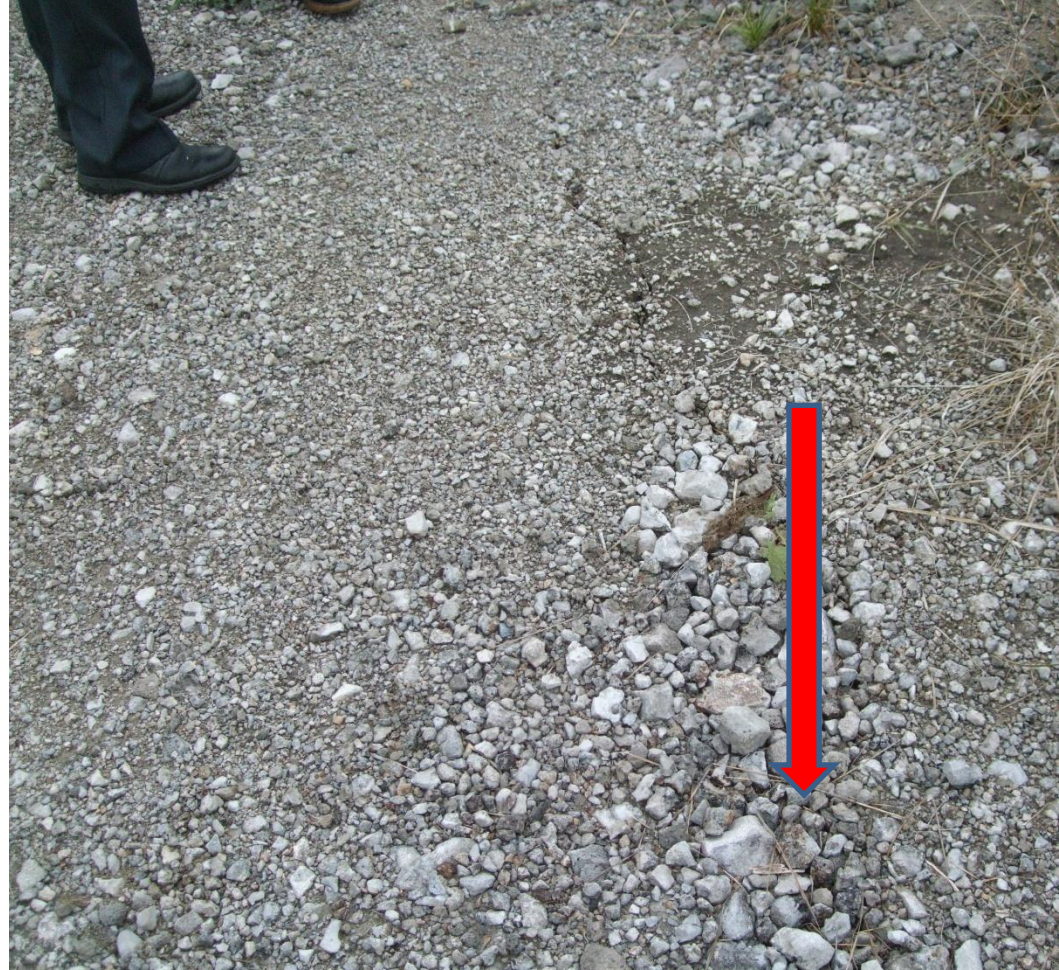
The crest of the tailings dam.
The breakaway crack is an
implicit sign of an incipient
landslide
