SATELLITE BASED RISK ASSESSMENTS AND MONITORING

SOUTH AFRICA, JAGERSFONTEIN, DIAMOND MINE TSF

SARDOBA TAILINGS STORAGE FACILITY (TSF), UZBEKISTAN

RIDDER-SOKOLNOE TAILINGS STORAGE FACILITY (TSF), KAZAKHSTAN

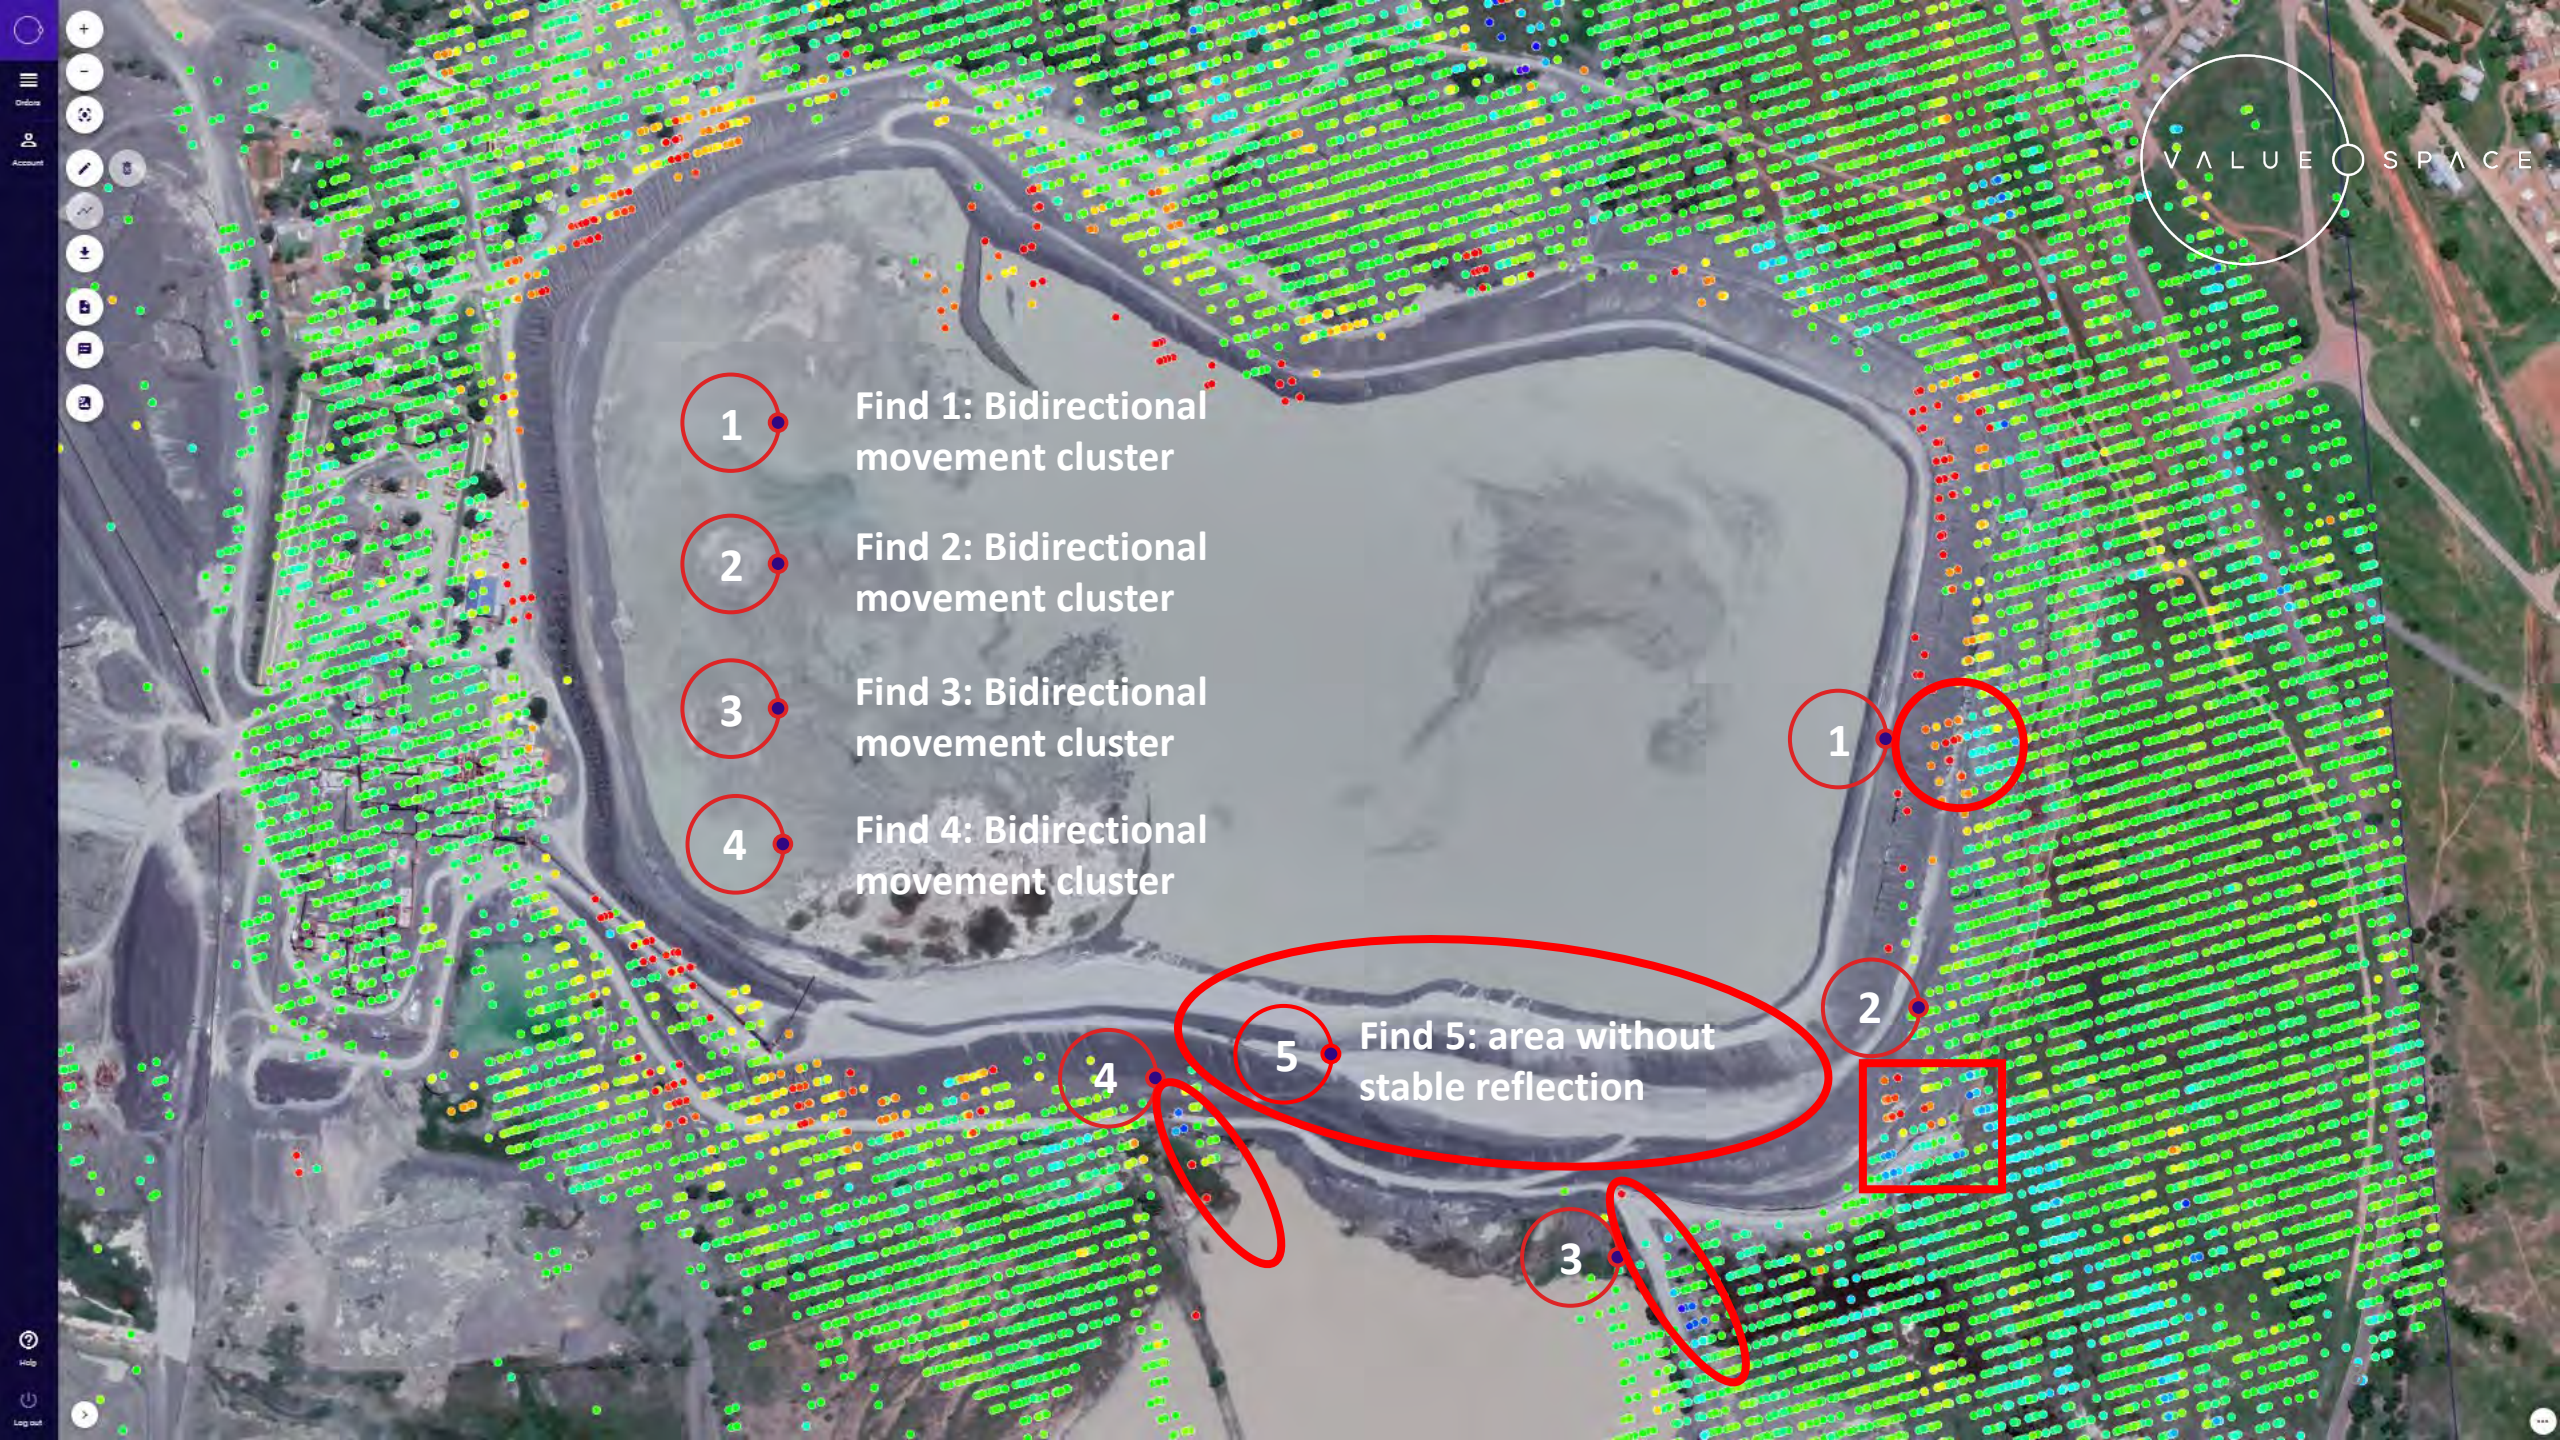
- 1 Find 1: Bidirectional movement cluster
- 2 Find 2: Bidirectional movement cluster
- 3 Find 3: Bidirectional movement cluster
- 4 Find 4: Bidirectional movement cluster

5 Find 5: area without stable reflection

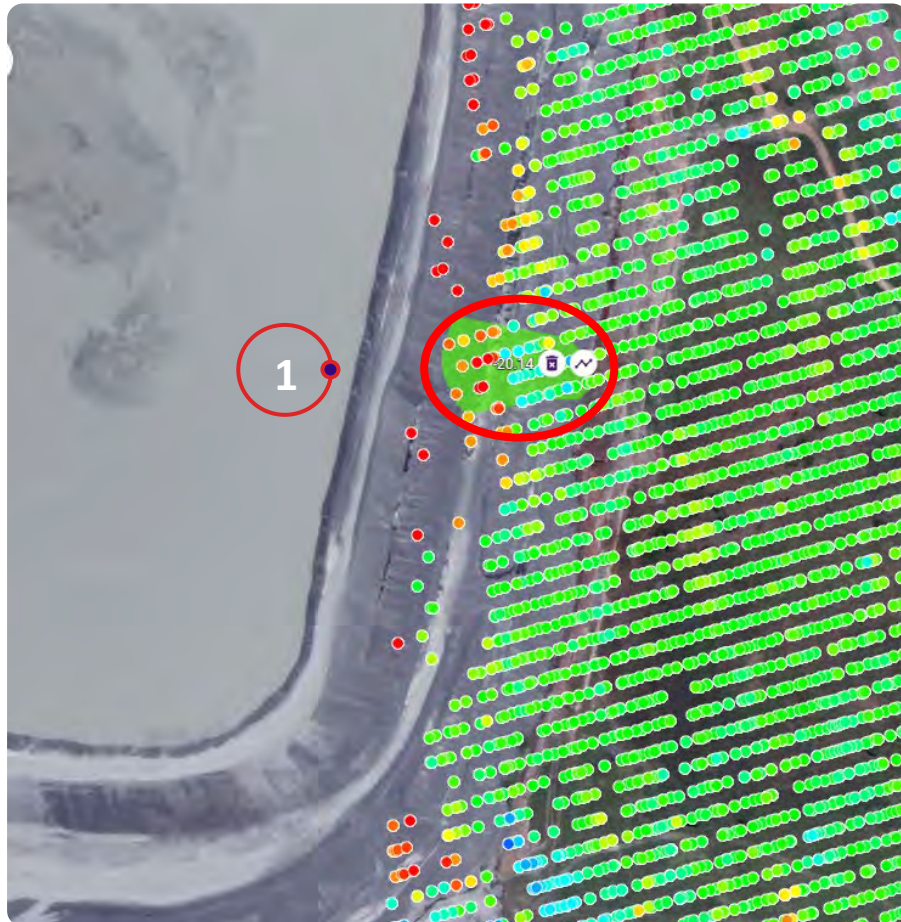
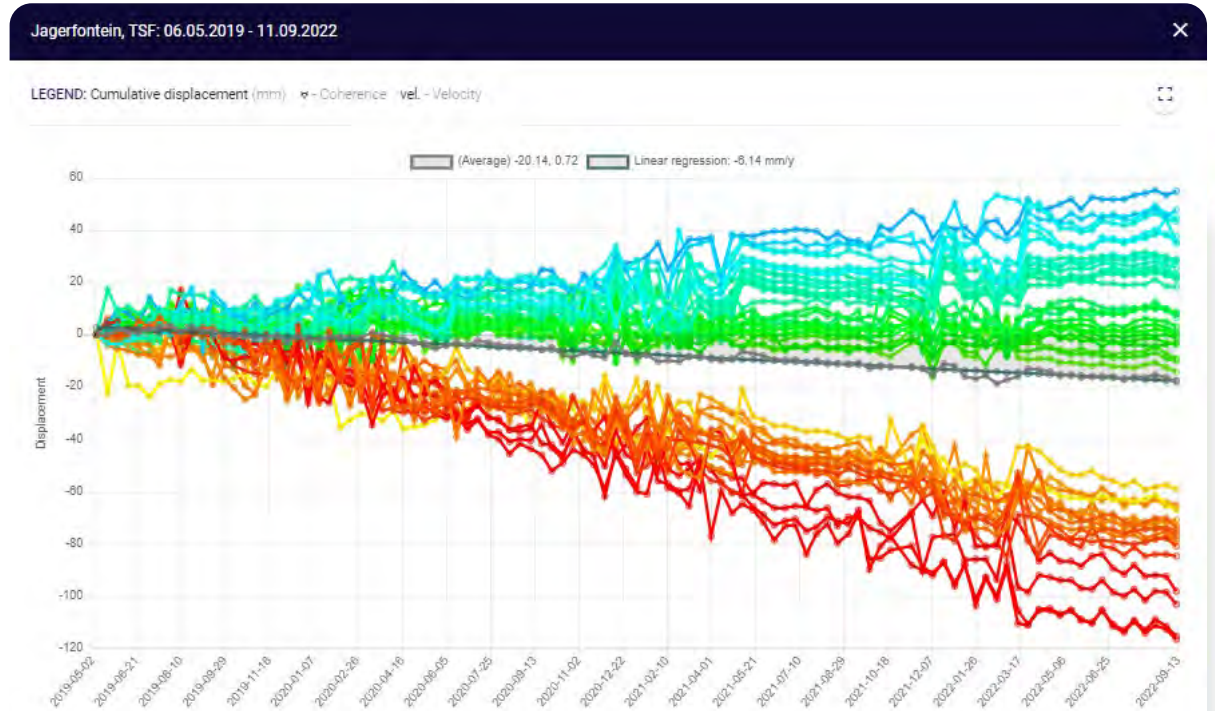
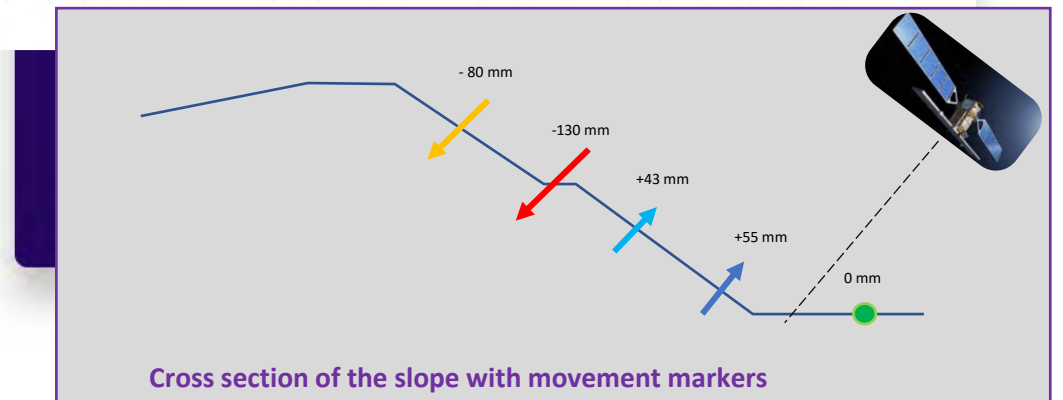
1

Timeline: 05.2019 – 09.2022
Find 1: Bidirectional movement cluster (differs from usual compaction behaviour)

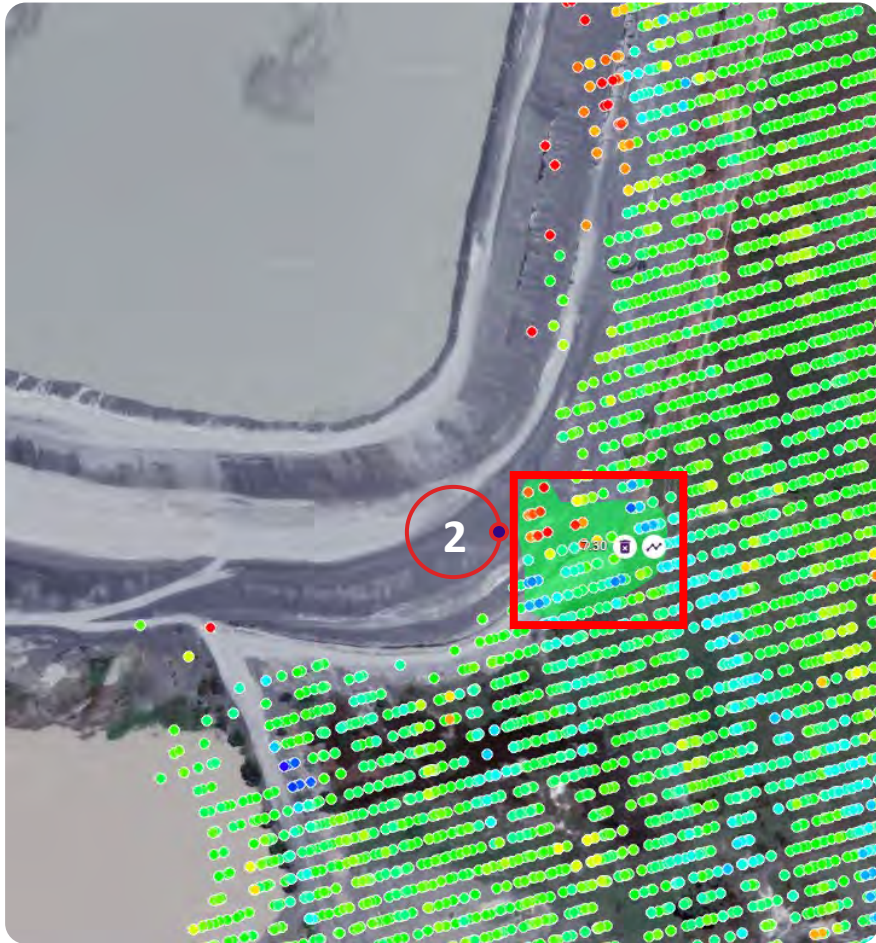
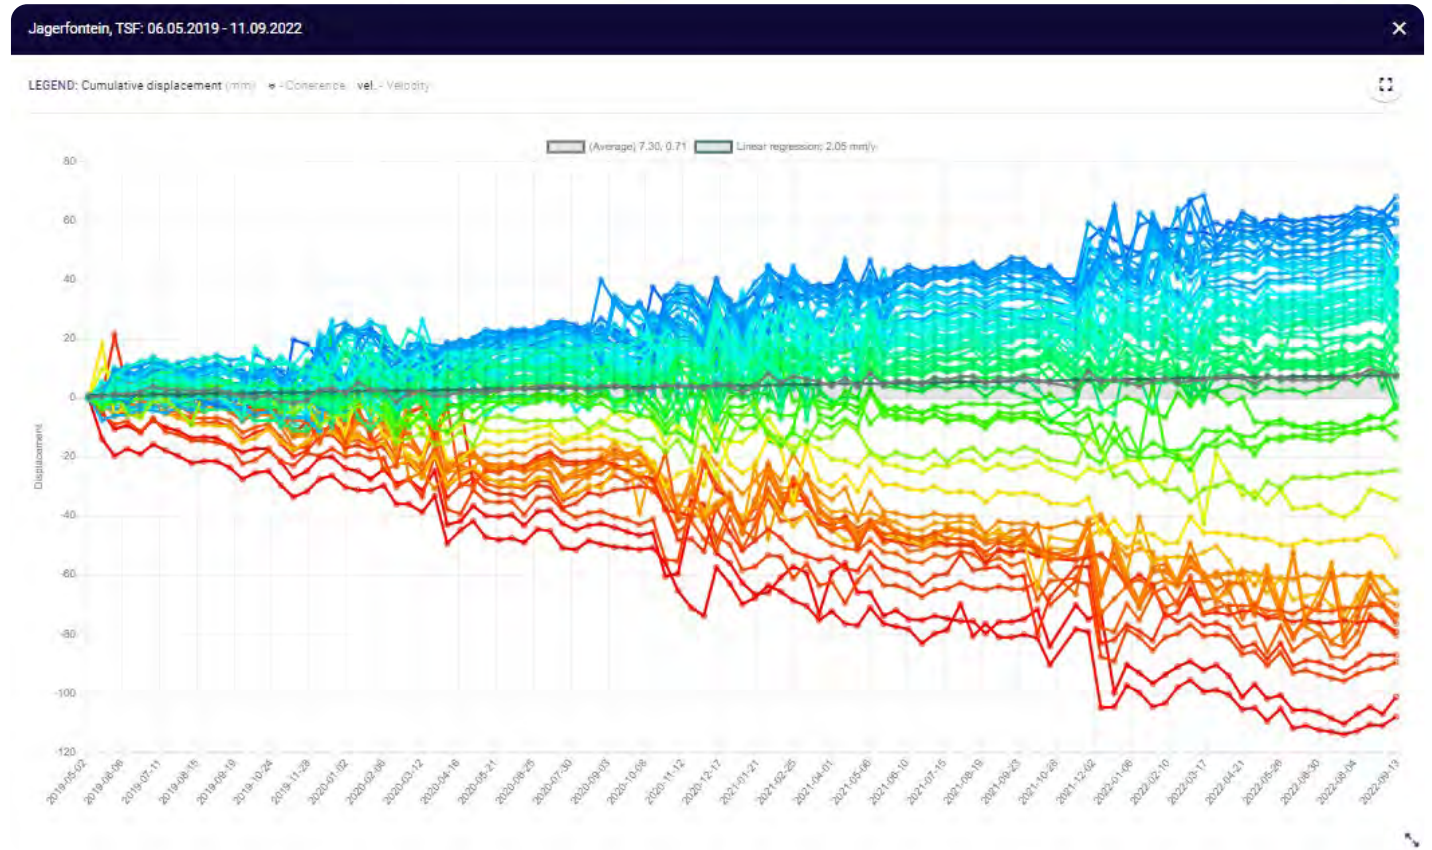
Find 2: Bidirectional movement cluster

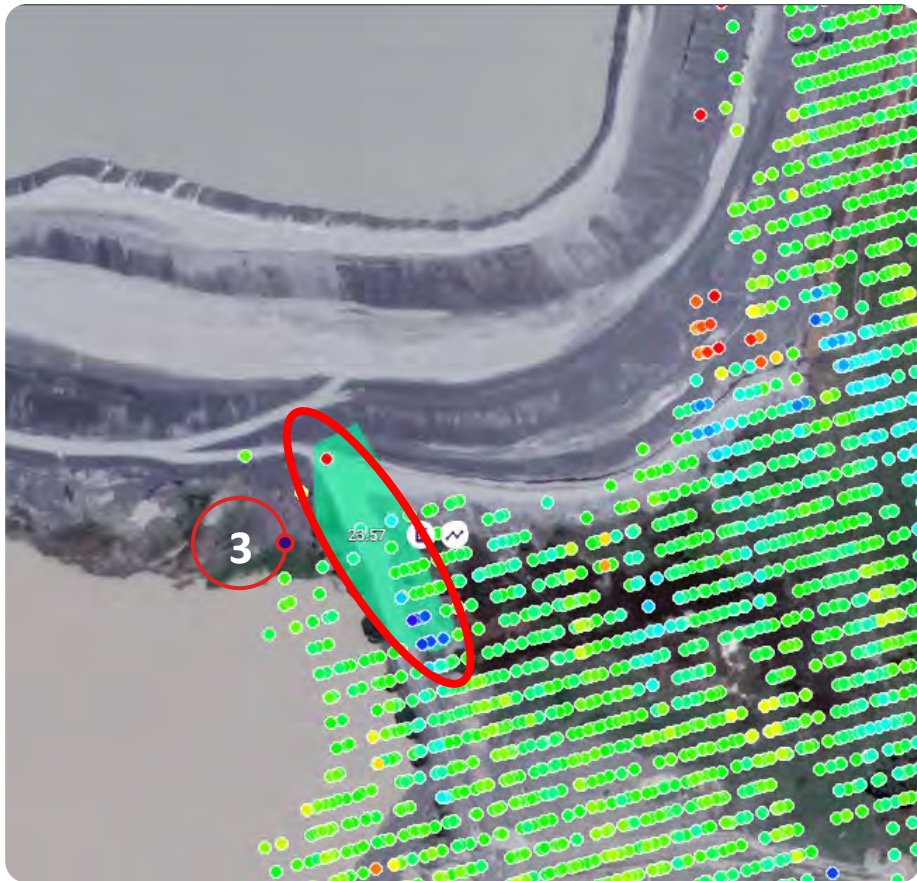
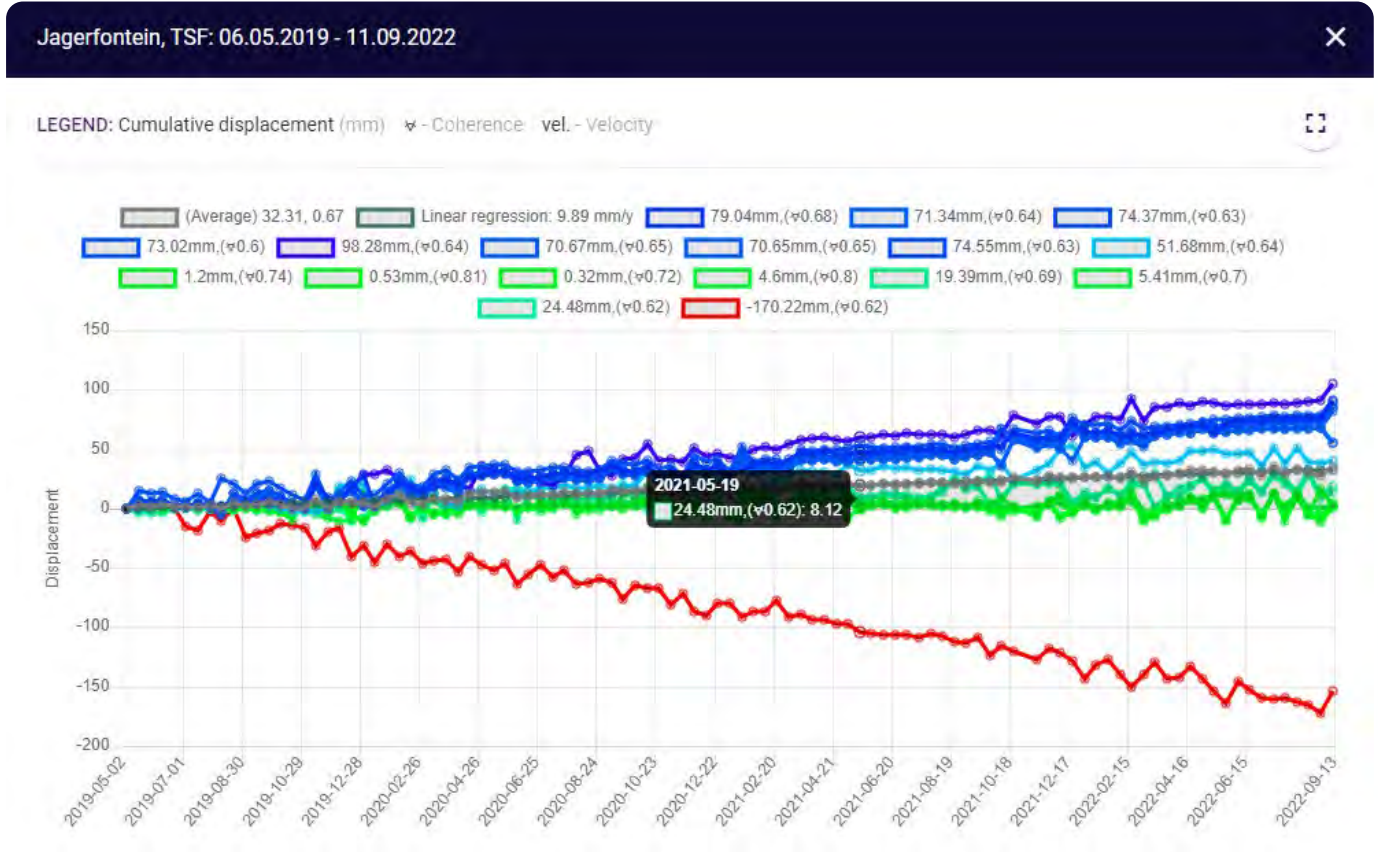
3

Timeline: 05.2019 – 09.2022

Find 3: Bidirectional movement cluster

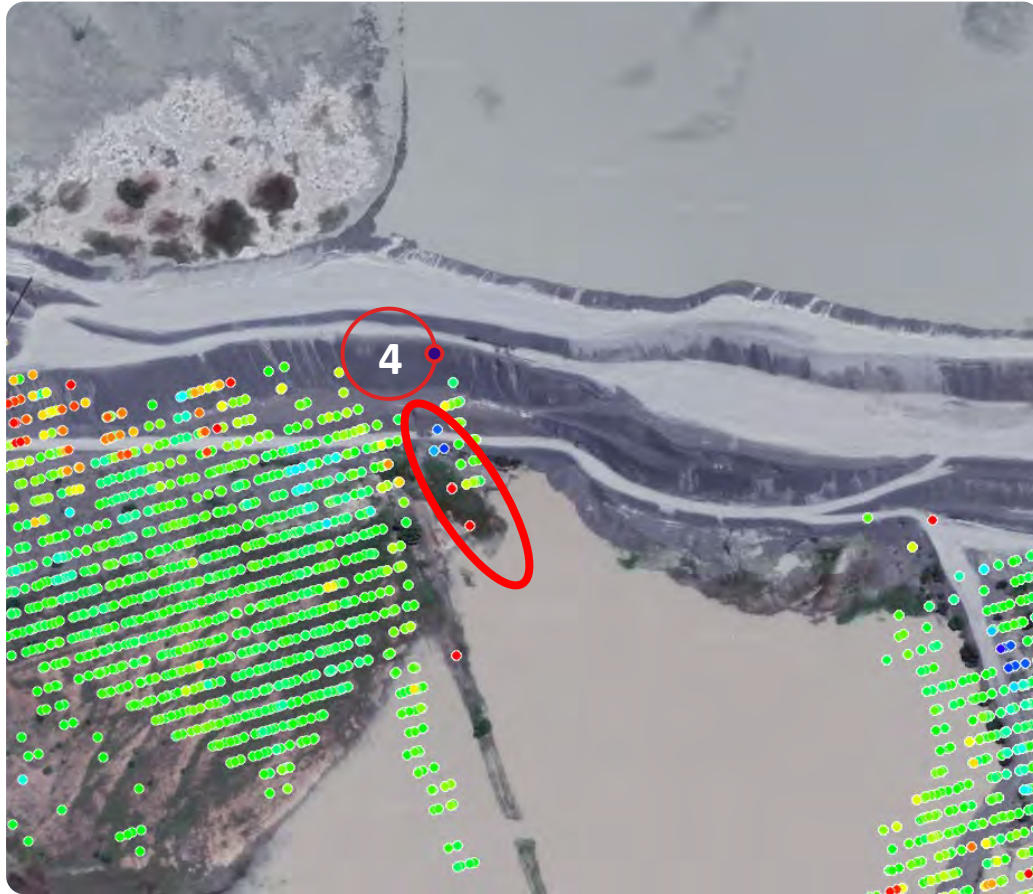
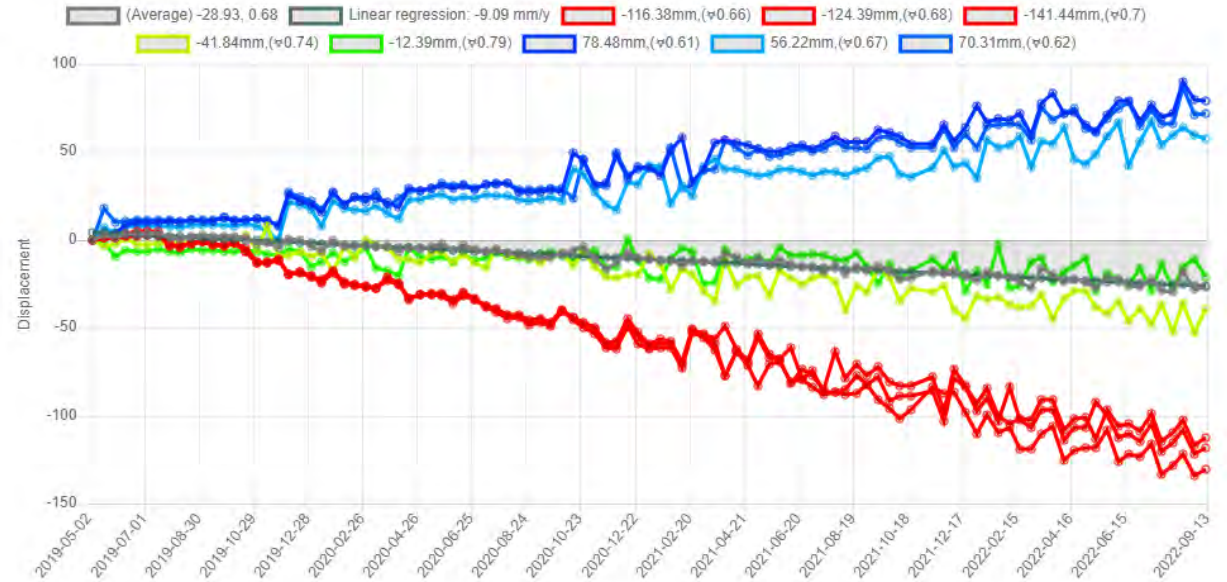
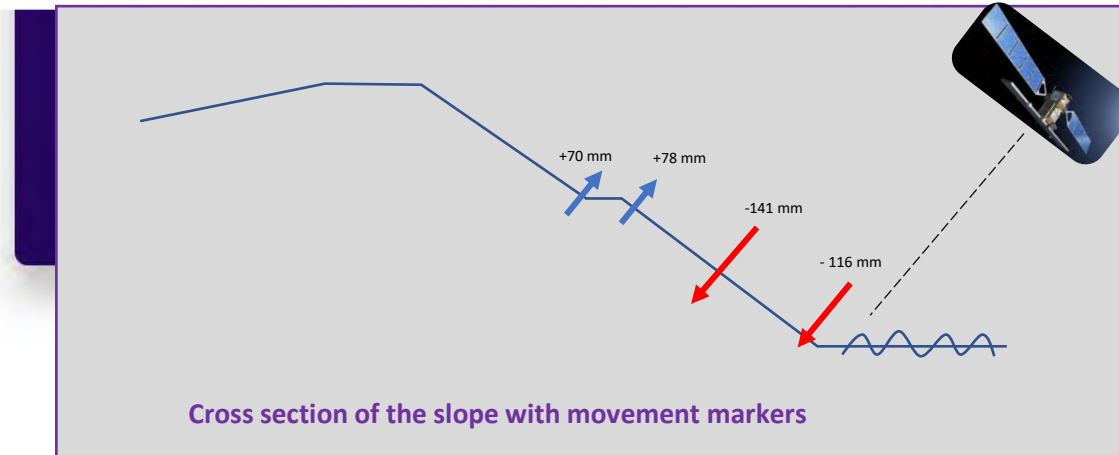
4

Find 4: Bidirectional movement cluster (between relatively stable areas)

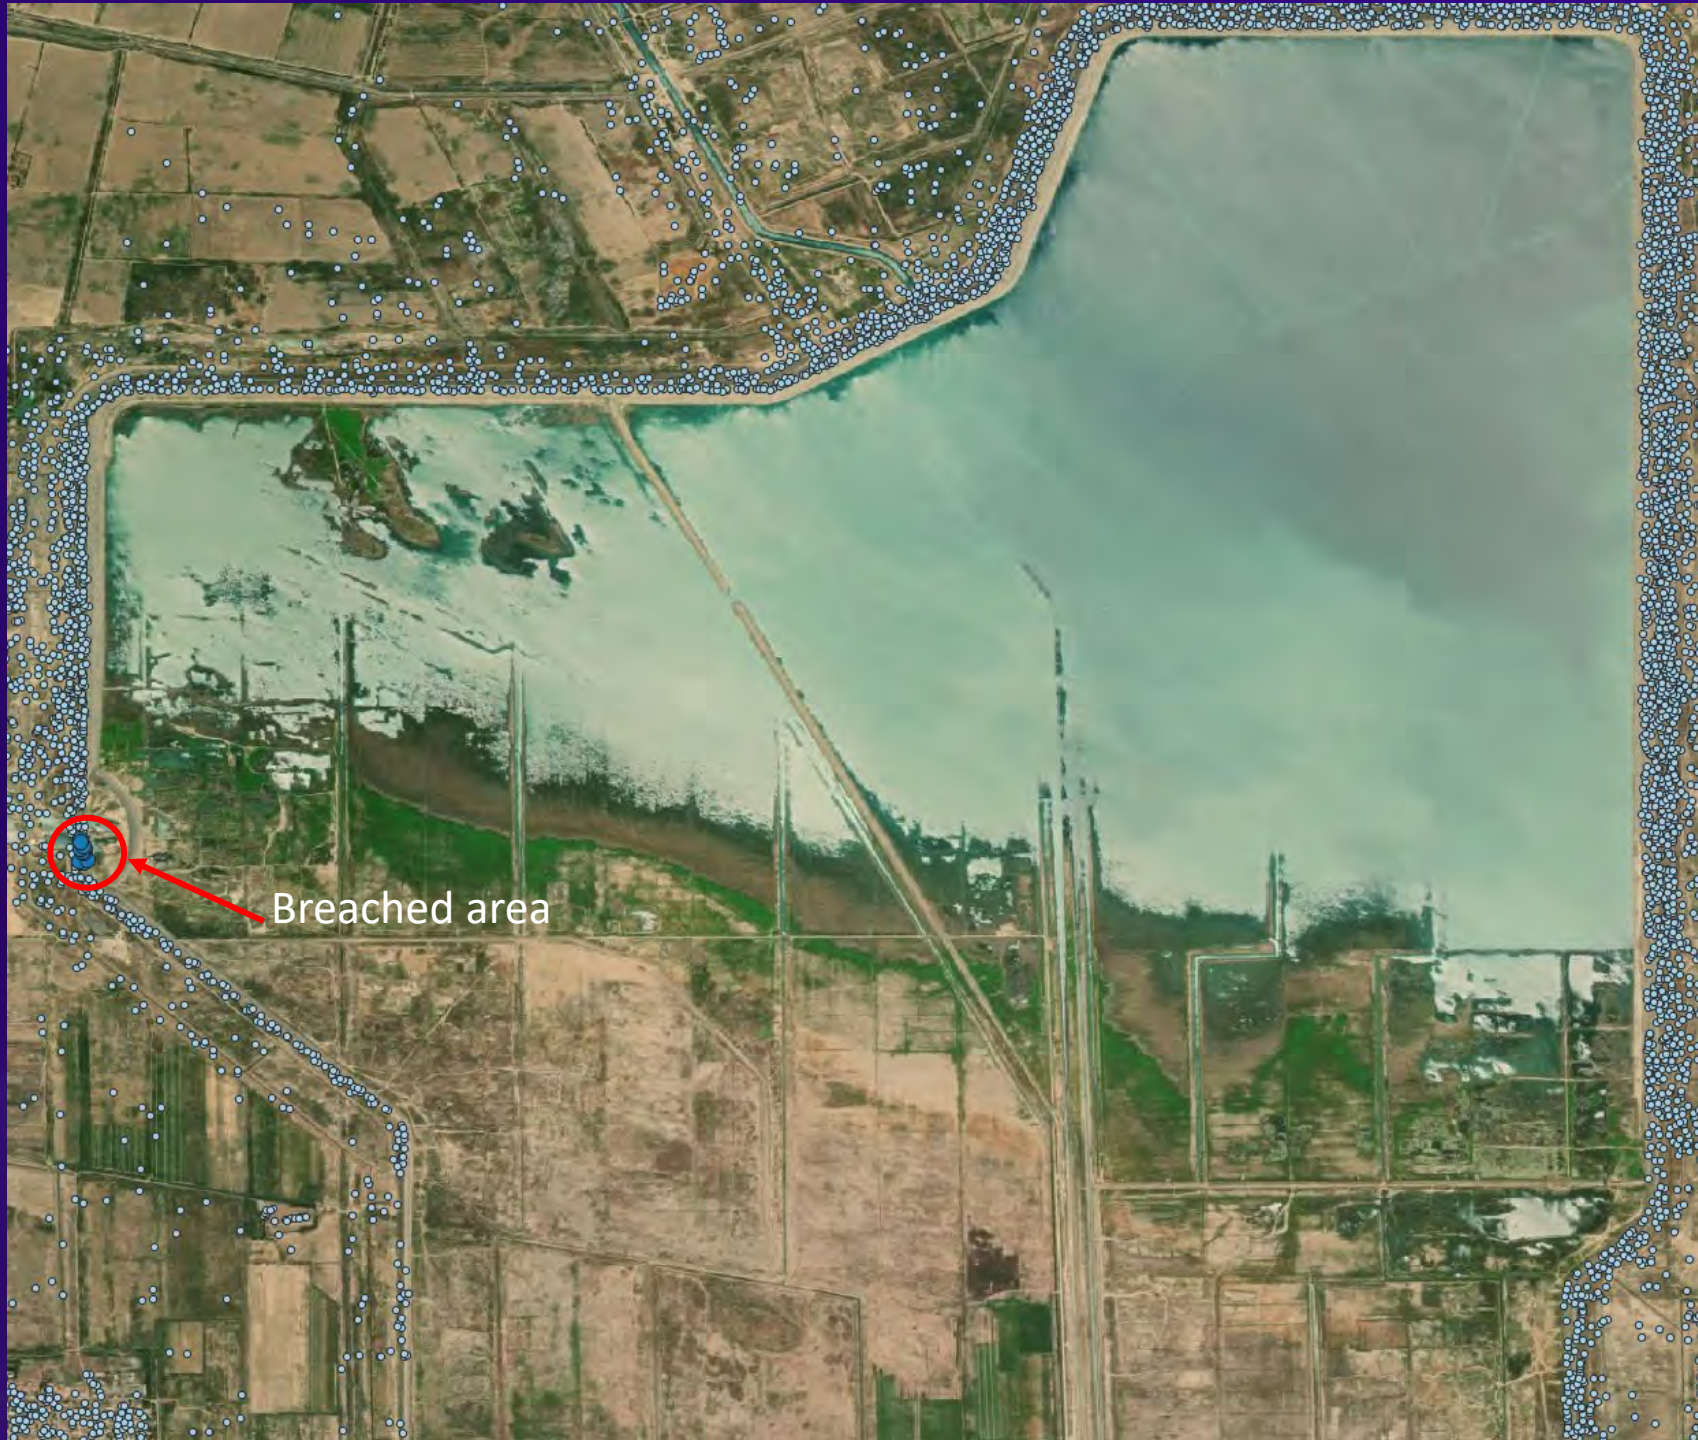
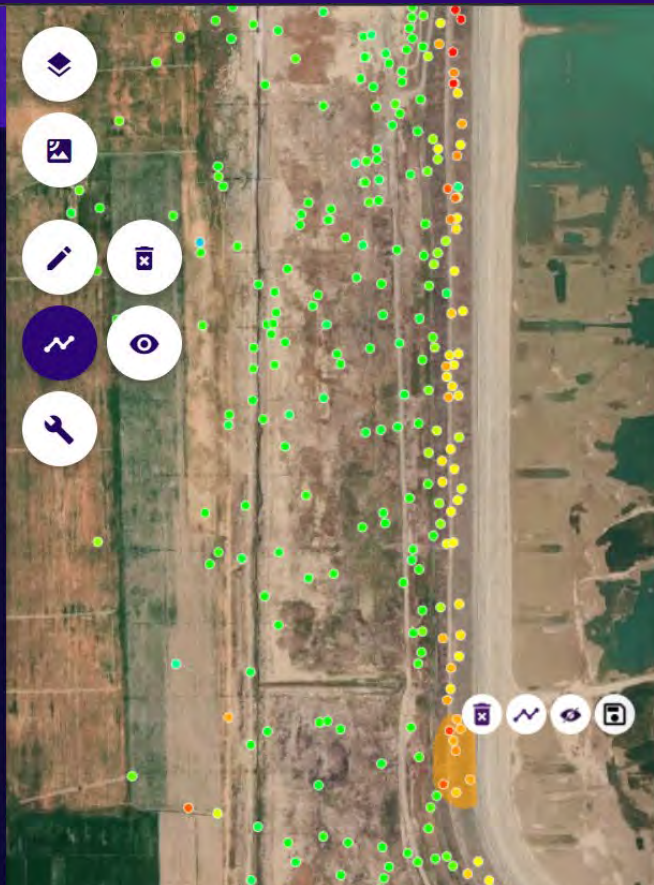
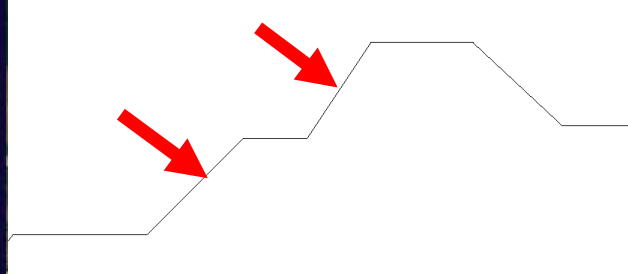
Breached area

43 mm/ year

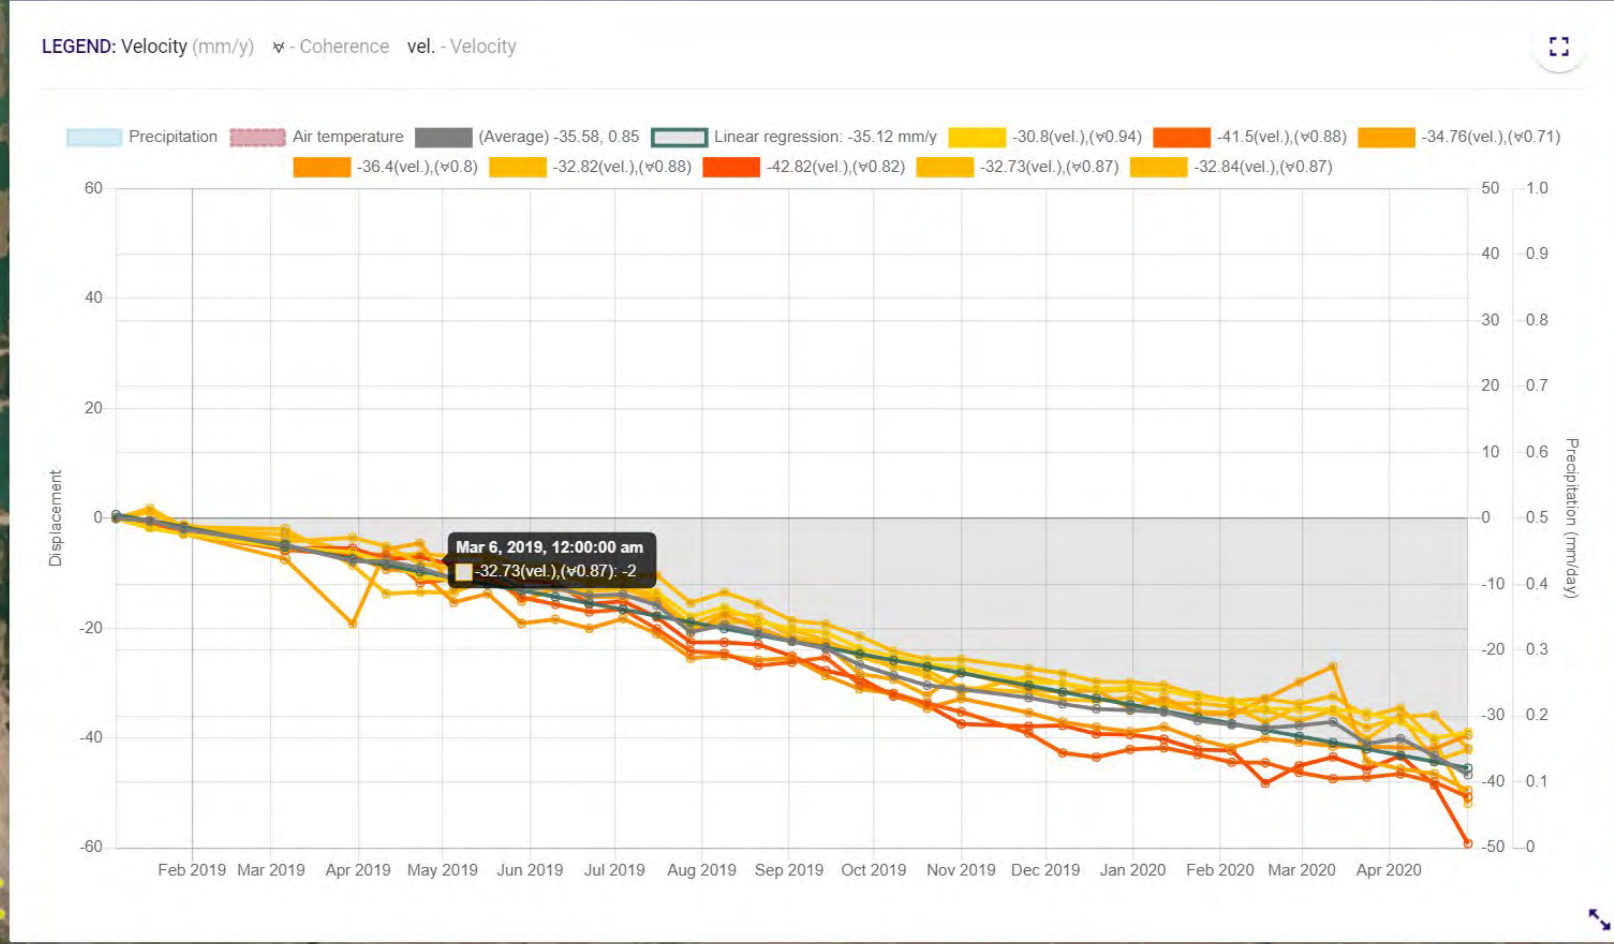
Sardoba Reservoir broke, Uzbekistan: 05.01.2019 - 29.04.2020 Aerial Image pre-failure

The breached area stands out with two specific patterns (behaviour of the slope is different from other sections nearby)

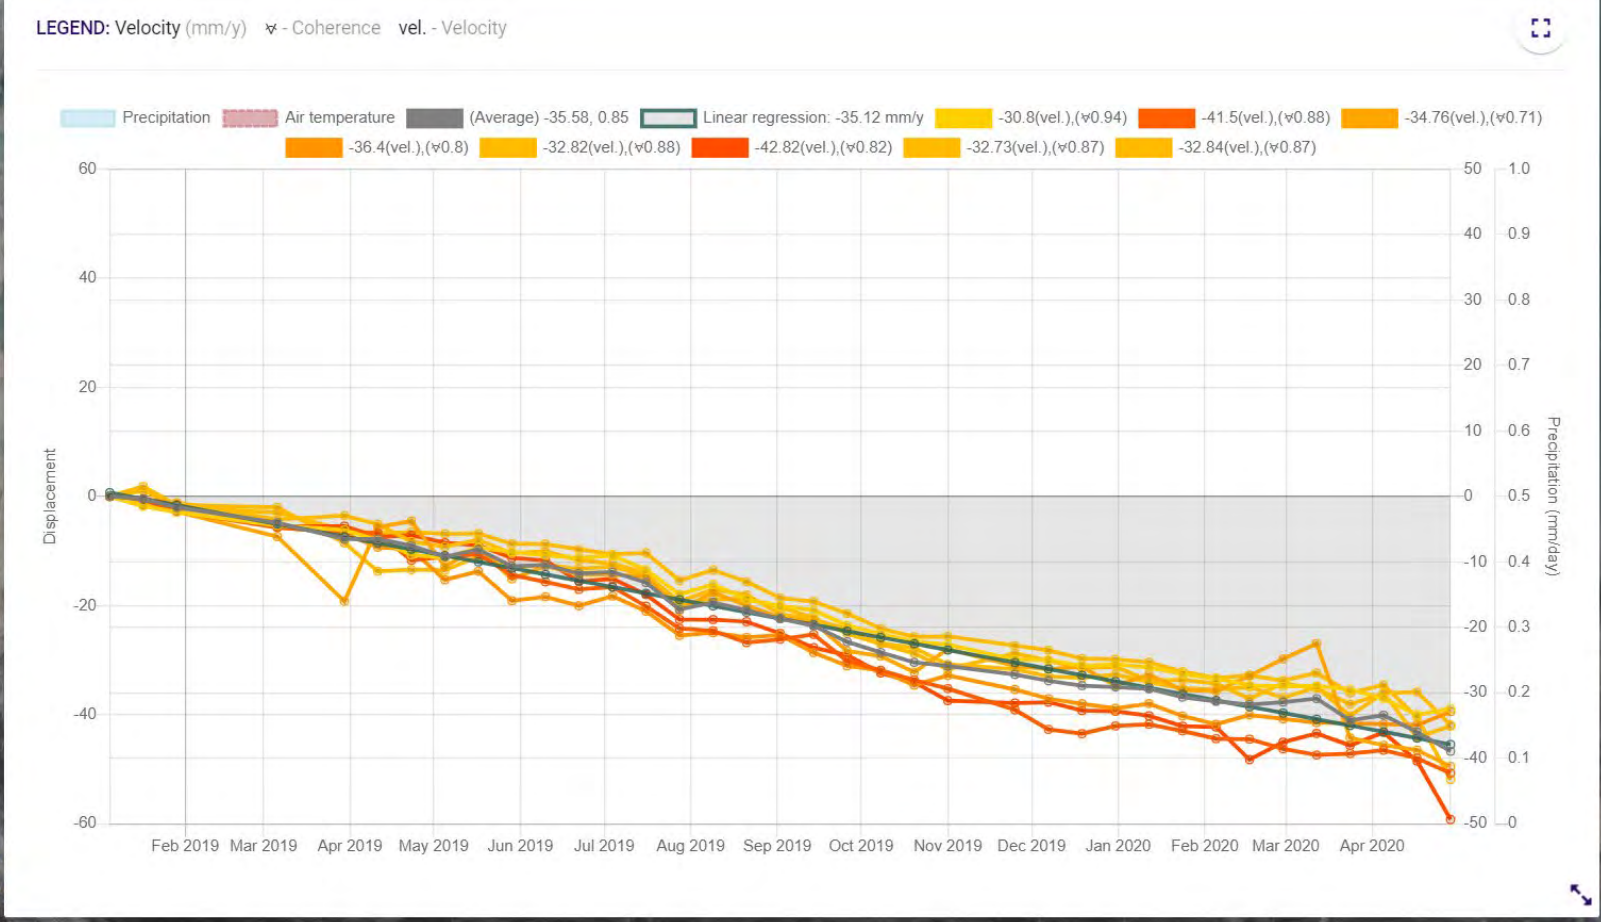
Sardoba Reservoir broke, Uzbekistan: 05.01.2019 - 29.04.2020 Aerial Image post-failure

Post-cat imagery reveals that there is a strong correlation between the breach area and outstanding Find

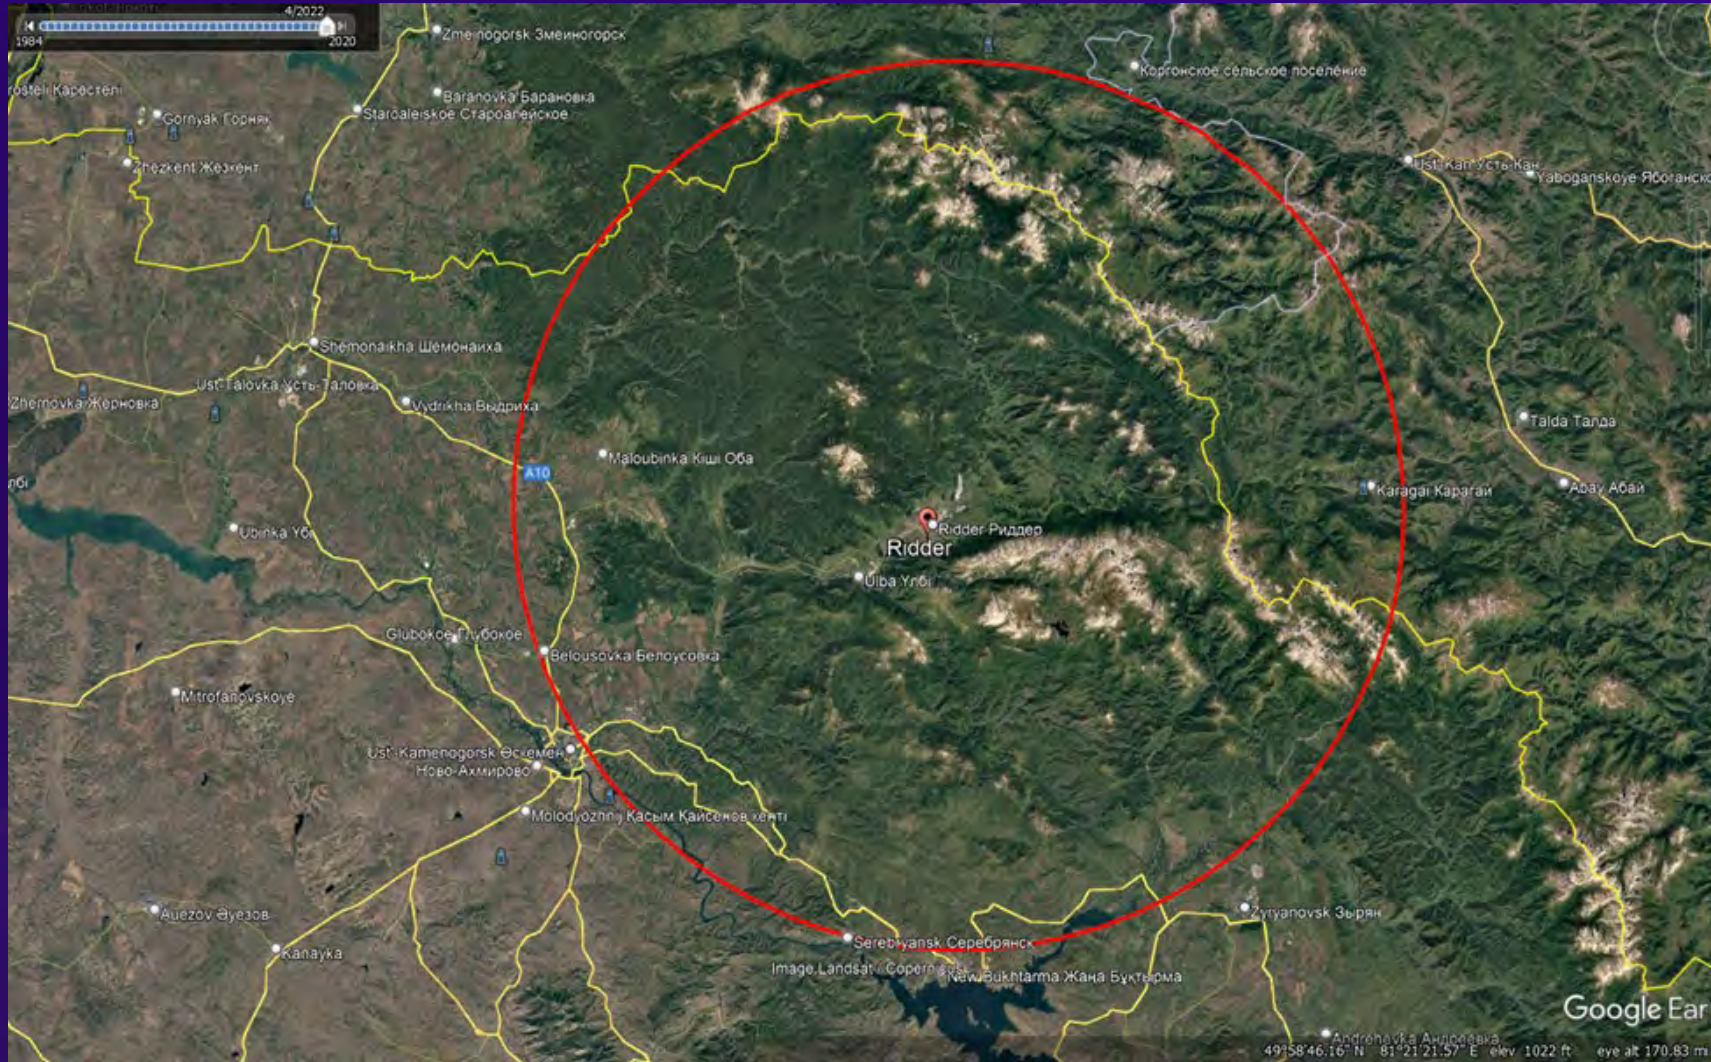
Ridder – Impact radius in event of failure

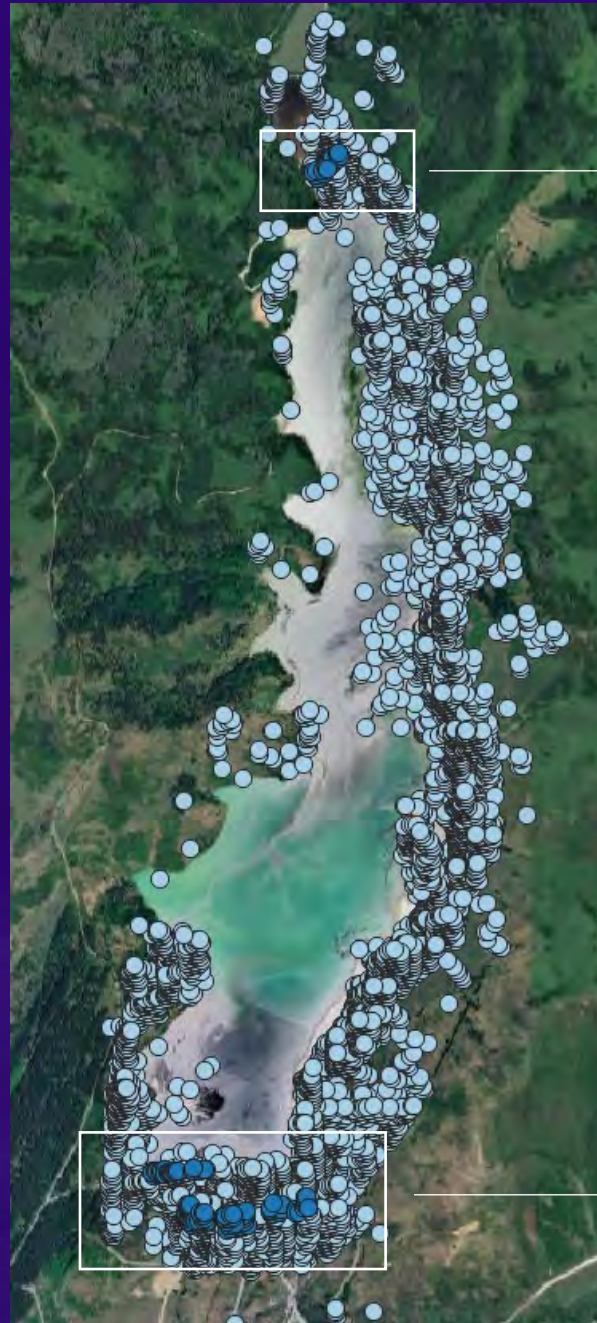
Ridder TSF - Macro Overview

Site B – North Dam
Find 7

Site A – South Dam
Finds 1, 2, 3, 4, 5, 6

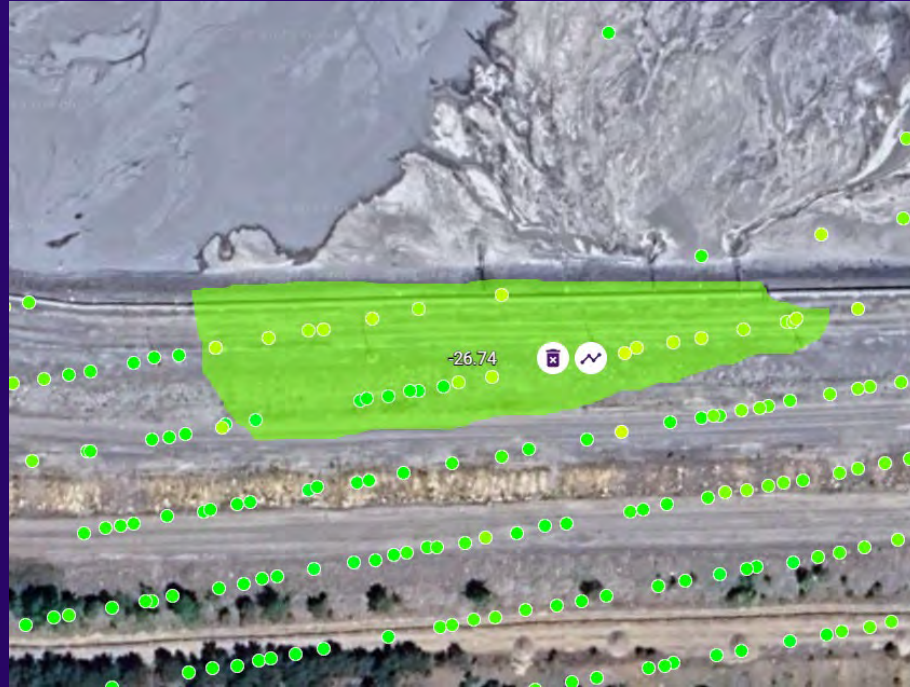
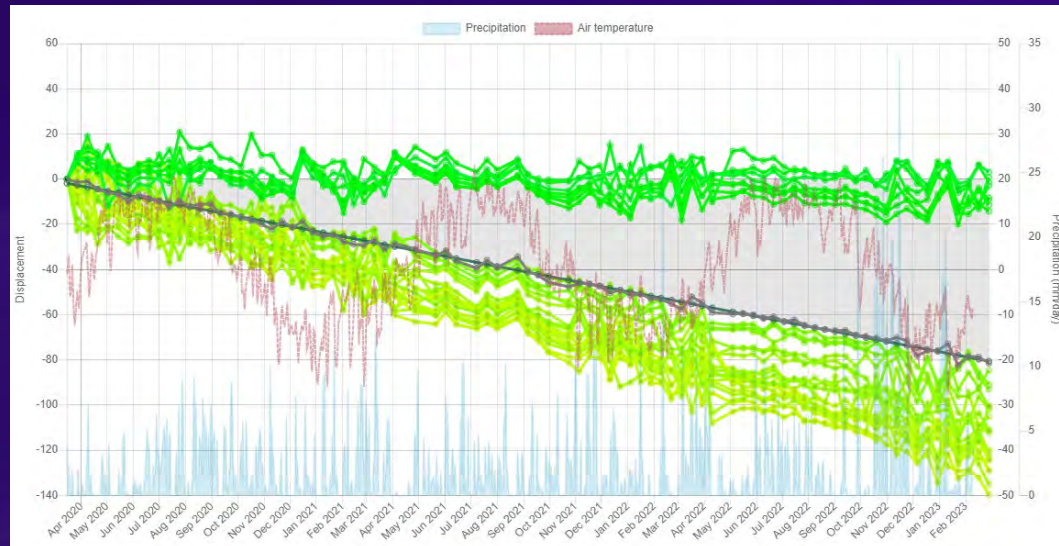
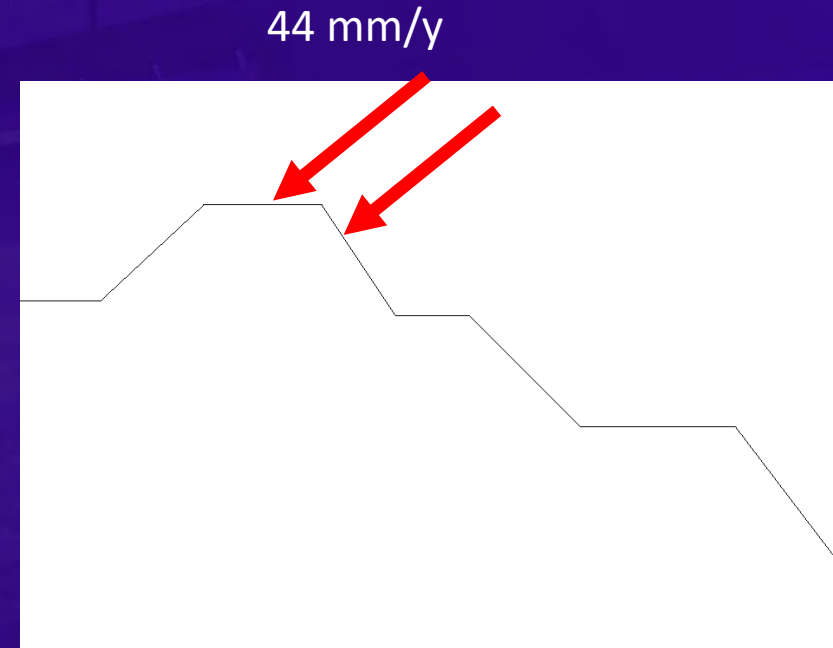
Site A, South Dam - Find 1 in Detail
 Section deformation up to 44 mm/year
