SATELLITE BASED RISK ASSESSMENTS AND MONITORING

SOUTH AFRICA, JAGERSFONTEIN, DIAMOND MINE TSF

SARDOBA TAILINGS STORAGE FACILITY (TSF), UZBEKISTAN

RIDDER-SOKOLNOE TAILINGS STORAGE FACILITY (TSF), KAZAKHSTAN

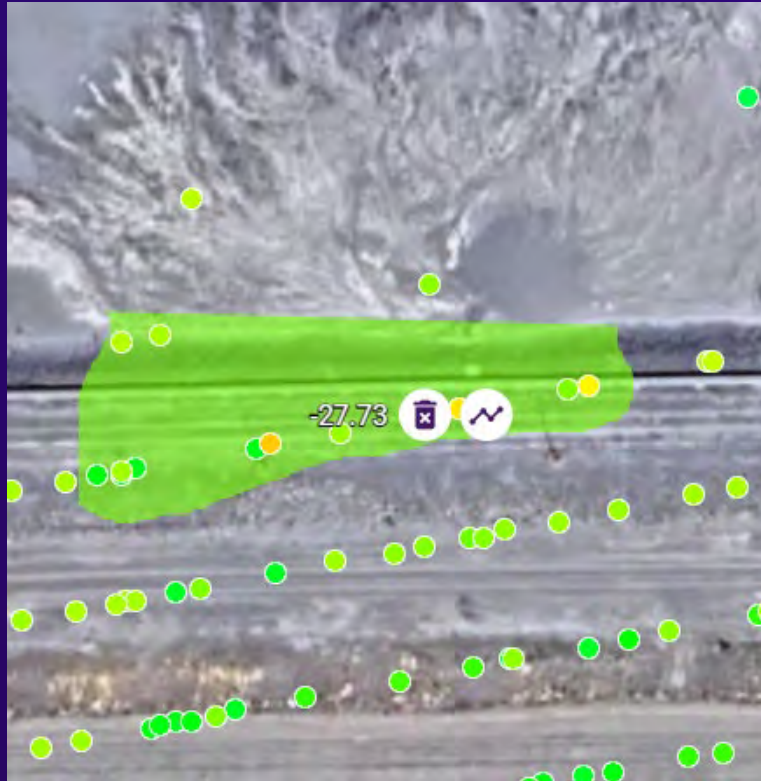
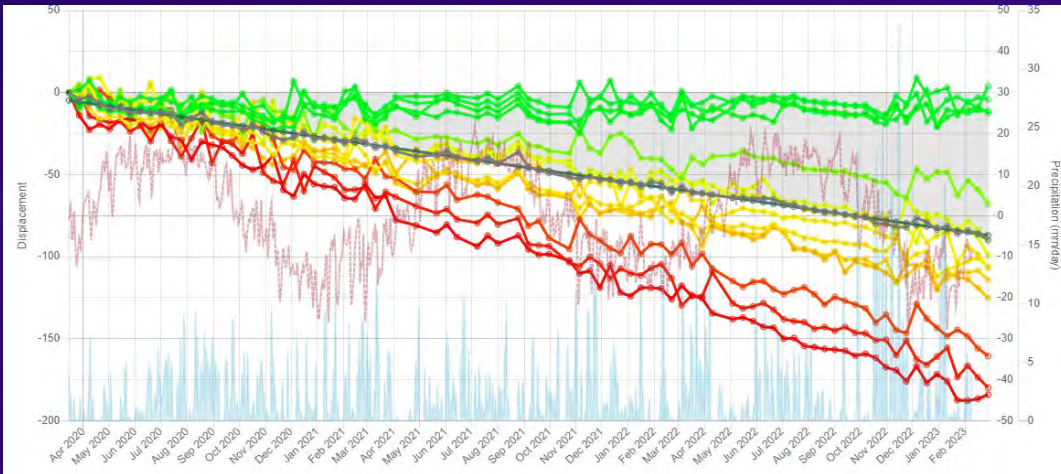
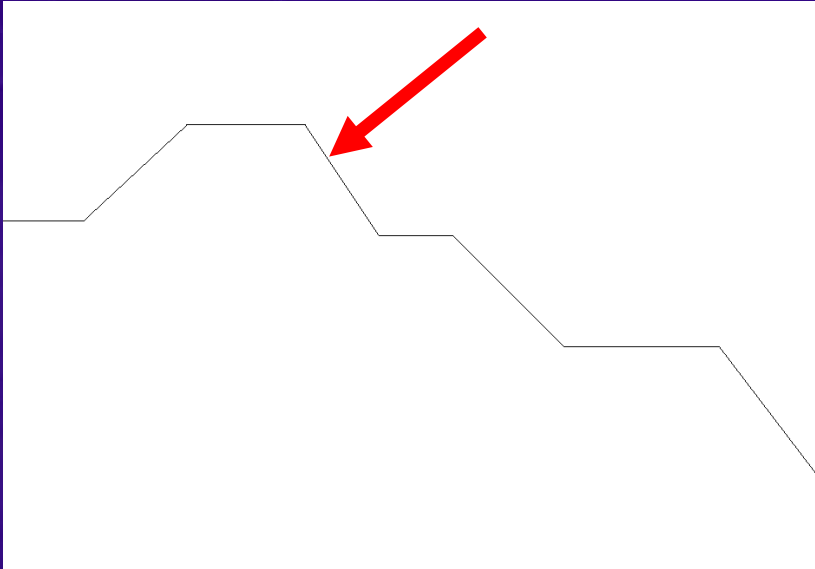
Site A, South Dam - Find 2 in Detail
Section deformation up to 61 mm/year

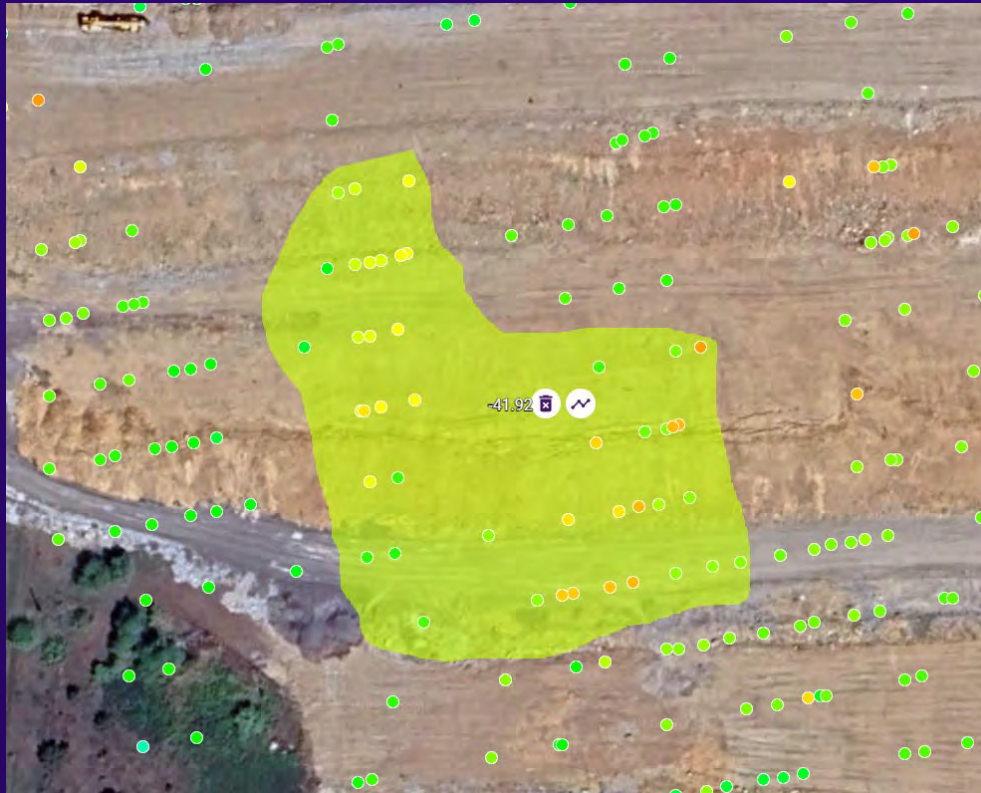
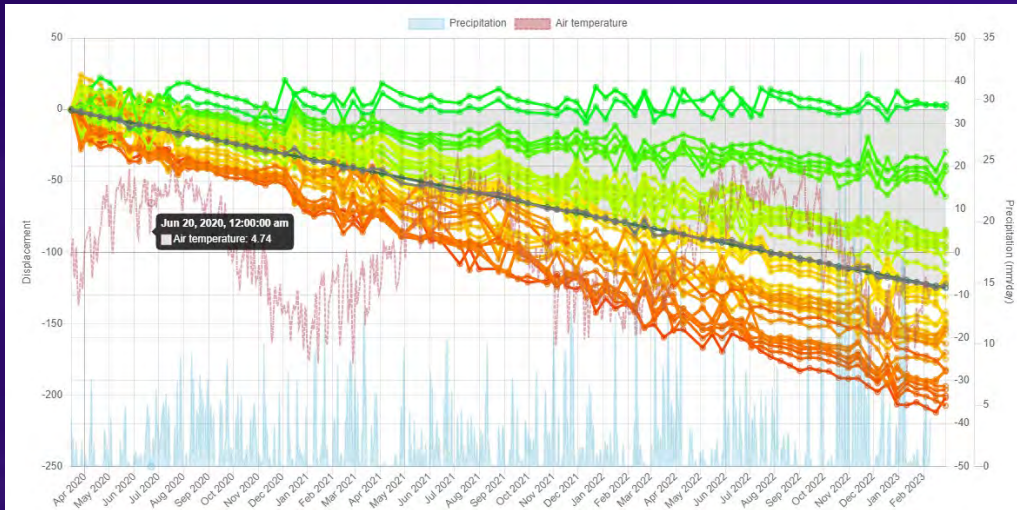
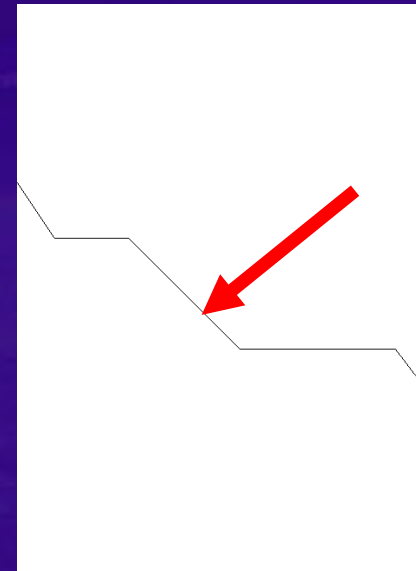
Site A, South Dam - Find 3 in Detail
 Section deformation up to 69 mm/year

69 mm/y

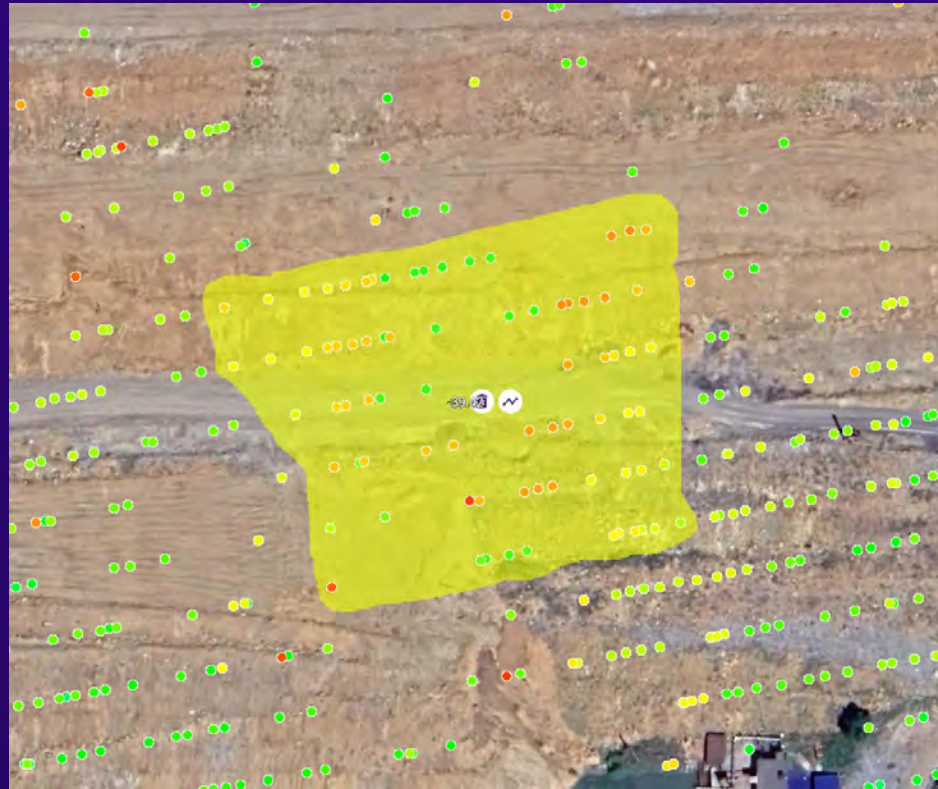
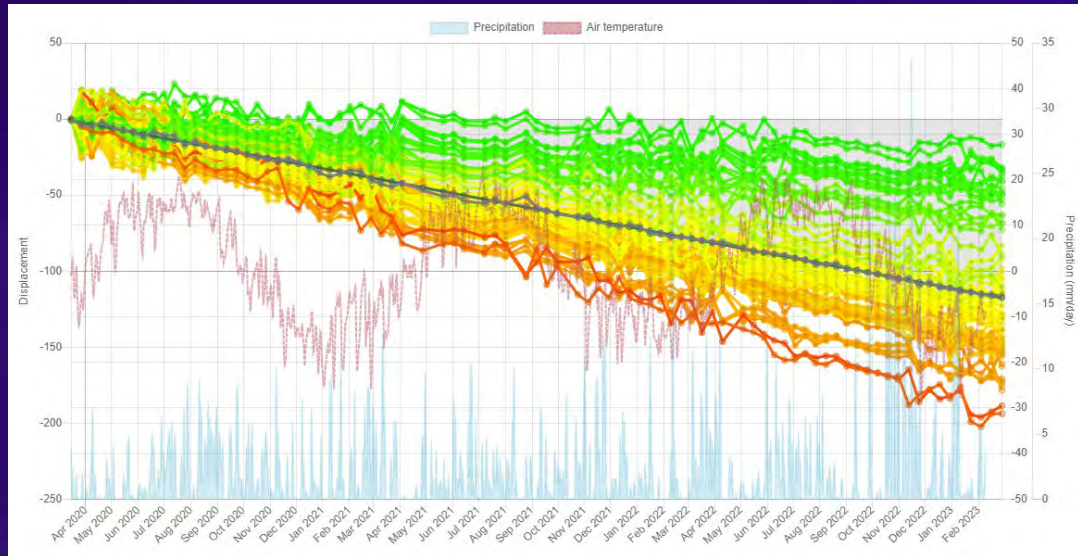
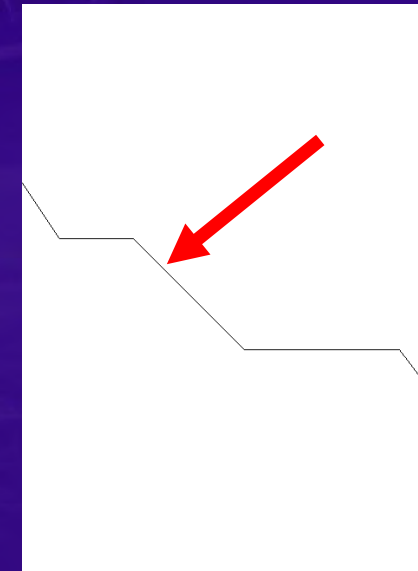
Site A, South Dam - Find 4 in Detail
Section deformation up to 69 mm/year

69 mm/y

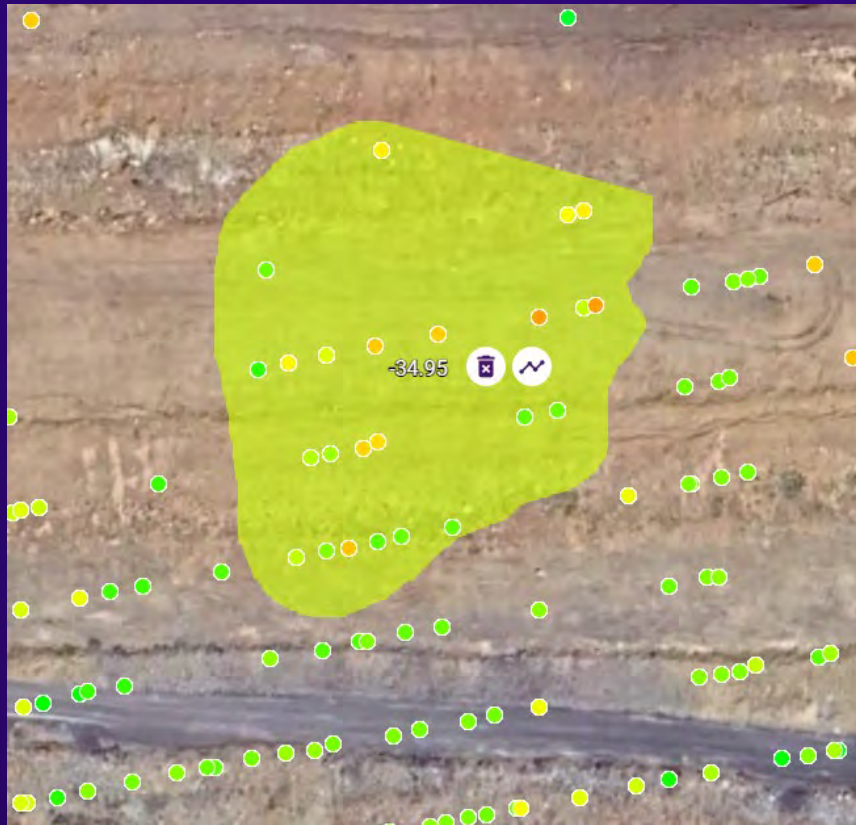
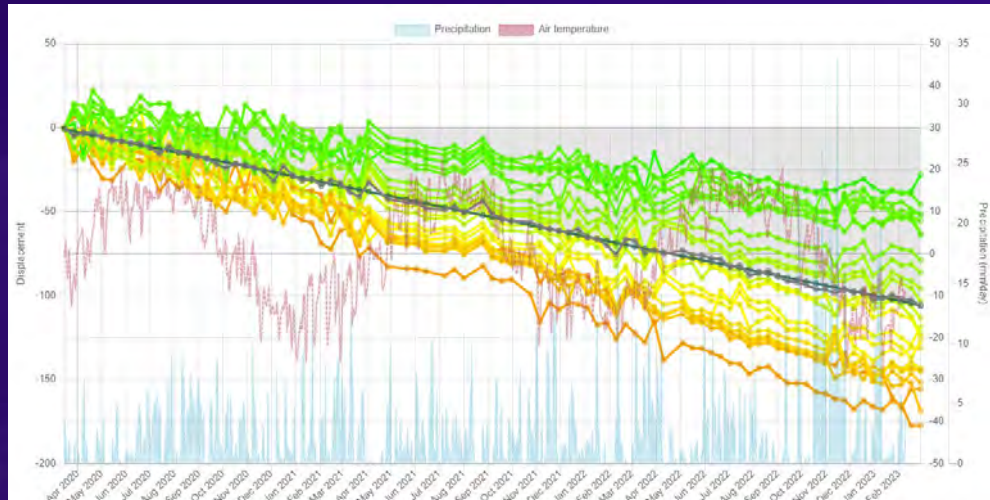
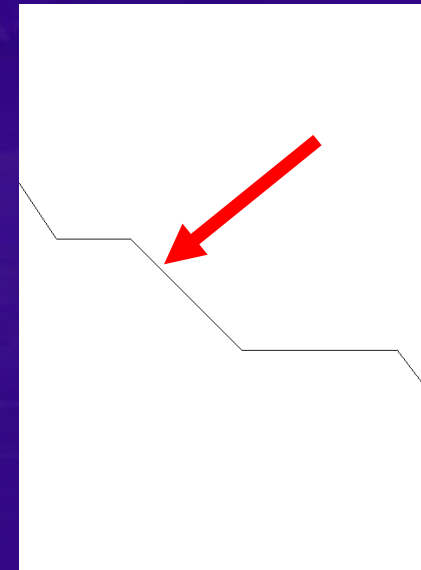
Site A, South Dam - Find 5 in Detail
Section deformation up to 55 mm/year

55 mm/y

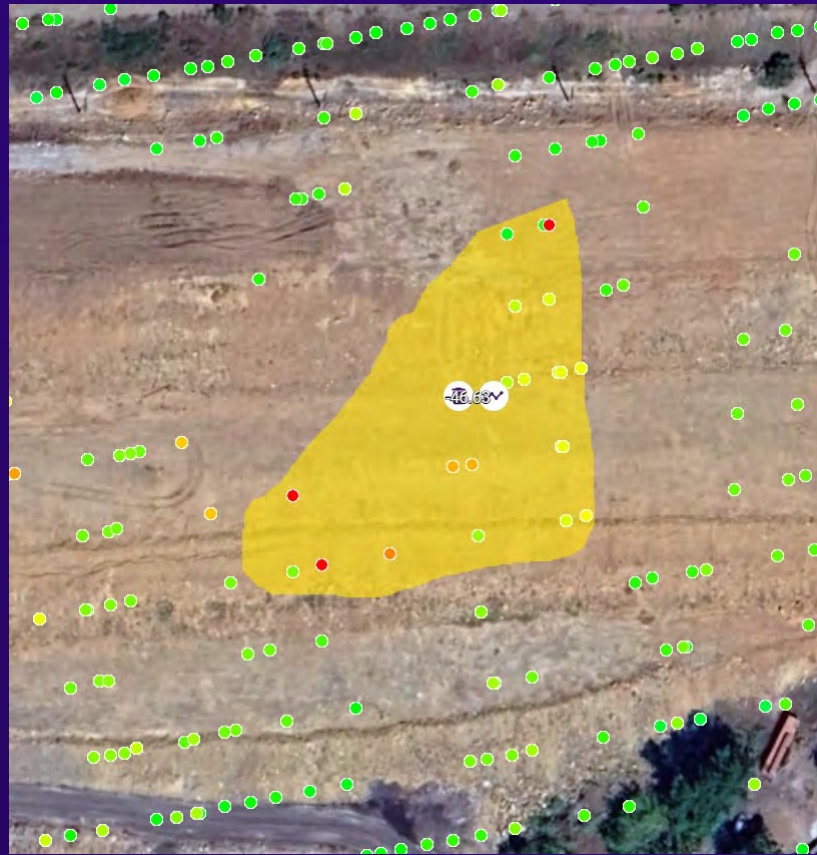
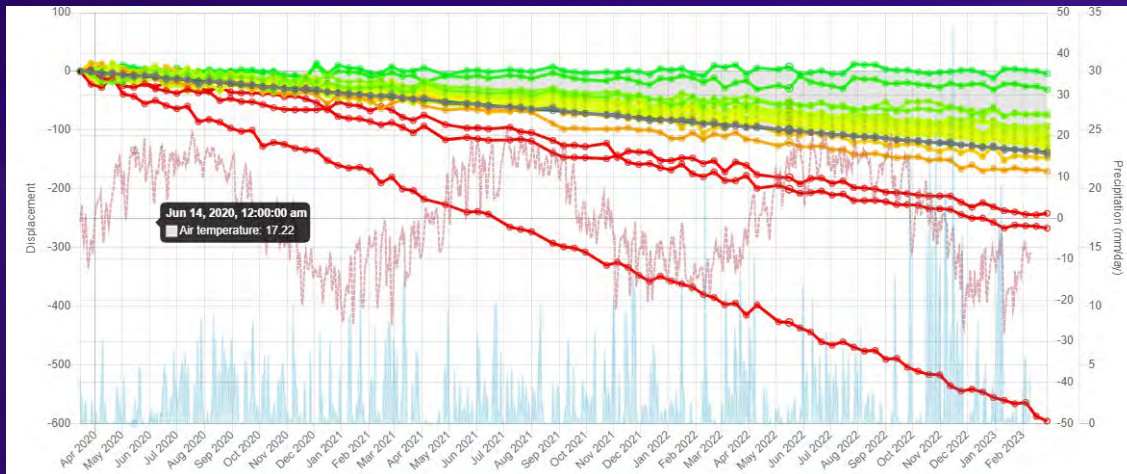
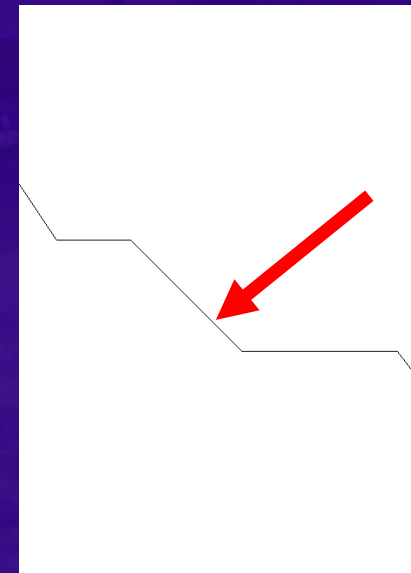
Site A, South Dam - Find 6 in Detail
 Section deformation up to 196 mm/year

196 mm/y

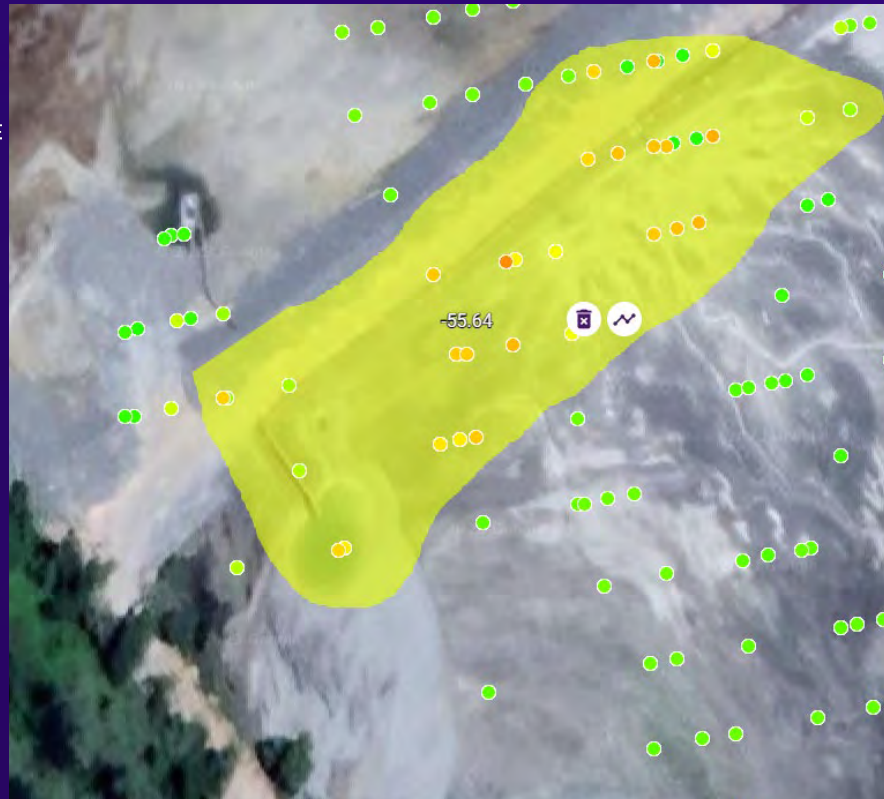
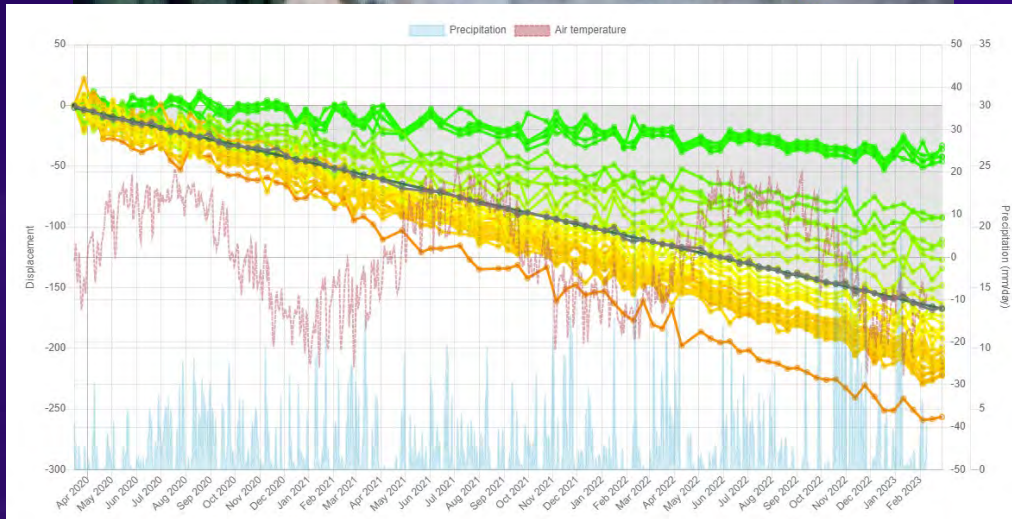
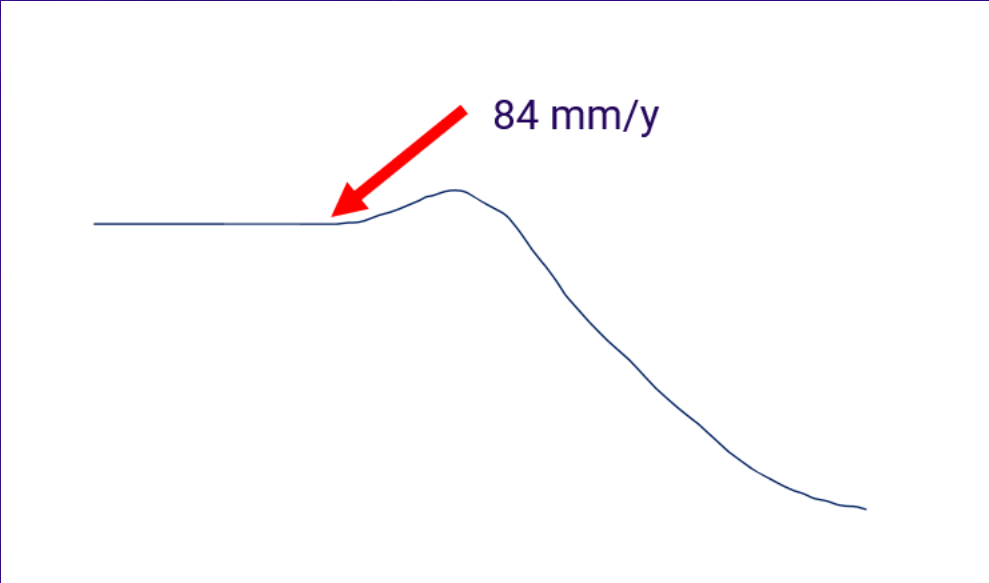
Site B, North Dam Find 7 in Detail: Section deformation up to 84 mm/year
