ECE/TRANS/WP.30/2006/16
4 August 2006

**CUSTOMS CONVENTION ON THE INTERNATIONAL TRANSPORT OF GOODS UNDER
COVER OF TIR CARNETS (TIR CONVENTION, 1975)**

Sealing of Vehicles

Good Practice Guide

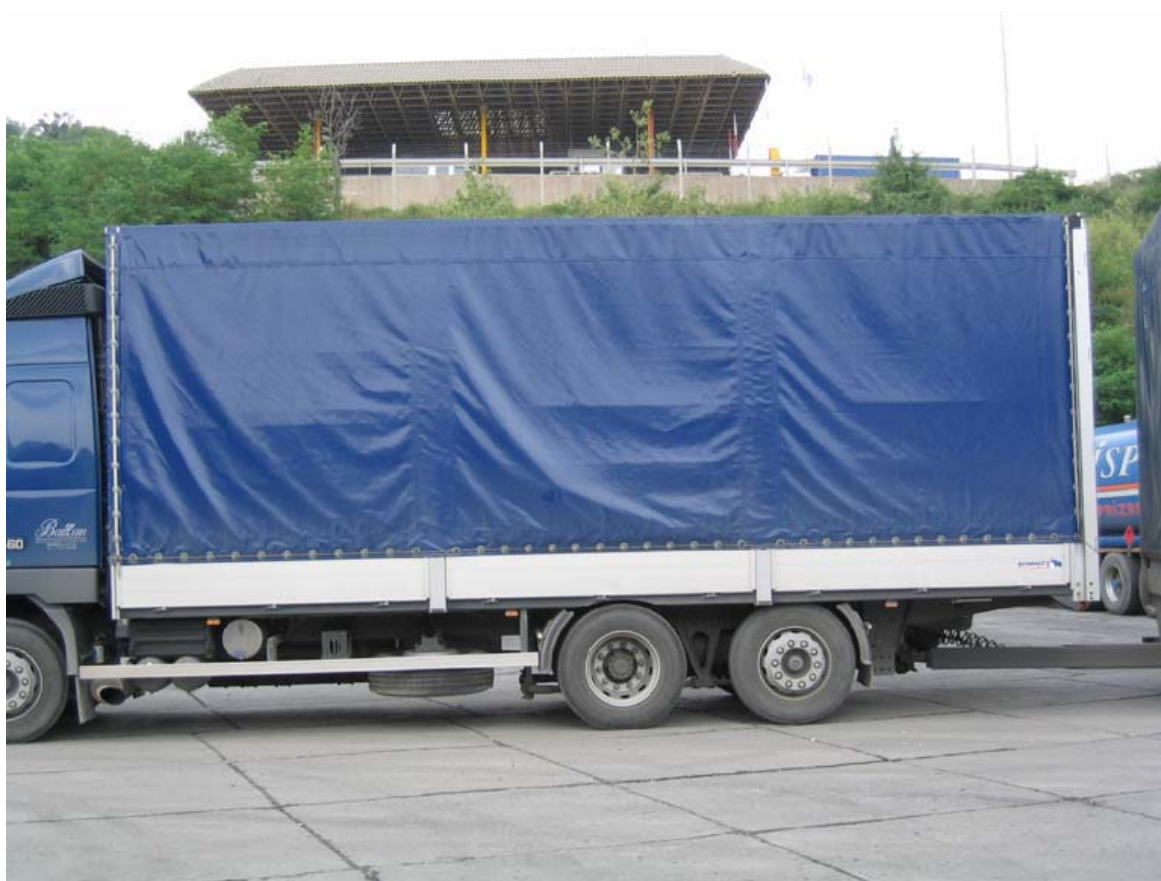
A: The sheet in perfect condition - without any: logos, damage, cuts or repairs. (The sheet for this truck is not equipped with ventilation apertures or tension flaps).

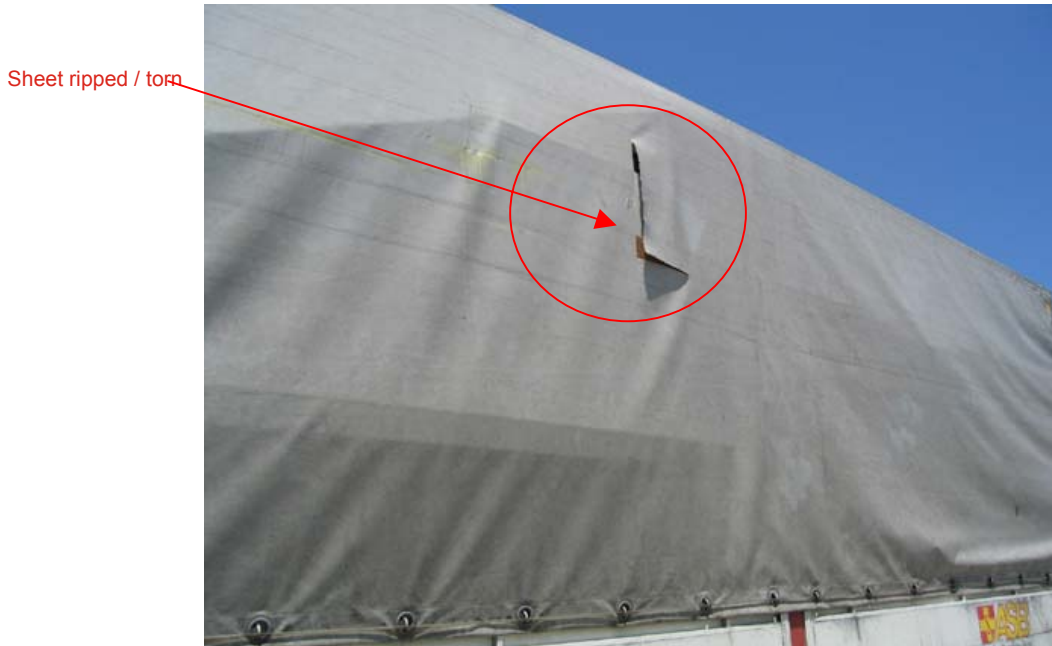
A: Sheet ripped during journey, with rather extensive damage. This trailer should NOT be allowed to continue to transport under customs seal - unless it is repaired.

The sheet may be accidentally ripped during the journey. Usually this is not serious damage and can be easily noticed - (Pic. A and B). The upper part (roof) of the sheet is more difficult to check and therefore more likely to have openings for fraudulent purposes.

A truck or trailer cannot be approved for carrying out the transport of goods under customs seal if the sheet is ripped - especially if the damage is combined with a row of missing eyelets (Pic. A and B).

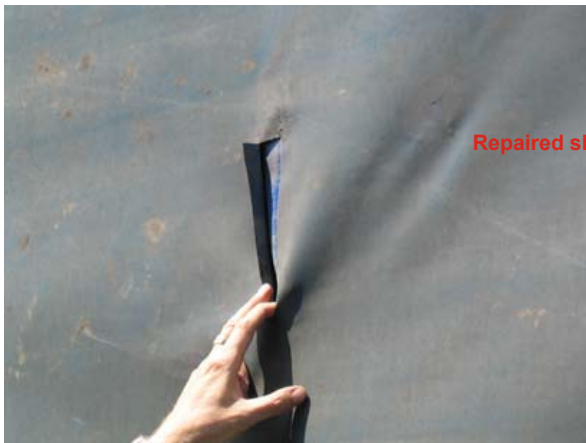
B: Sheet ripped during journey, with minor damage. Dependent on the commodity being transported, this trailer COULD be allowed to complete the current journey - but should NOT be able to carry out further international transport without being repaired.

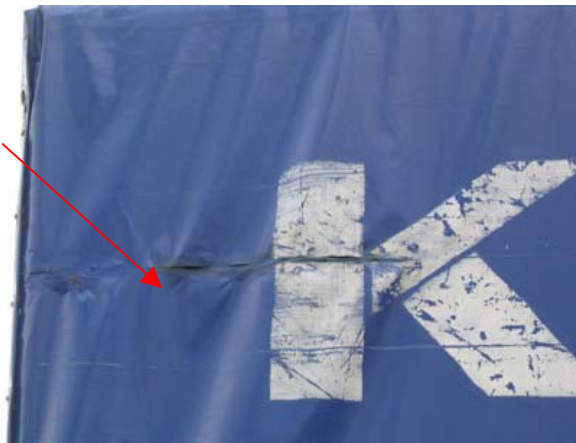
C: Company logo covering repair made incorrectly - sheet repaired by using adhesive tape on the inner side of the sheet.

Special attention should be paid to those parts of the sheet containing inscriptions - (i.e. Company name or logo) - as they might cover repairs made incorrectly and be difficult to detect - (Pic. C).

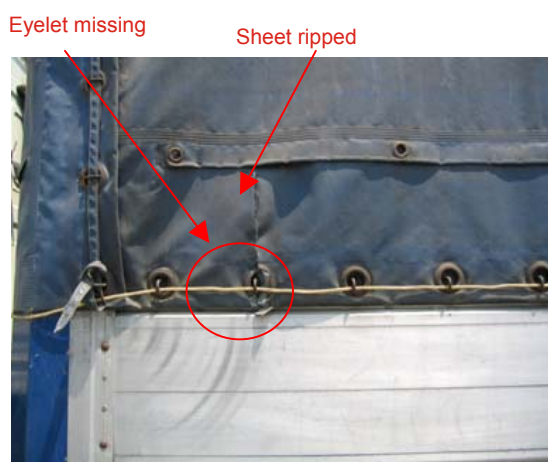
A: Eyelet missing, sheet torn – minor damage (only one eyelet missing – not several in a row).

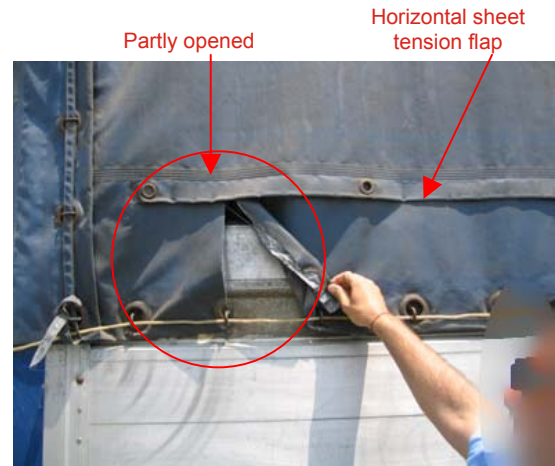
B: Limited access to the load compartment. Dependent on the commodity being transported, the trailer could be allowed to complete its current journey. Notice the sheet tension flap - there could be damage behind this.

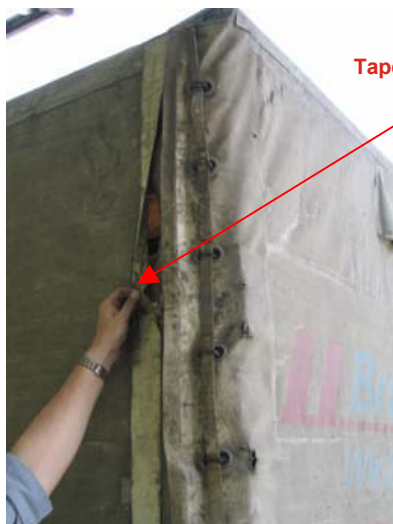
C: The sheet repaired with adhesive tape only.
Unauthorised (homemade).

Repairs should be made by professionals, as only very few methods of repairing the sheet are approved. Unauthorized or “homemade” repairs should not be approved (Pic. C and D).

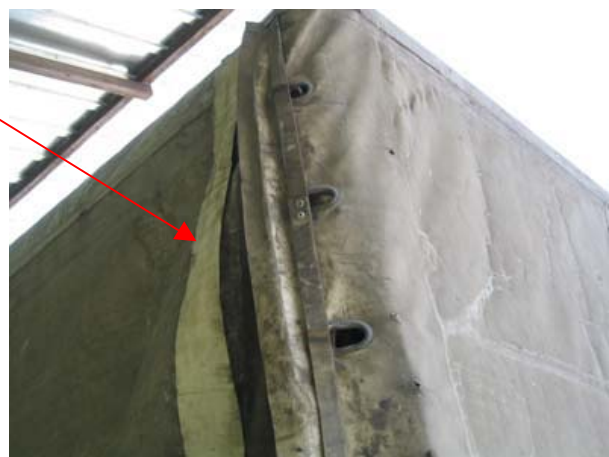
D: It is very easy to gain access to the load compartment.

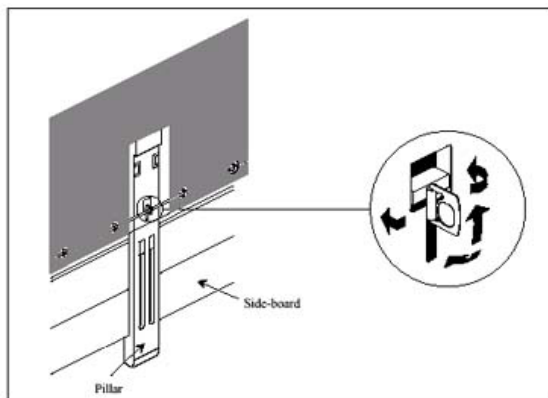
A: Folding type of TIR-ring - integrated pillar and sideboard locking mechanism.

Some manufacturers of trailers prefer to install a folding type of TIR-ring in the welded pillars, which support and contain the locking mechanisms for the sideboards - Pic. A. This means, that in folded out position - and secured by the TIR-wire - the TIR-ring will not only secure the sheet to the pillars, but also serve as a lock for the vertical movement of the locking pins and the sideboards cannot be released. Always make sure that this TIR-ring is in use - if installed. An incompatible sheet for the truck/trailer and (or) missing TIR-rings results in incorrect closure of the vehicle and makes it possible to get access to the load compartment - Pic. B. Damage or adaptation of the TIR-rings or eyelets are a risk as they are difficult to detect. If several TIR-rings in a row are damaged it is easy to get access to the load - Pic. C.

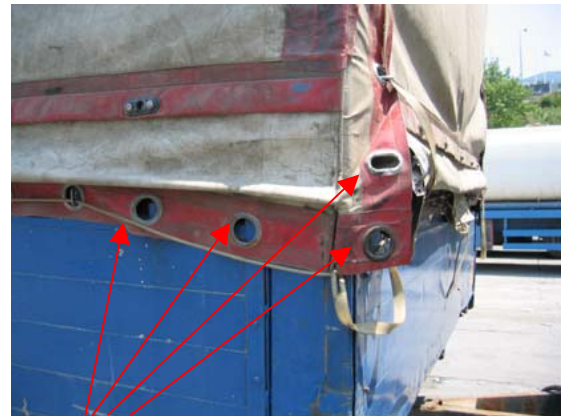
B: TIR-rings missing or sheet does not fit the trailer.

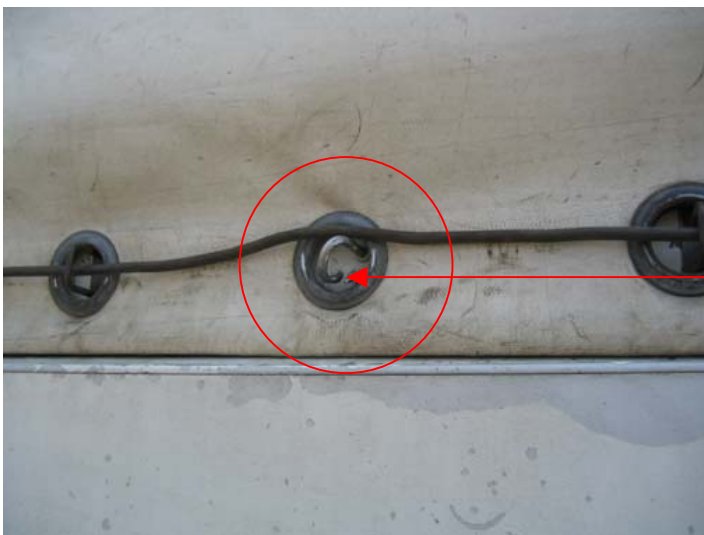
C: TIR-ring open - TIR-wire can pass and sheet released. In this case a typical example of wear and tear and not adaptation.

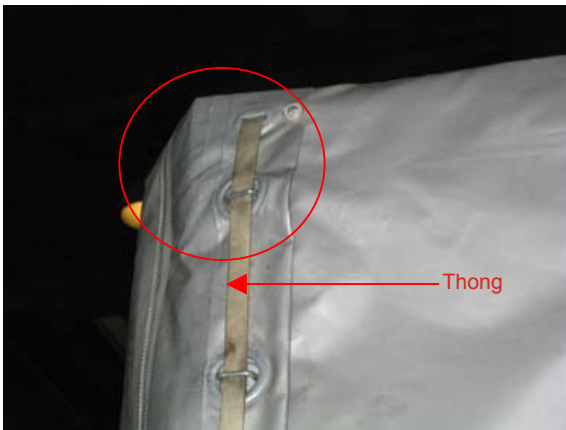
A: Thong - inserted through a special hole for passing through all layers of the sheet.
(Upper front part of the trailer)

The thong shall be secured and mounted with rivets to the inner layer of the sheet which makes it impossible to remove or replace without cutting the sheet - Pic.A, B, C and D.

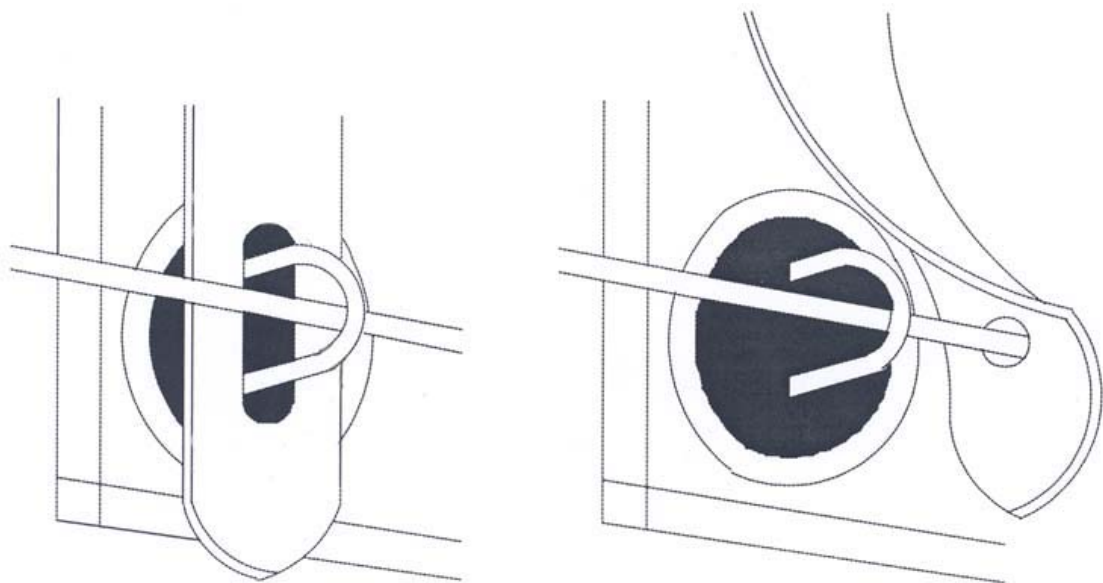
B: Examples of securing thongs with the TIR-wire.

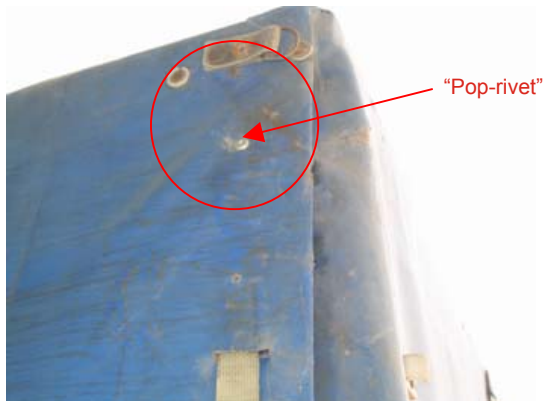
A: Thong fitted with a “pop-riquet”.
Note that is a brand new rivet!
OUTSIDE view.

Thongs should be fitted, replaced or repaired by professionals only. It is common to find trucks and trailers having thongs replaced and the new thong being fitted in an unauthorized way - Pic. A, B and C.

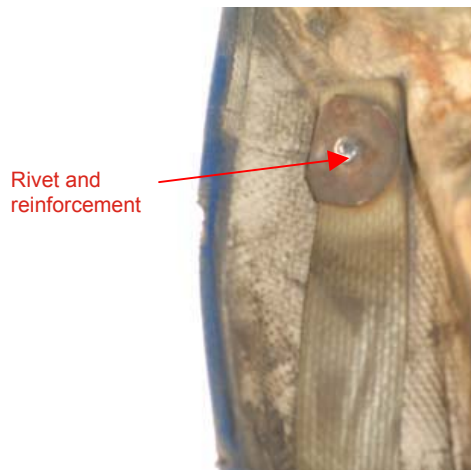
B: “Pop-riquet” and reinforcement.
When was it last replaced?
INSIDE view.

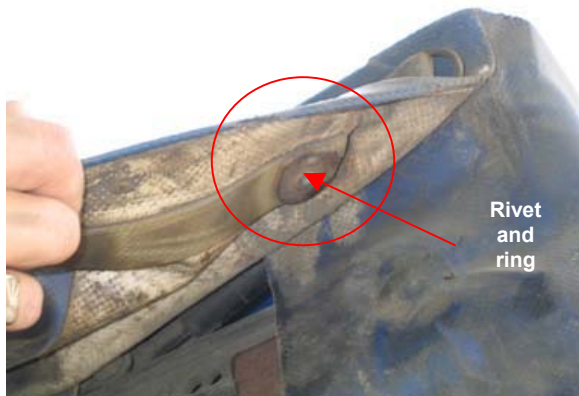
C: Thong fitted only to the outer layer of the sheet - making it easy to replace the rivet.

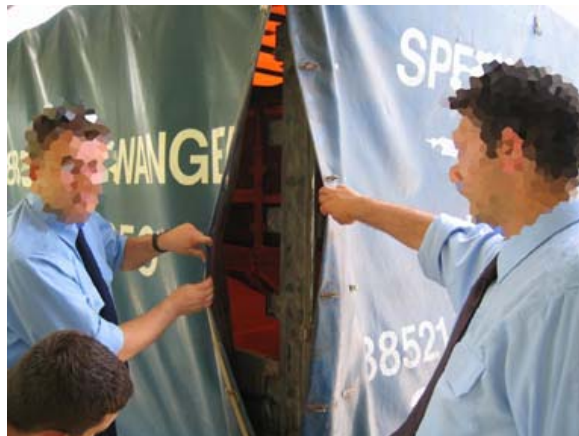
D: Good access when thong is removed.

The “pop-riquet” securing the thong can easily be removed (and a new one inserted) – leaving direct access to the load compartment - Pic. D.

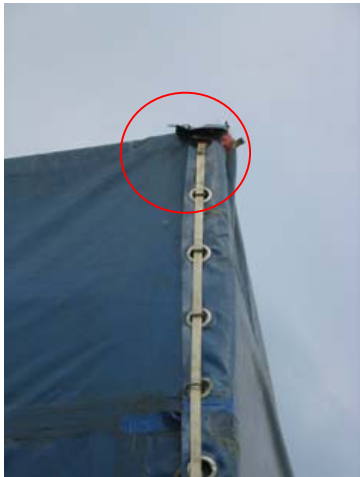
A: Thong - joined outside (with rivets).

A wide range of unauthorized or “homemade” repairs of the thong can be found; the examples shown below - Pic. A, B, C, D and E - are just few. Trucks and trailers equipped with such poorly repaired thongs should not be allowed to carry out international transport - and certainly not any transport of goods under customs seal.

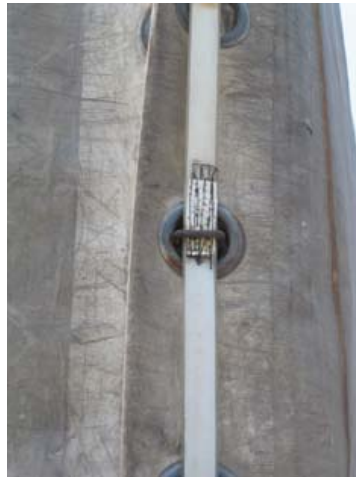
B: Thong repaired or joined with an extra layer of textile and sewing.

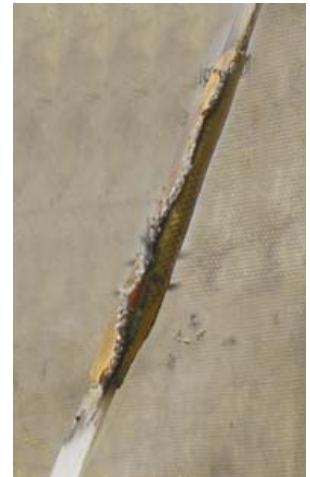
C: Thong repaired or joined with tape.

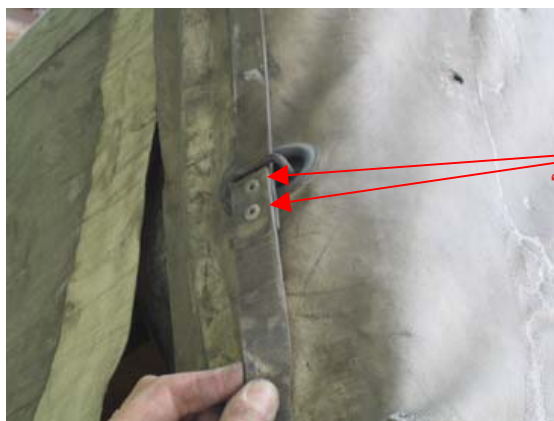
D: Thong, cut or broken, repaired - joined with blind rivets.

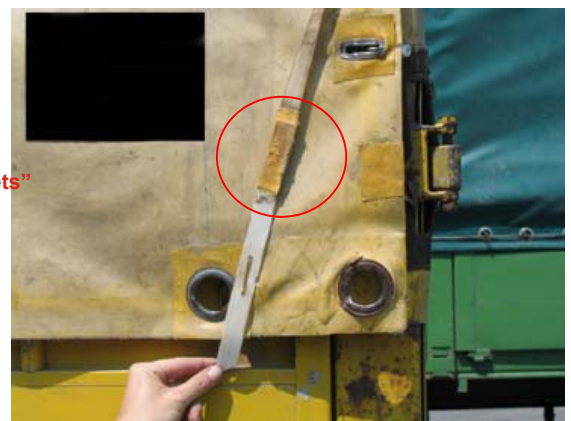
E: Thong repaired - joined with adhesive tape.

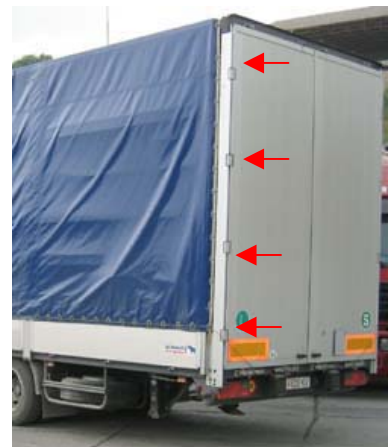
E: Trailer in good condition - no damages to sideboard- or rear door hinges

In general all hinges are vulnerable parts - exposed to wear and tear - so by just a distant view of a truck or trailer it is possible to estimate the standard - Pic. E.

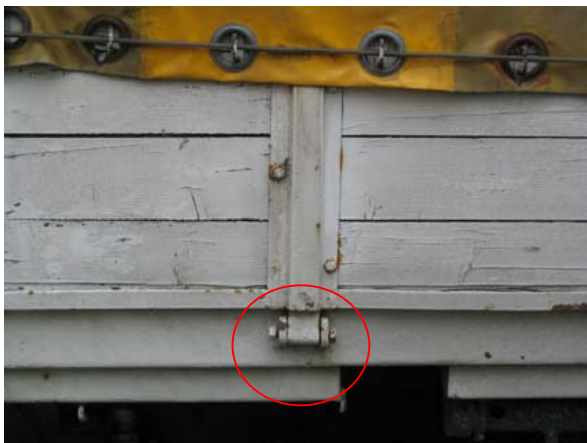
A: Unsecure hinge for sideboard.
(Truck of an earlier date.)

The bolt inserted as a pin - Pics: A and B - cannot be considered as securing the hinge. The nut and head should be cut off, leveling the outer of the bearing, and properly welded. The bit of metal bar inserted as a pin - Pics: C and D - cannot be considered as securing the hinge. The split pins are easy to remove and the pin taken out. The hinge can be adapted to be secure if the pin is cut and welded properly - see Pic. B.

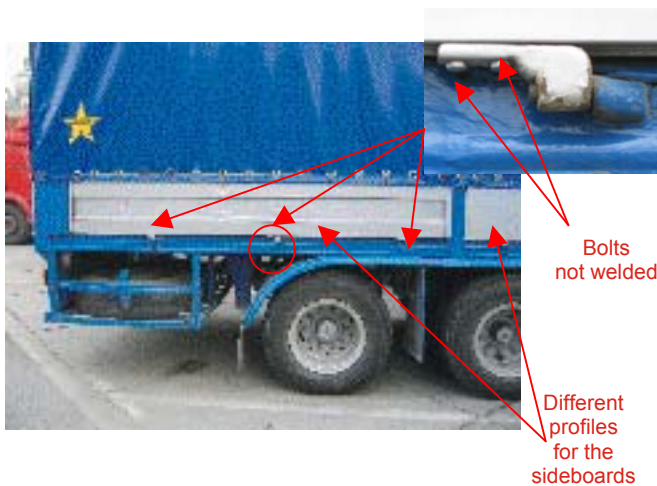
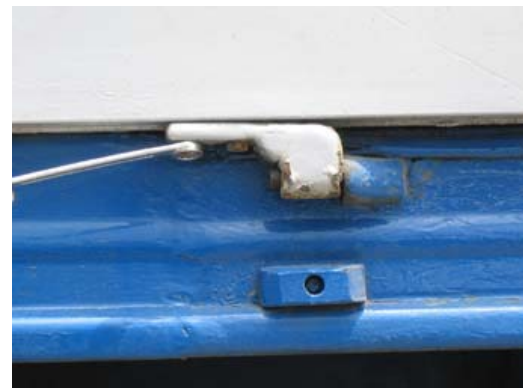
A: Different profiles for the sideboards - indicates replacement. Bolts for the hinges not secured (not welded).

B: It is easy to loosen both bolts by using a standard wrench.

Unauthorized repair or replacement of sideboards are always a risk factor - note the profiles for the sideboards on the trailer shown below. A close inspection reveals that the two bolts for each integrated part, the sliding bearings, are not secured (not welded) - Pic. A.

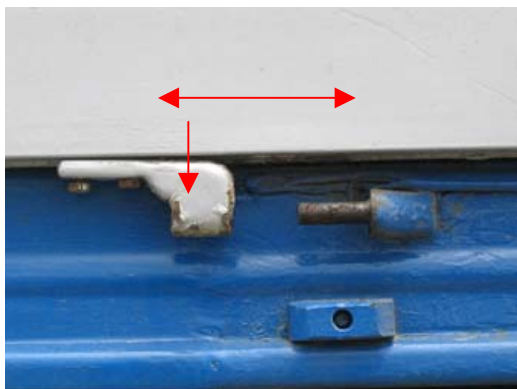
C: Bearing can be slid off the pin.

It is easy to loosen the bolts and then slide the bearings off the pins - Pics. B and C – leaving limited, but still unacceptable, access to the load compartment - Pic. D.

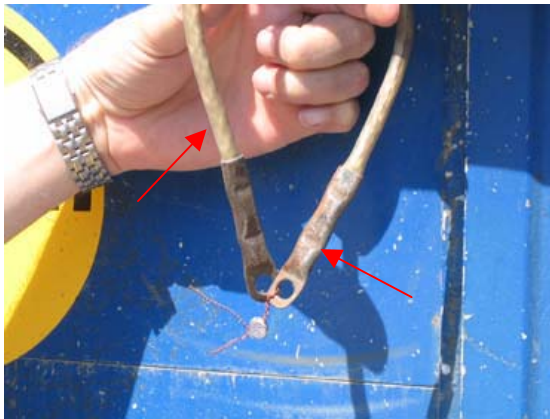
A: Nylon rope in plastic sheathing with homemade end-pieces.

It is common to find trucks and trailers equipped with irregular TIR-wires and end-pieces.

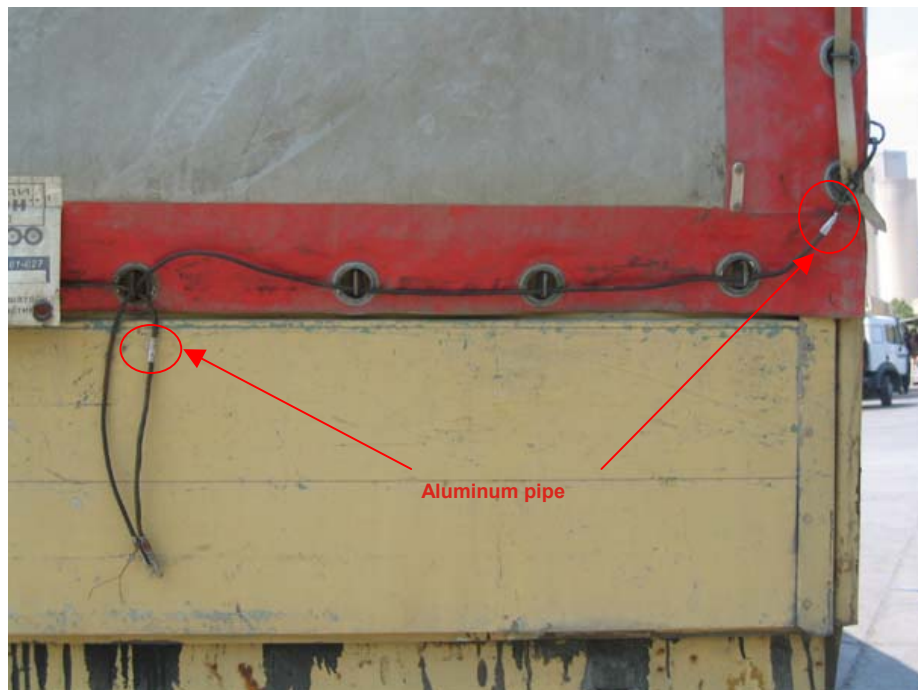
C: TIR-wire repaired at two places. The broken wire is jointed with pieces of aluminium pipe.

Broken or cut (adapted) TIR-wires are often found to be jointed by use of short pieces of copper or aluminium pipe - Pic. C.

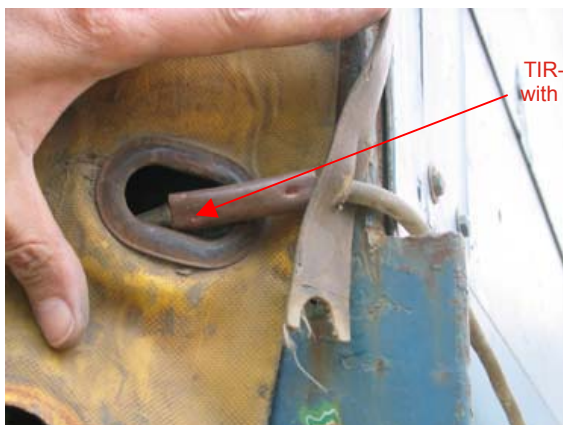
A: TIR-wire cut or broken - repaired with a piece of copper pipe.

Replacement of broken, damaged or cut TIR-wires should be requested immediately when found - trucks or trailers equipped with such wires should not be allowed to carry out transport under customs seal. Such repairs as shown below - Pic. A and B - are unacceptable, as it is impossible to determine whether or not the wire is broken, the sheathing just being damaged and the steel cord being rusty, or it is made on purpose (adaptation).

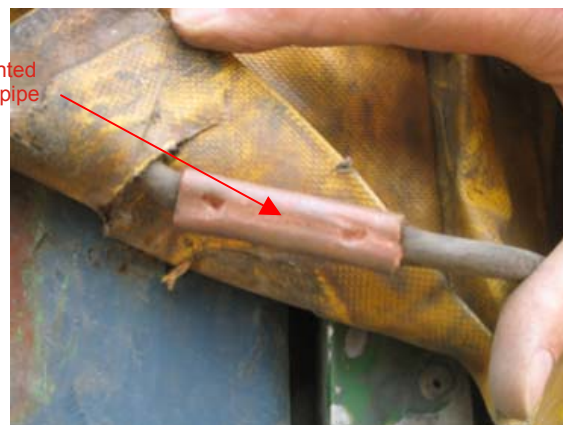
B: TIR-wire repaired with a piece of copper pipe. Note the shiny copper - when was it last replaced?

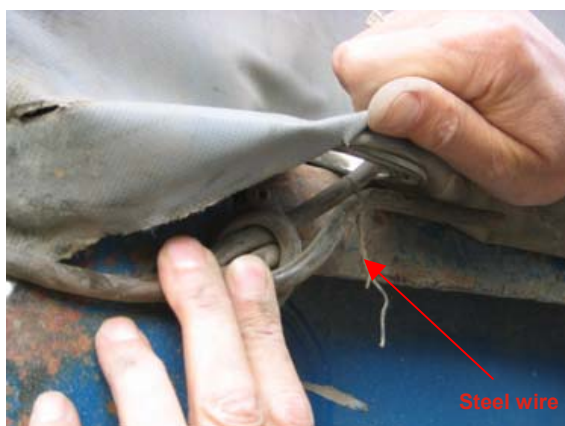
C: Broken TIR wire repaired - two loops made, the ends being secured by thin steel wire, twisted.

An obvious way - and easy to discover - of repairing a broken wire is to make loops by using pieces of wire to secure the ends (twisted) - Pic. C.

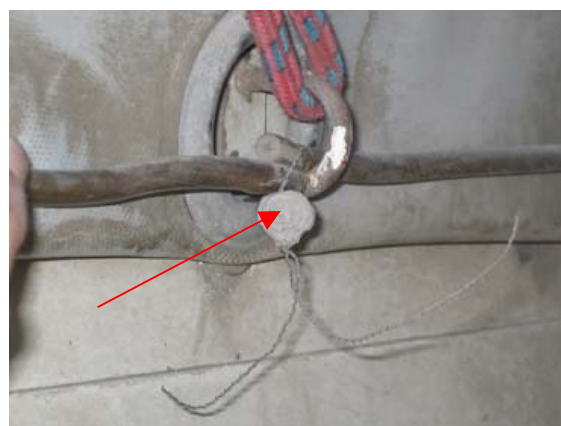
D: Rather unusual joining of a broken or cut wire. Jointed behind the cabin with a CUSTOMS SEAL.

It is even possible to find broken TIR-wires being jointed by the use of a Customs Seal - Pic. D.

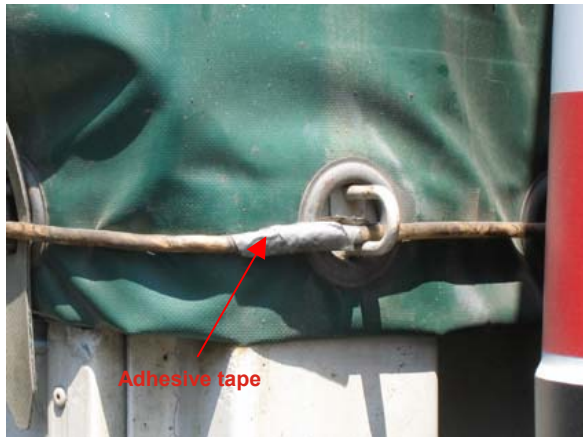
A: TIR-wire wrapped with adhesive tape.
(Camouflage)

It is quite common to find repairs being camouflaged. In most cases this camouflage is made by using adhesive tape or plastic material. In most cases the driver will claim that the plastic sheathing for the TIR-wire is damaged, and the tape is put on only to prevent the steel cord from getting rusty.

As recommended good practice, such camouflage should always be removed - and in most cases the wire is found to be broken and repaired (jointed).

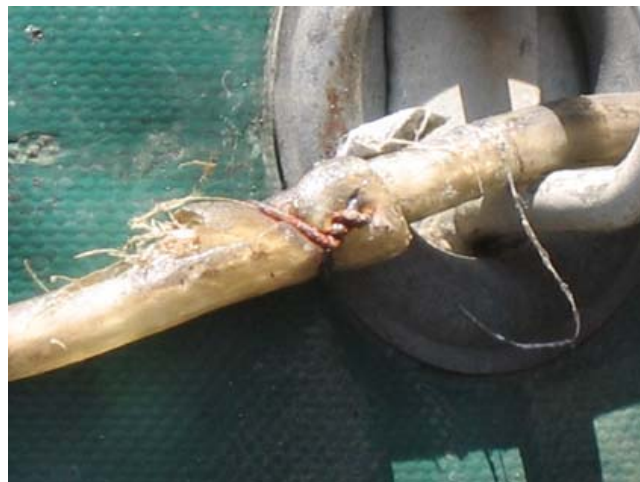
C: TIR-wire jointed with a piece of wire –
just twisted and easy to replace.

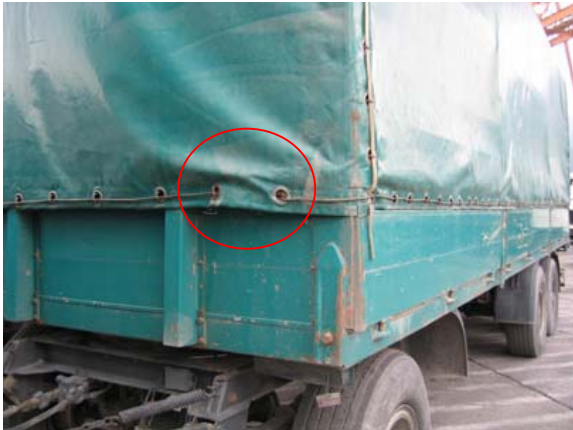
A: TIR-wire hidden behind the sheet.

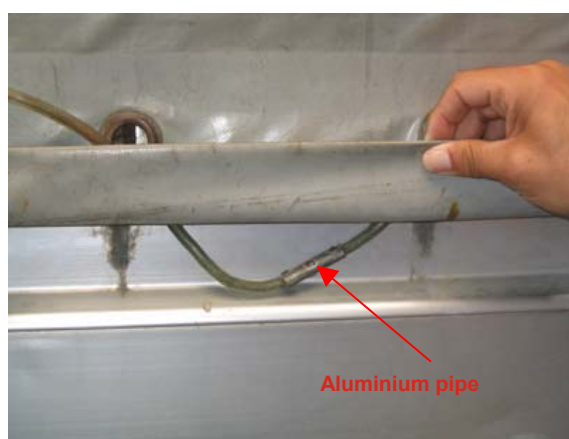
D: TIR-wire jointed - a piece of aluminium pipe being used.

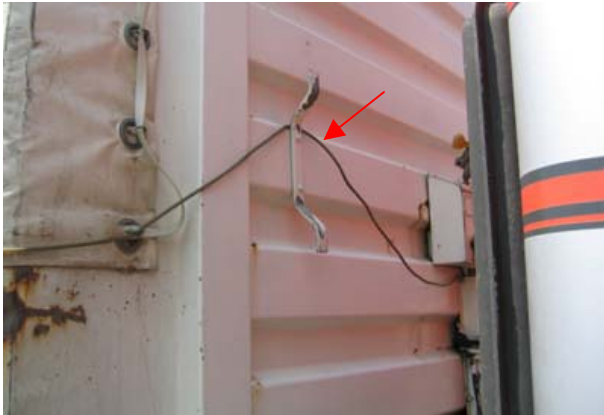
A: TIR-wire hooked up next to the junction box.

The TIR-wire shall correspond exactly to what is required for each individual truck or trailer. No extra length shall be hidden anywhere, i.e. as loops between the TIR-rings. In most cases such extra length will be hidden at places difficult to inspect, i.e. next to the junction-box for electrical and brake connections - Pic. A and B, or behind the cabin - Pic. C and D. Substantial extra length of TIR-wire can be found in some cases - Pic. E.

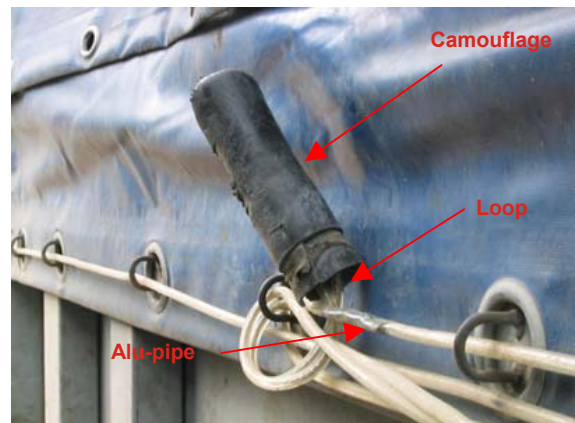
D: Plastic pipe used as a cover for the folded end loop. Note the aluminium pipe - repair of cut or broken wire.

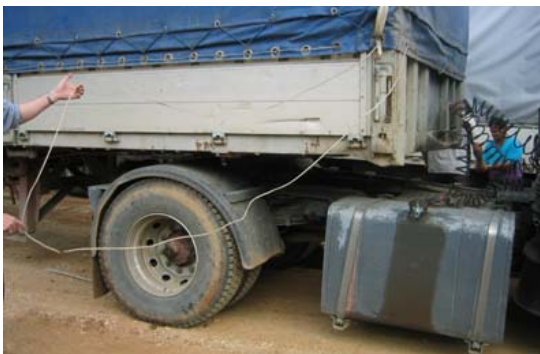
E: The hidden extra length unfolded. Approximately 5 meters was hidden.

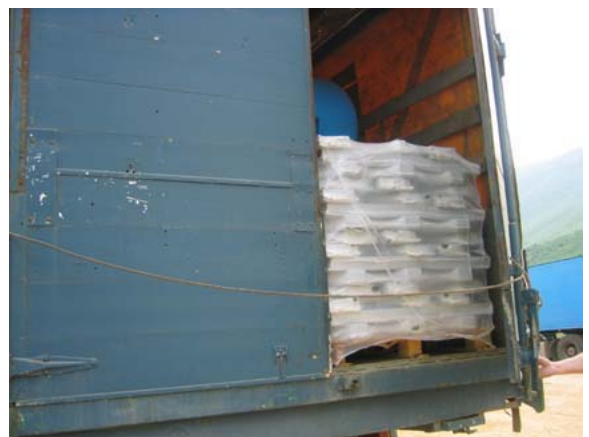
D: Just 1 meter of extra wire makes it possible to open the door widely.

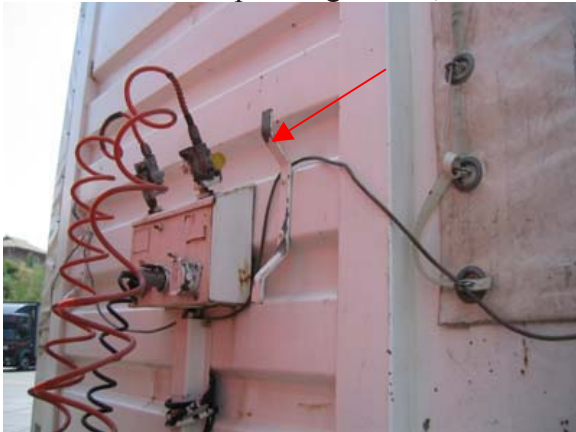
A: Approximately 50cm of extra wire hidden.

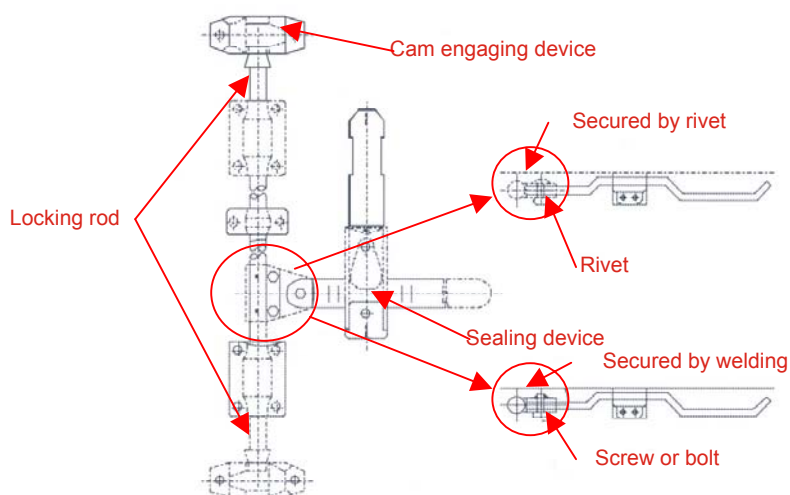
B: Standard version - used for “sheeted” trucks as well as for trucks having solid sides (“non-sheeted”).

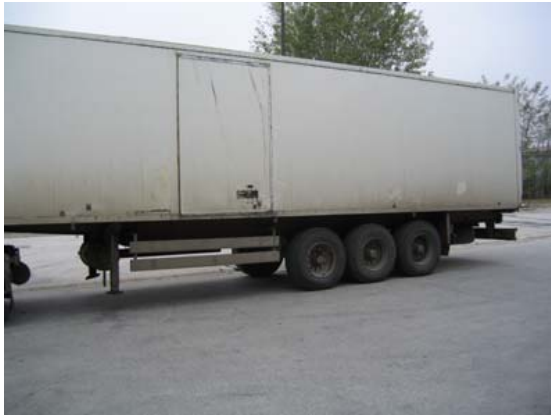
A: Refrigerator trailer with side door.

Illustrated below is a refrigerator trailer equipped with side door. Due to only limited inspection, wear and tear of the sealing device and the string (wire) not being pulled tightened) as much as possible - leaving a large loop - it is possible to open the door without breaking the seal. ALWAYS fix the Customs seal at tightly as possible - not leaving any loop or additional thread. If the seal is fixed very tightly it is far more difficult to manipulate the thread (wire) or the sealing device.

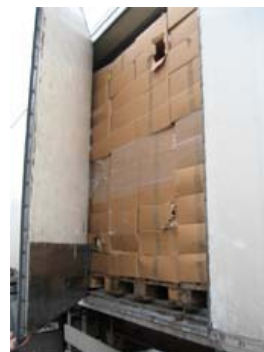
F: Access to the load (cheese). Seal not broken.

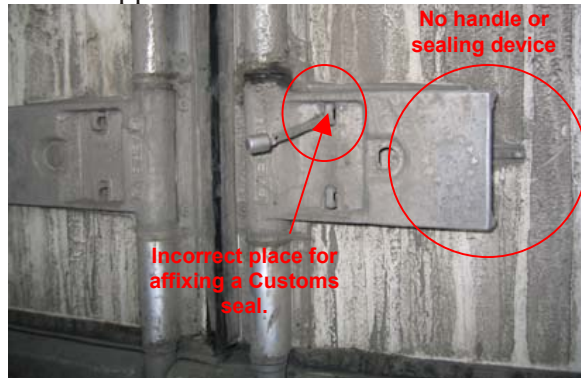
B: Handle and sealing device missing – right hand side - seal affixed incorrect.

The handle for the door at the right hand side is broken - leaving this door without the correct sealing device in working order. Instead the officer affixed the Customs seal at the device which is normally used for the carriers own security measures - i.e. a pad-lock - Pic. B.

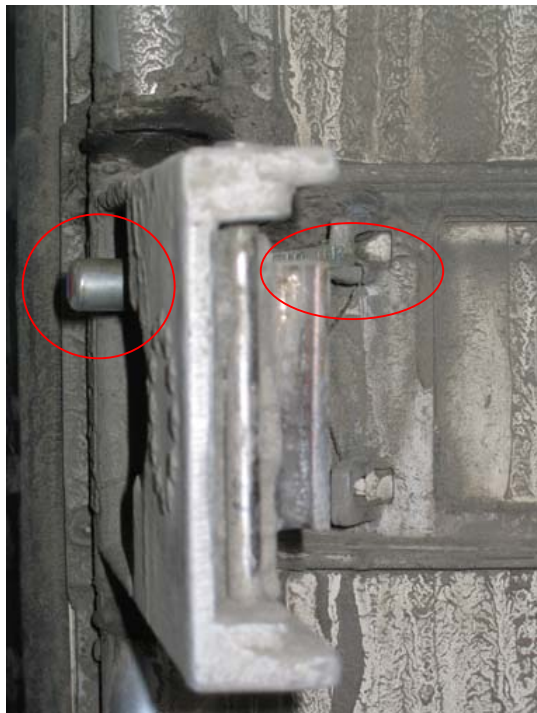
C: Handle turned, locking rod activated - the metal strip for the seal can pass, the actual seal itself remains unbroken.

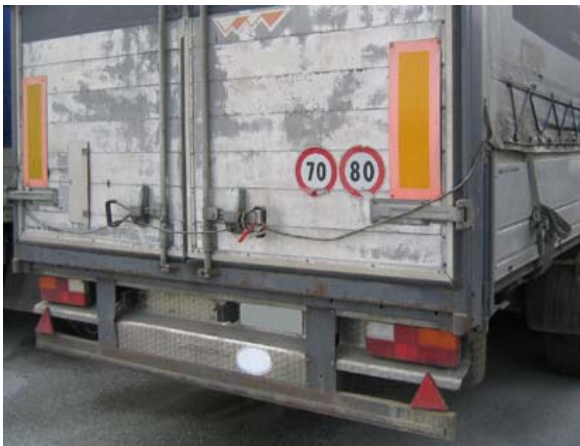
A: Standard conditions fulfilled – apparently acceptable security and sealing.

The trailer illustrated below seems to fulfil the conditions for carrying out transport under Customs seal - Pic. A. - but a close inspection determined otherwise.

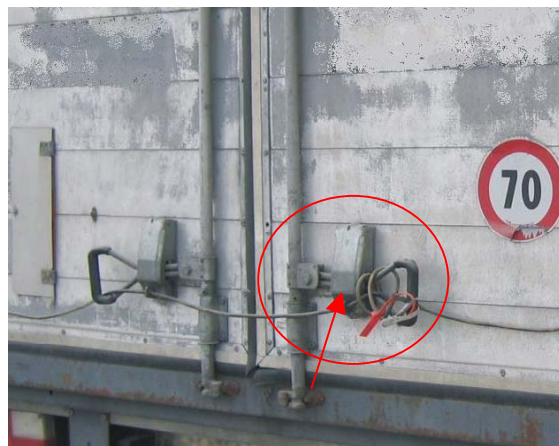
B: Locker for the metal-box covering the pivoting device secured by the sealed TIR-wire.

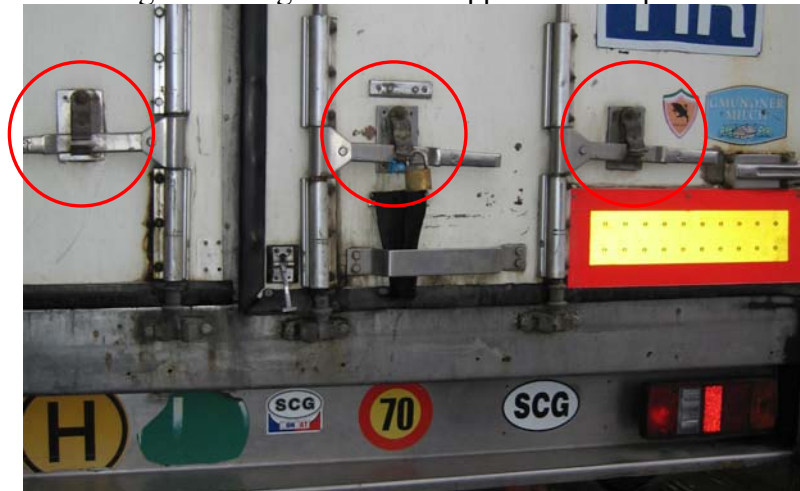
A: Original devices for all locking rods obviously replaced.

Refrigerated trailer equipped with a pivoting Customs sealing device – the same type of device being used for all locking rods. Original devices appear to be replaced.

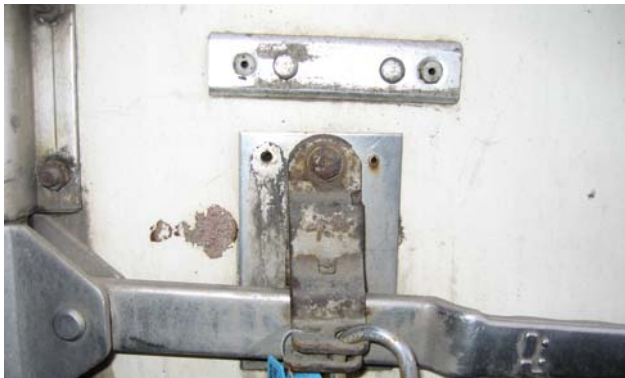
B: Pivoting Customs sealing device appear to be assembled from parts made of different metals – iron and stainless steel. Normally all parts for such devices are made of stainless steel.

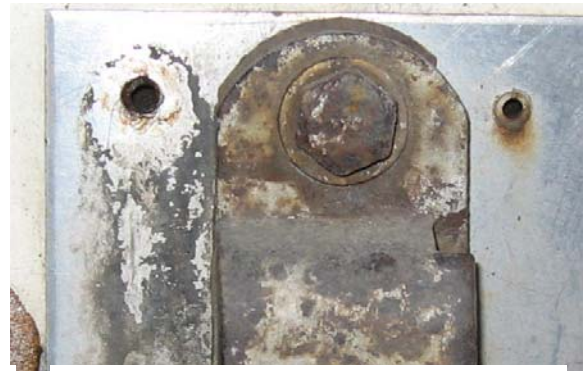
C: The device illustrated clearly indicates that it has been repaired and parts replaced – or it could be adopted for easy manipulation.

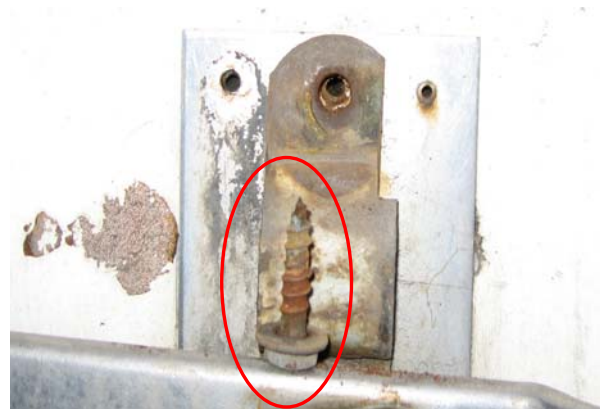
D: The pivoting section secured by a normal Lag bolt meant for wood. The bolt is easily removed and the pivoting section lowered – still attached to the back plate via the string for the Customs seal. The handle is free and can now be operated and the door opened.

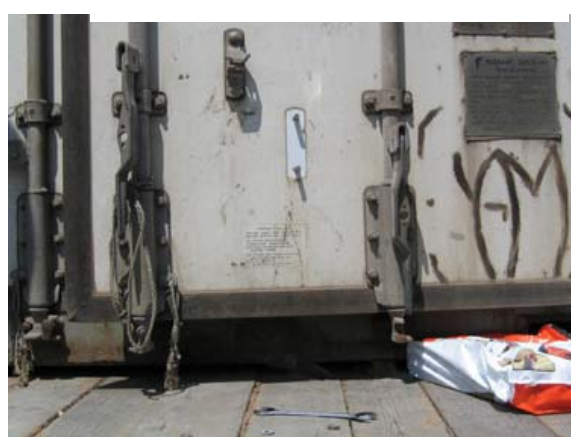
E: Locking rods released - door slightly opened.

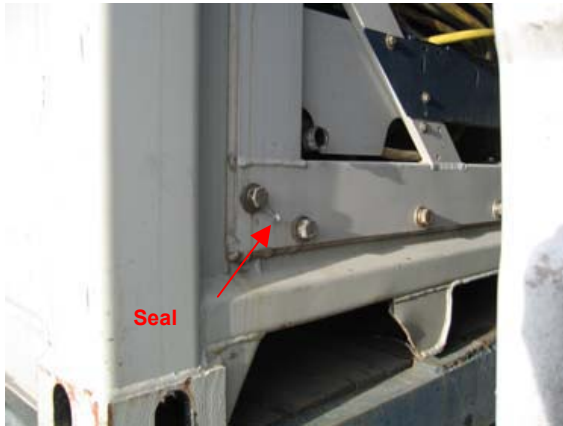
A: Lower part of the frame, bolts and seal for the refrigerator unit.

The entire refrigerator unit for containers can easily be replaced - although it is a heavy unit. Normally the frame for the unit is mounted to the container by many strong bolts and they are not welded.

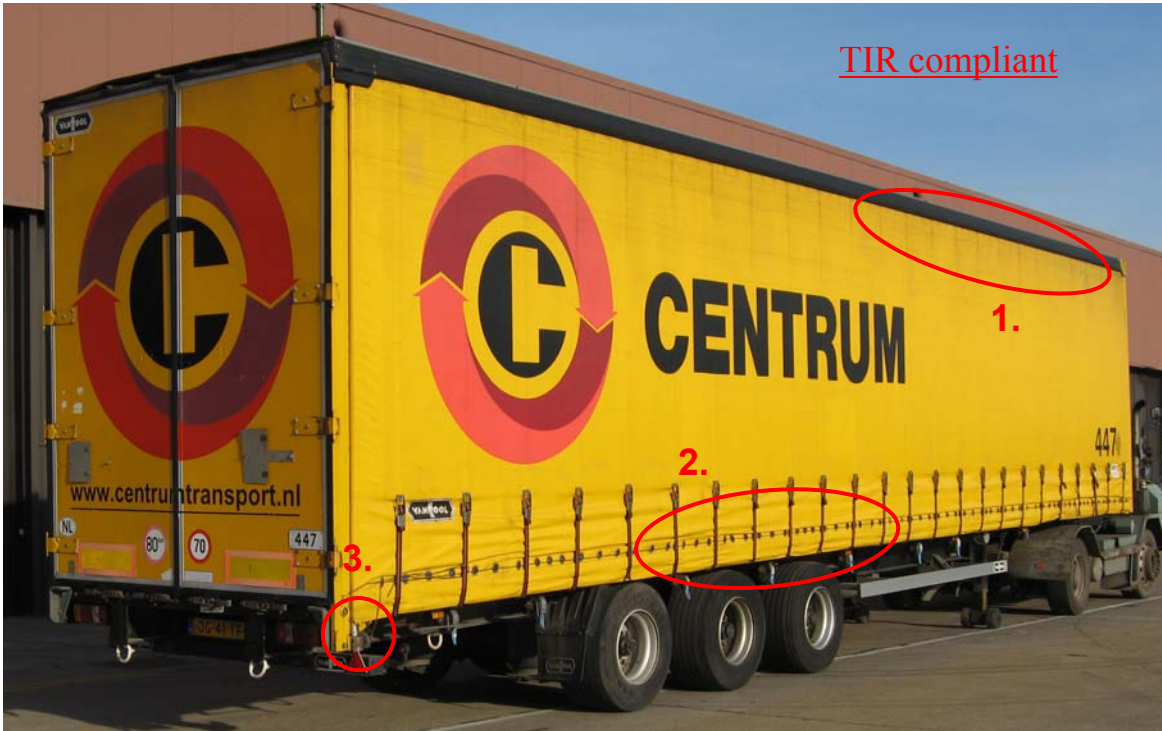
1. Profiles for the rail system, sheet overlap, space between rollers - at the top of the vehicle.
2. Sheet overlap, securing the sheet - at the bottom of the vehicle.
3. Sheet tensioning device.

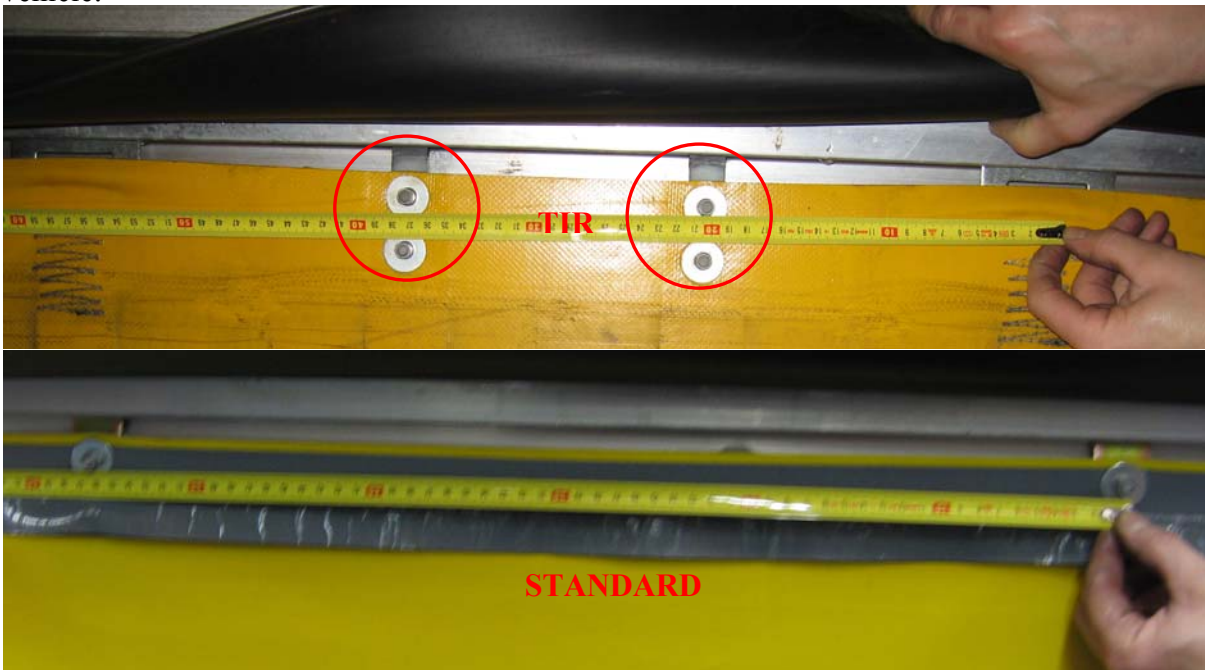
Note the additional rollers on the TIR vehicle! – No additional rollers on the standard vehicle.

Illustrated below, the impact of the difference in distance between the rollers at the top of the vehicle.

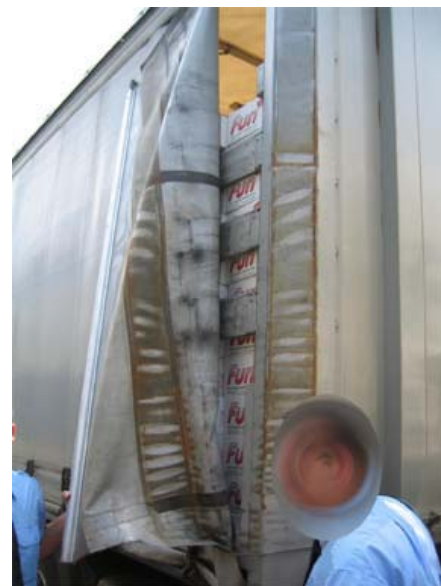
D: Limited - but still unacceptable - access to the load.

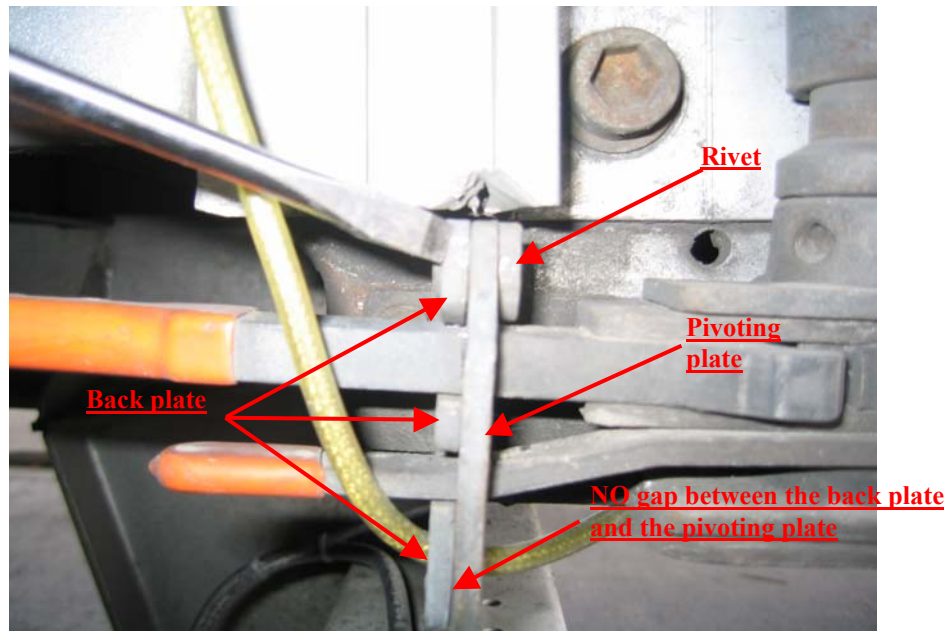
A: This device can only be considered secure and not manipulated if there is no gap between the back plate and the pivoting plate - the rivet must be pressed extremely tight.

Illustrated below an example of a modern version of a tensioning device of the type “ratchet”. This device is mass-produced and it is currently being used by a number of trailer-manufacturers. The weak point is the mounting of the pivoting plate – mounted by a rivet. This device can easily be manipulated - and even wear and tear can have a negative impact regarding the security of this device.

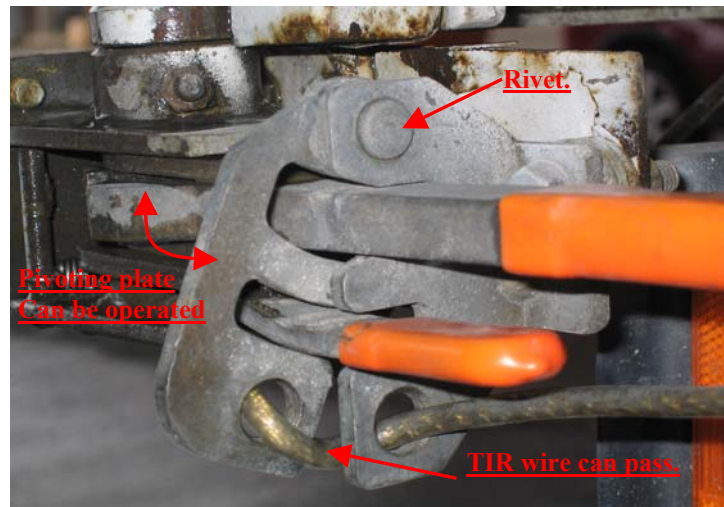
A: Rivet manipulated – or it is not fully pressed, a significant gap between the back plate and the pivoting plate. The pivoting plate can be operated – the TIR wire can pass without being damaged.

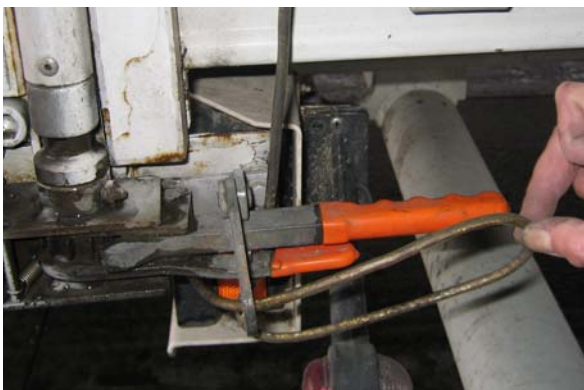
B: The device can be operated if additional length of the TIR wire can be found and located next to the handles – only 15 cm is required. On this trailer 35-40 cm were found.

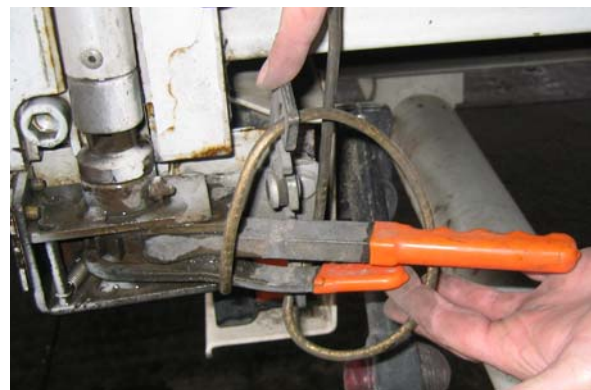
C: The additional 35-40 cm made it possible to place the wire behind the handles – the device is now ready to be operated as if there was no wire at all.
