ECE/TRANS/WP.30/2006/16
4 August 2006

**CUSTOMS CONVENTION ON THE INTERNATIONAL TRANSPORT OF GOODS UNDER
COVER OF TIR CARNETS (TIR CONVENTION, 1975)**

Sealing of Vehicles

Good Practice Guide

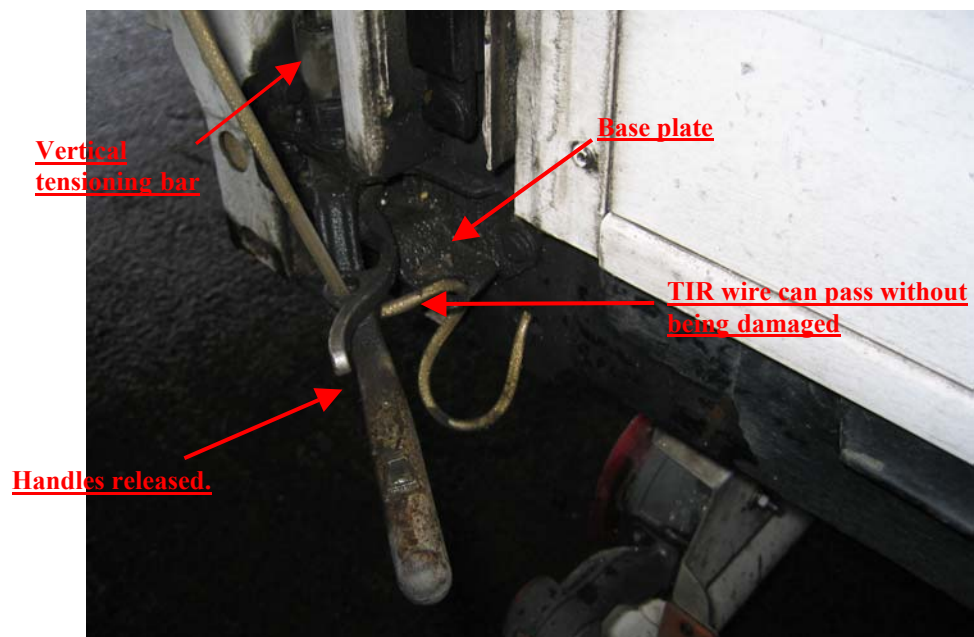
B: The gap between the base-plate and the main handle – 1 cm - allows the wire to be squeezed and pass between the handle and base-plate without being damaged. The length of the TIR wire makes it possible to disengage and operate the tensioning device, release tension on the sheet and lift the tensioning bar off its base. Only 10-15 cm of TIR wire needs to be placed next to the device in order to disengage the system.

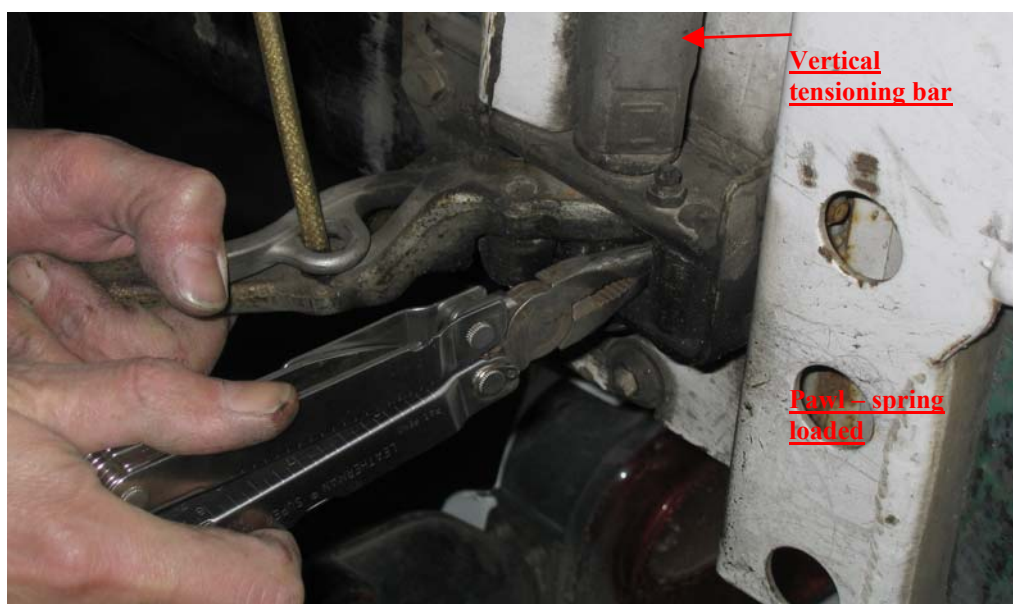
C: This picture illustrates how to disengage the spring loaded pawl. This pawl and the cam wheel creates a ratchet system and it is the brake for the tensioning bar. By the use of a "LEATHERMAN" multi-tool or a screw driver it is easy to disengage the system.

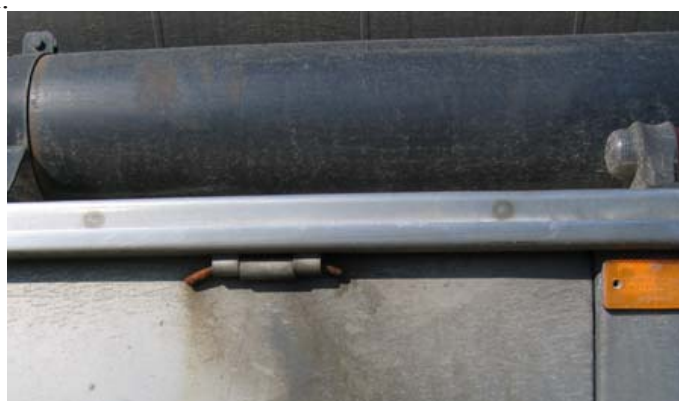
D: Inspect the hinges. The pin for this hinge has been replaced by a piece of rusty iron bar - not secure at all.

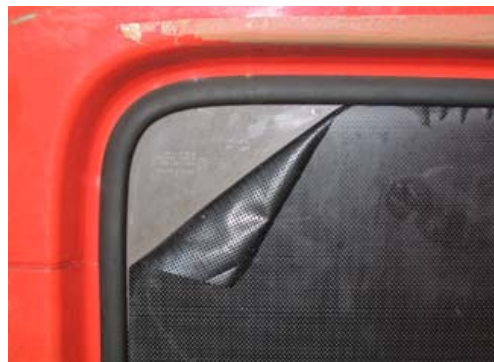
E: Detail - adhesive plastic foil.

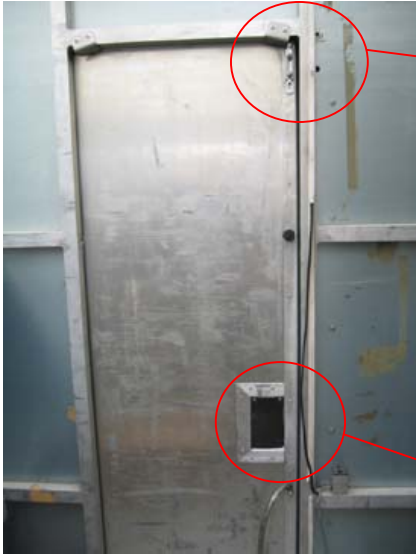
A: Sliding door between the cabin and the load compartment.

Occasionally small trucks only designed for domestic transport - i.e. designed for mail or parcel delivery service - can be found to carrying out international transport. In most cases such vehicles do not meet the international standards - and should not be accepted for transport under customs seal. Illustrated below is the interior of a vehicle originally designed for a courier company - United Parcel Service (UPS) - now owned by a locally registered company and carrying out international transport. It is obvious that such vehicles cannot be accepted without proper security measures being installed.
