THIS PAPER IS TO BE PRESENTED IN BELGRADE,  
ON THE INTERNATIONAL CONF. ON  
“SCIENCE AND MOTOR VEHICLES 2003.”

## **LESSONS AND CONCLUSIONS- LEARNED FROM THE ANALYSIS OF BUS ROLLOVER ACCIDENTS**

Dr MATOLCSY, Mátyás  
Co-president  
Scientific Society of Mechanical Engineers (GTE)  
Hungary

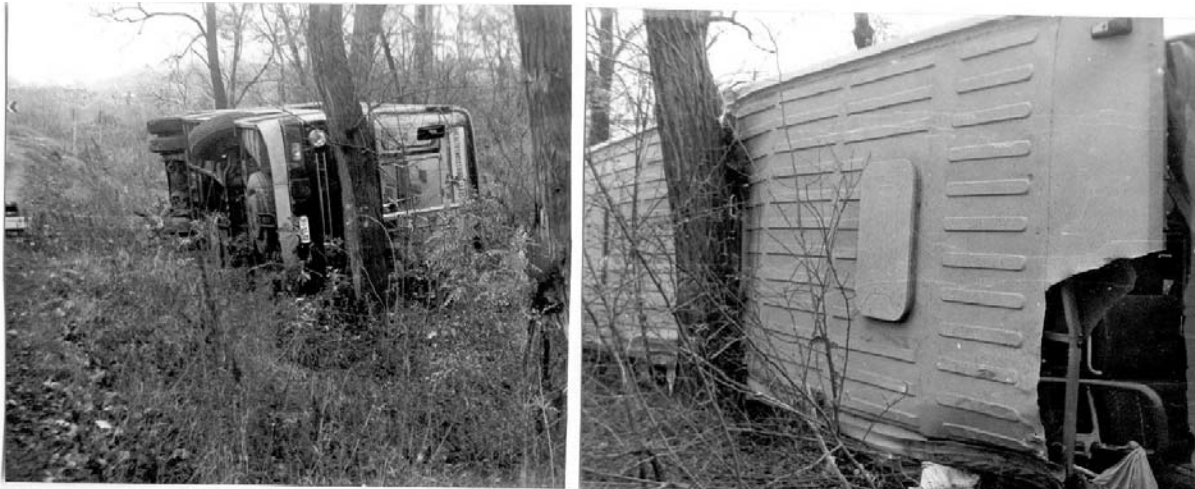
Fig.1. Turn on side, where the rotation is stopped by a tree

- a) What accident situation will result “turn on side” rollover accident? It depends mainly on the circumstances and not on the construction of the vehicle. Many rollover accident start on the following way: the bus slips on the road, the one side wheels are stopped (blocked) by the soft, deep soil of the road-side (or by the curb stone) and the lateral accelerations rotates the bus around the blocked wheels. The further motion depends on the circumstances. Fig.1. shows a situation, when a tree or another example: the shape of the ditch and the soft deep snow (Fig.2.) prevented the further rotation,

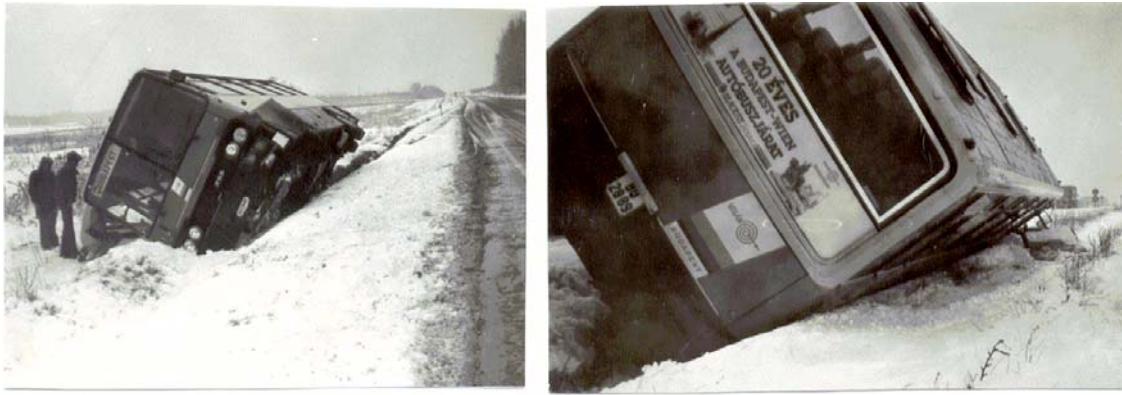
*Fig.2. Turn on side in a snowy ditch.*

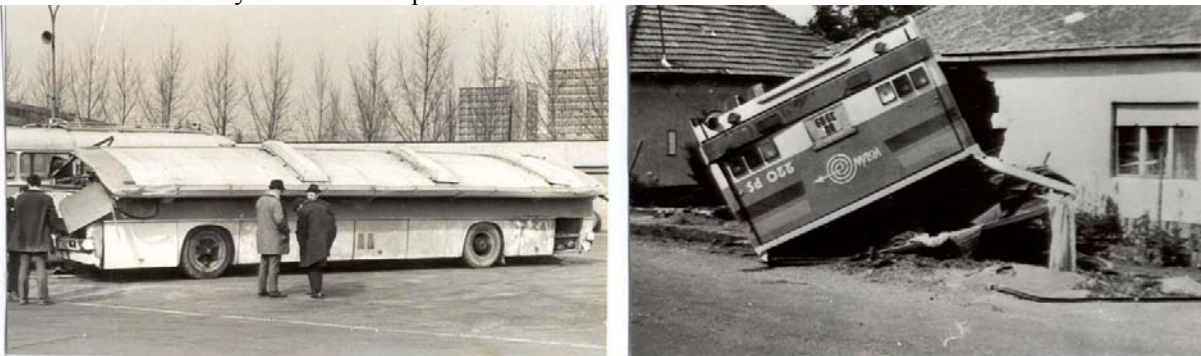
*Fig.3. The results of real rollover accidents with weak superstructure*

It is difficult to control whether the decided and used standard approval test is adequate to separate the strong superstructure from the weak one, to meet the demand of the public, to assure the required safety for the passenger. A slow feedback can be found from the accident statistics, from the analysis of rollover accidents. Fig.3. shows the results of two rollover accidents happened to the same bus type: “a” rolled down from a road having a slope with a tangent 4/6, “b” rolled over on a flat road. It is obvious that the superstructure is weak, can not assure a survival space for the passengers. Different kind of standard rollover tests showed the same result [1] After reinforcing the superstructure, all the different standard rollover tests gave positive result. Fig.4. shows the final position of a reinforced bus in a rollover accident, Fig.5/a shows also this reinforced type, while Fig.5/b gives another example with an approved vehicle rolled down on the same slope of the road which destroyed the weak superstructure.

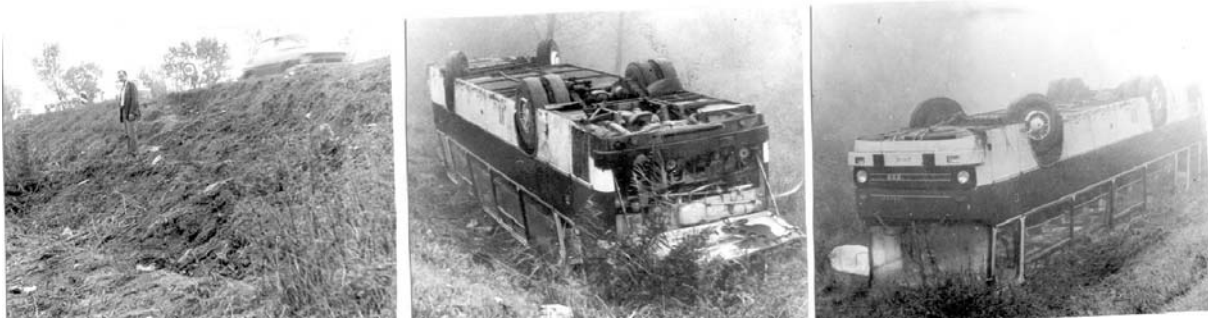
Fig.4. Rollover accident with reinforced superstructure

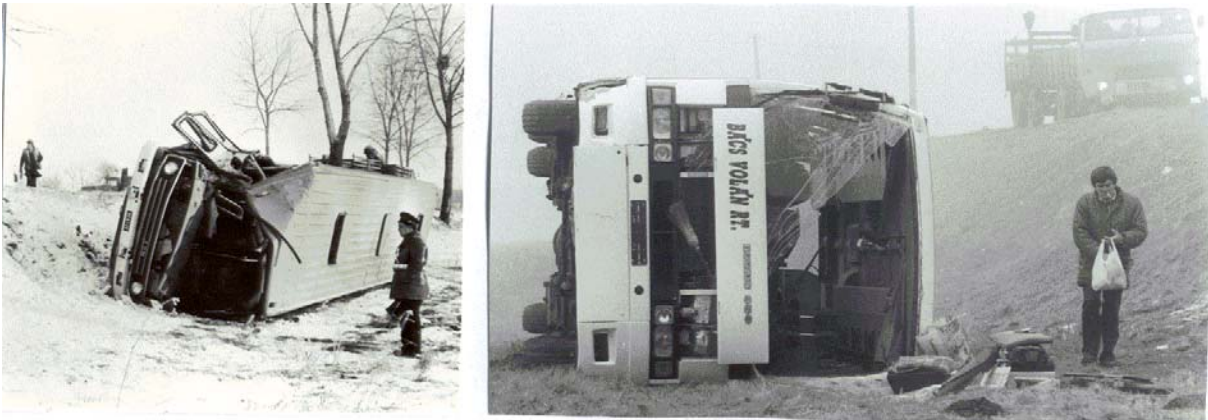
Fig.5. Strong superstructure assures the survival space
