DEVELOPMENT OF A PEDESTRIAN LOWER EXTREMITY PROTECTION CAR USING A BIOFIDELIC FLEXIBLE PEDESTRIAN LEGFORM IMPACTOR

Atsuhiro Konosu, Takahiro Issiki Japan Automobile Research Institute (JARI) Masaaki Tanahashi Japan Automobile Manufacturers Association, Inc. (JAMA)

Paper Number 05-0106

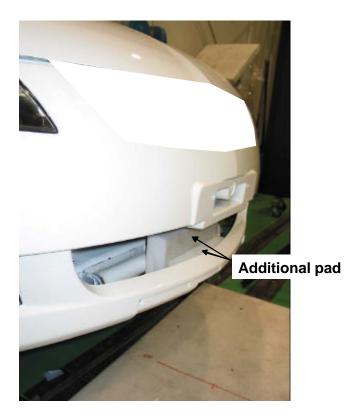
Figure 10. Modifications to Sedan 2.

The pedestrian lower-extremity protection methods adopted to Sedan 2 are shown in Figure 10. A pad was added so as to increase the rigidity of the bumper's lower portion. The test results with this modified sedan are given in Figure 11. The measured bending moment and elongation values at all the positions on the thigh, knee and leg of the Flex-PLI were measured to be below the injury risk level, thus affirming a capability of the modified Sedan 2 to protect the pedestrian lower-extremity in a collision.

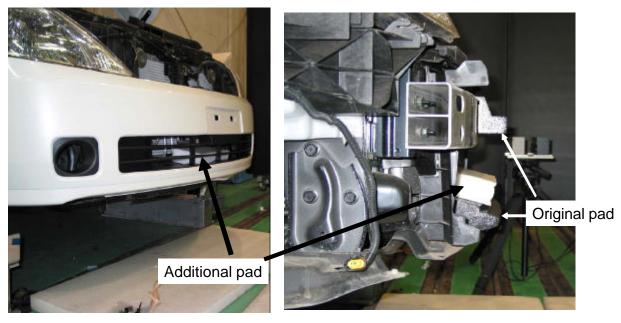
Figure 14. Modifications to Minivan.

The pedestrian lower-extremity protection introduced into the Minivan is shown in Figure 14. A pad was added so as to increase the igidity of the bumper's lower portion. The test results with this modified Minivan are given in Figure 15. The measured MCL elongation remained at the tentative injury risk level, and it was evident that the addition of the pad was ineffective. The test results with the original and modified Minivans were compared in Figure 16. The protection employed in the modified Minivan proved to be ineffective, except that elongation values for the knee slightly improved. This was attributed to the fact that because several pads already existed in the bumper area of the original Minivan (see Figure 14), the additional pad had to be placed on top of them in a higher position comparing to the Sedan 1 and Sedan 2 (see Figure 17).
