GRSP – 43rd Session Mary Versailles

Full Frontal Crash Test

Motorcoach Details

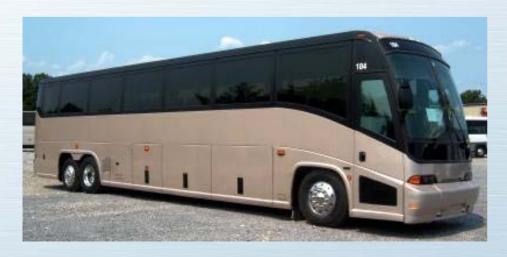
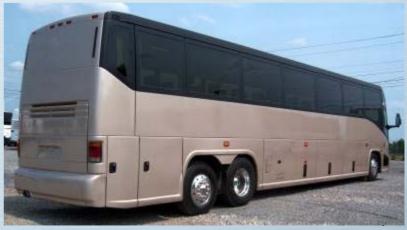
- 2000 MCI 102EL3 Renaissance
- Series 60 diesel engine
- B500 Allison Automatic transmission
- 54 seats
- 14 meters long, 381 cm tall
- 19,377 kg test weight

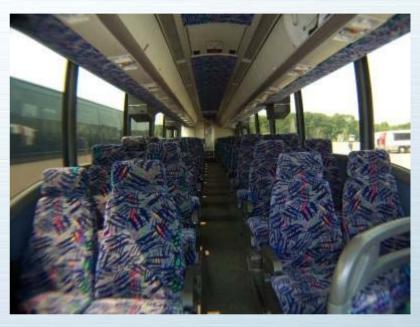
Seats on the Motorcoach

- Baseline seats
 - No belts
 - American Seating
- Seats with Belts
 - MCI/Amaya
 - 3 point belts 4 rows (dual seats)
 - 2 point belts 1 row (dual seats)
 - Freedman Seating
 - 3 point belts 1 row (dual seats)

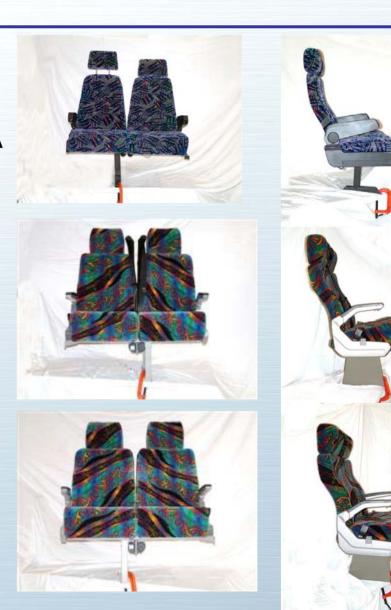
Seats (Continued)

- Baseline (No belts)
- MCI/Amaya/FAINSA
 - -3 point
 - -2 point
- Freedman 3 point

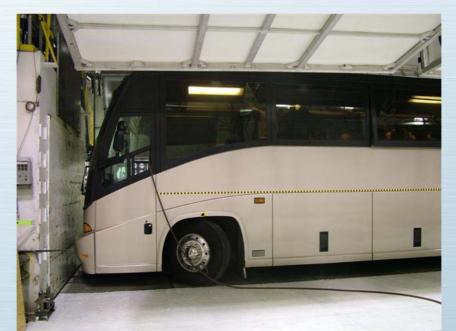
Test Conditions

- Speed: 48.3 km/h (30 mph)
- Frontal impact: 0 degrees; full overlap
- Fixed Rigid Barrier
- Data channels: 355 dummy; 26 vehicle channels @ 12500 samples/sec

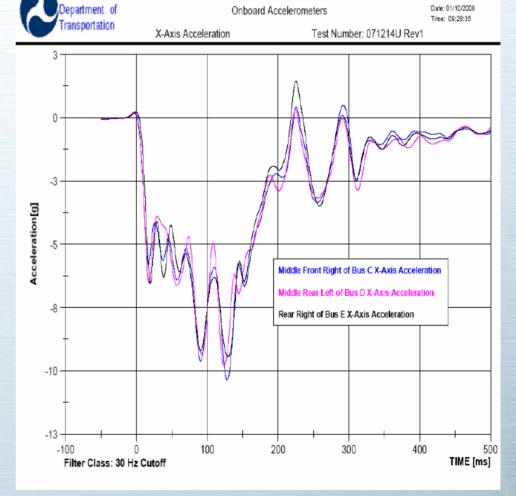
VRTC MOTORCOACH INTO FLAT FRONTAL BARRIER AT 30MPH

Crash Data

- Speed: 48.86 km/h
 (30.36 mph)
- Dynamic Crush:198 cm (6.5 ft)
- Peak deceleration:
 10g at 125 msec

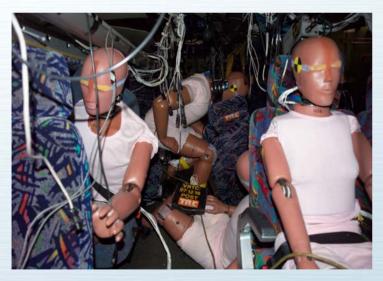
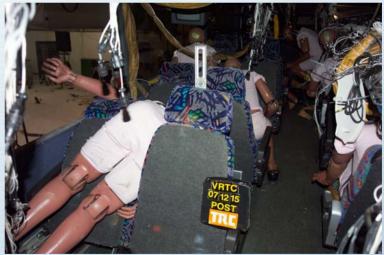
Observation - Unbelted Dummies

- Unbelted dummies typically made head contact with the backseat in front within 150-180 ms
- Dummies on the aisle seats ended up on the floor and dummies on the window seats ended up on the front seats or on the floor

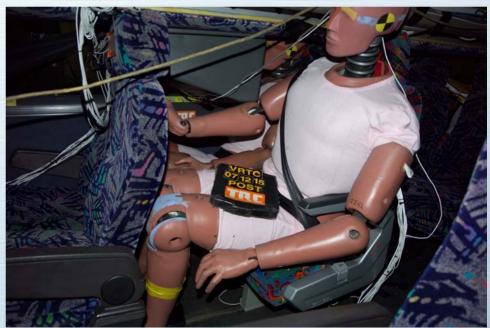
Observation - Belted Dummies

- Dummies stayed in seats
- Head/Knee contact with front backseat for 95th male dummies

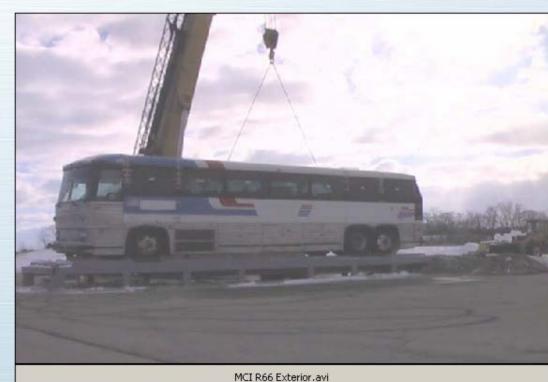
Rollover Tests

Tests were done on 2 motorcoach models:
 MCI and Prevost

- ECE-R66 test procedures
- Data is being analyzed

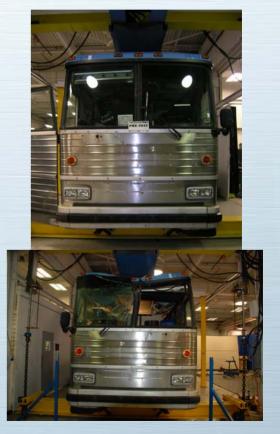
Roof Crush Tests

Tests were done on 2 motorcoach models: MCI

and Prevost

- FMVSS 220 test procedures
- Data is being analyzed
