**HYDROGEN VEHICLE FUEL SYSTEMS – LOCALIZED FIRE
PROTECTION CONSIDERATIONS**

CYLINDER TEST VALIDATION REPORT

**Transport Canada
Road Safety**

**Powertech Labs Inc.
12388 – 88th Avenue
Surrey, B.C. V3W 7R7
Canada**

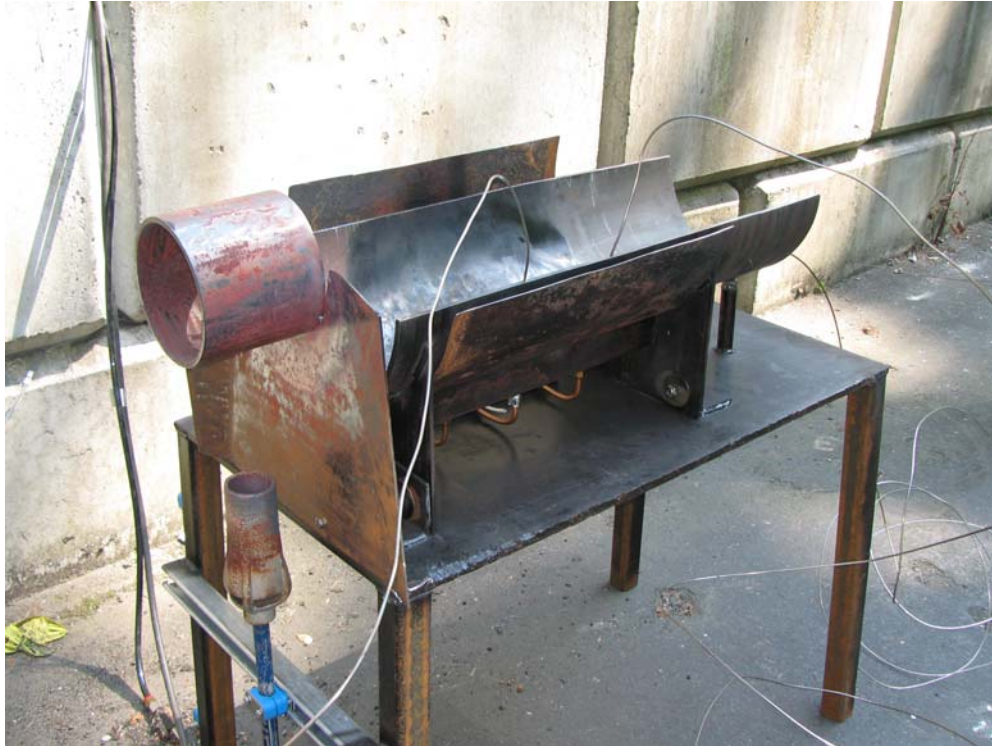
The localized fire test apparatus that was developed to achieve the required temperatures within the required time used a heated metal plate in contact with the fuel tank surface sidewall (see Figure 2). For the valve end, metal “prongs” were extended from the metal plate to transfer the required heat (see Figure 3). The purpose of using the metal plate is to allow close control of the temperature.

Figure 2 – Overall view of localized fire test apparatus

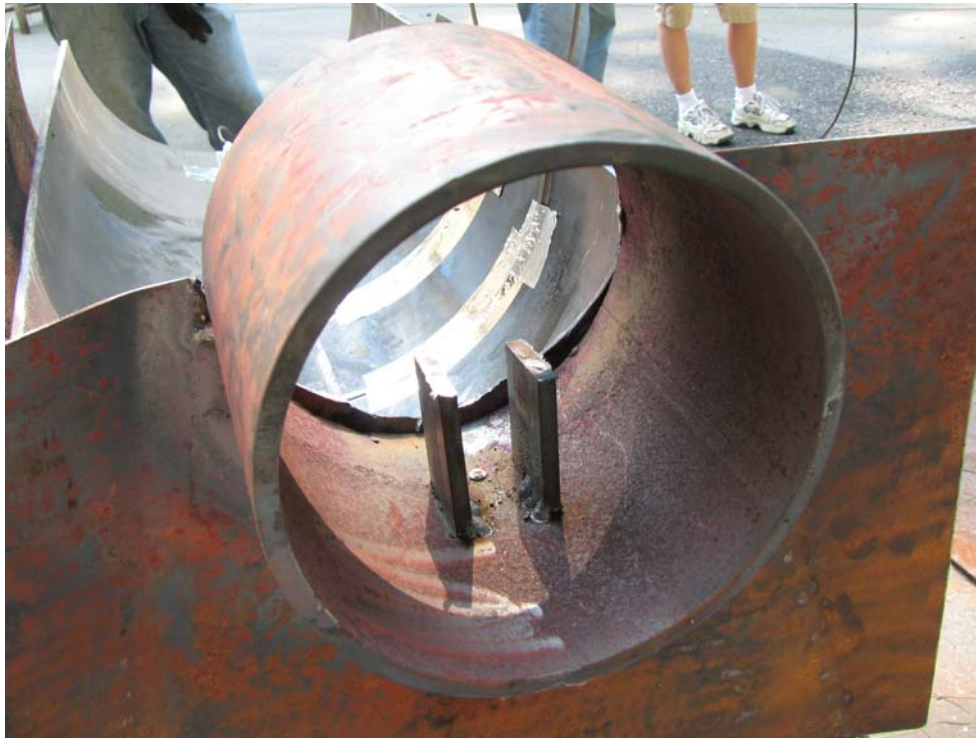
Figure 3 – Temperature transfer “prongs” for the valve end

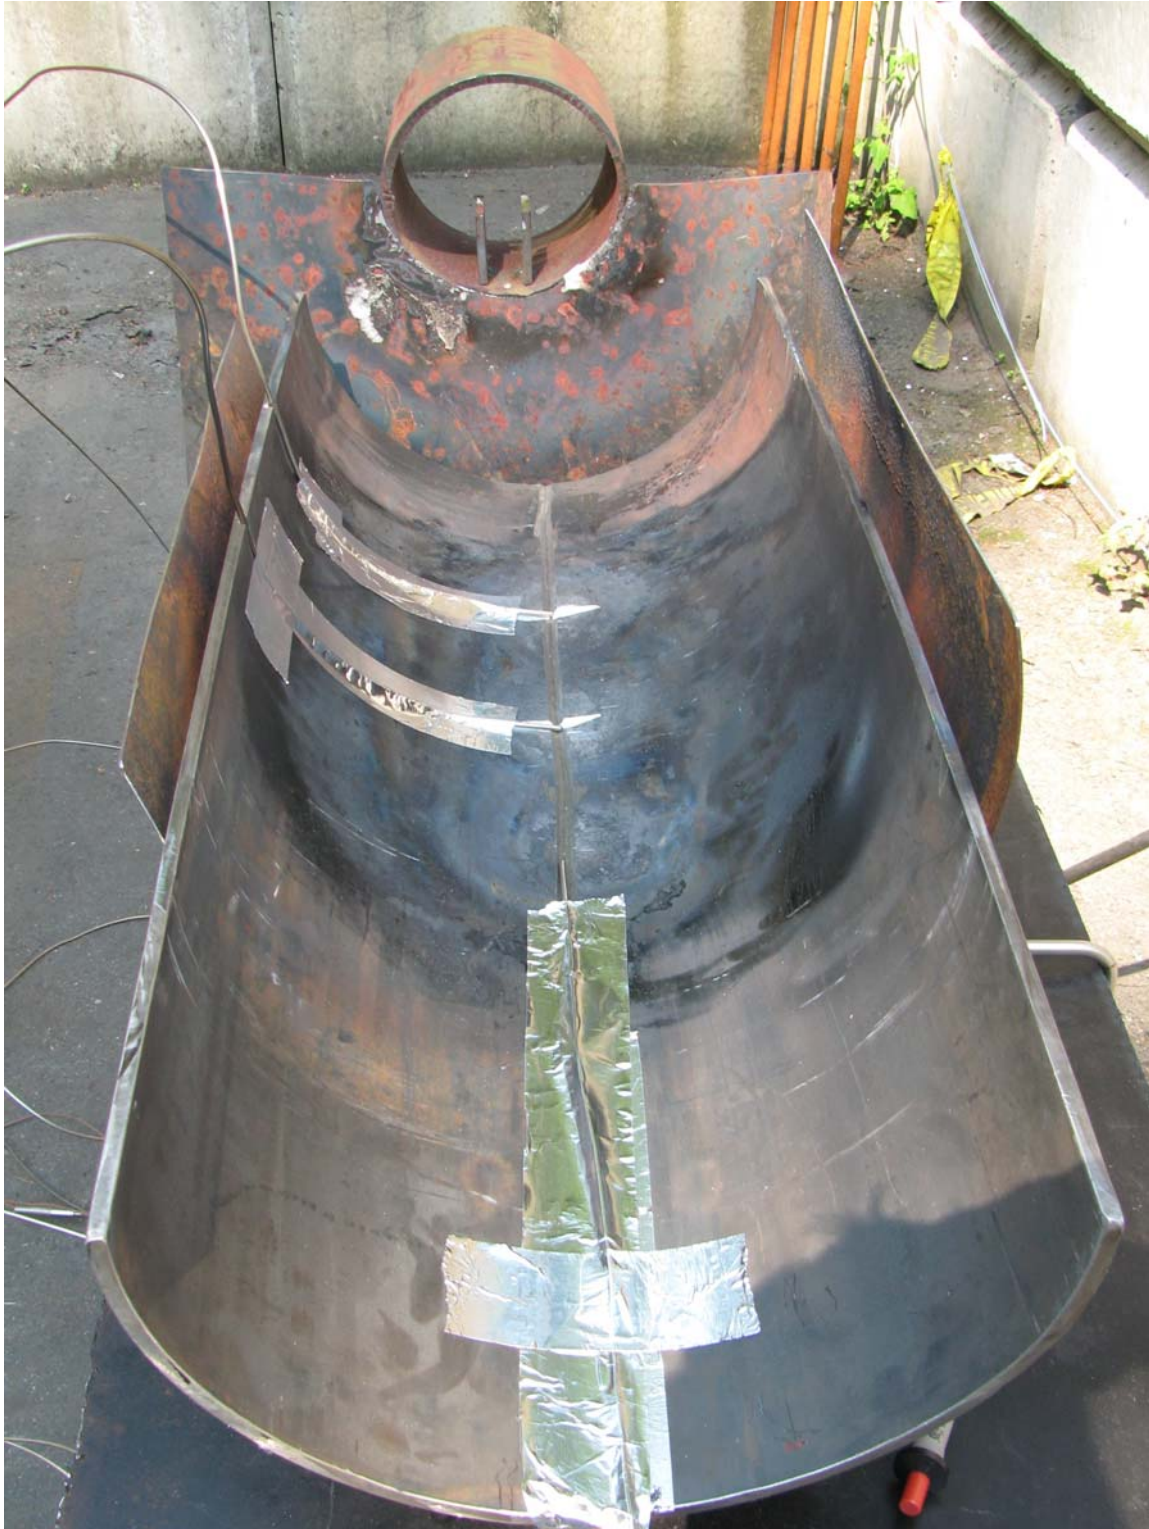
Temperatures on the sidewall were measured using thermocouples inserted in grooves cut into the metal plate, between the plate and the tank surface (see Figure 4). Similarly, for the valve end a thermocouple is located between the “prong” and the valve surface.

Figure 4 – Thermocouple locations in the metal plate.

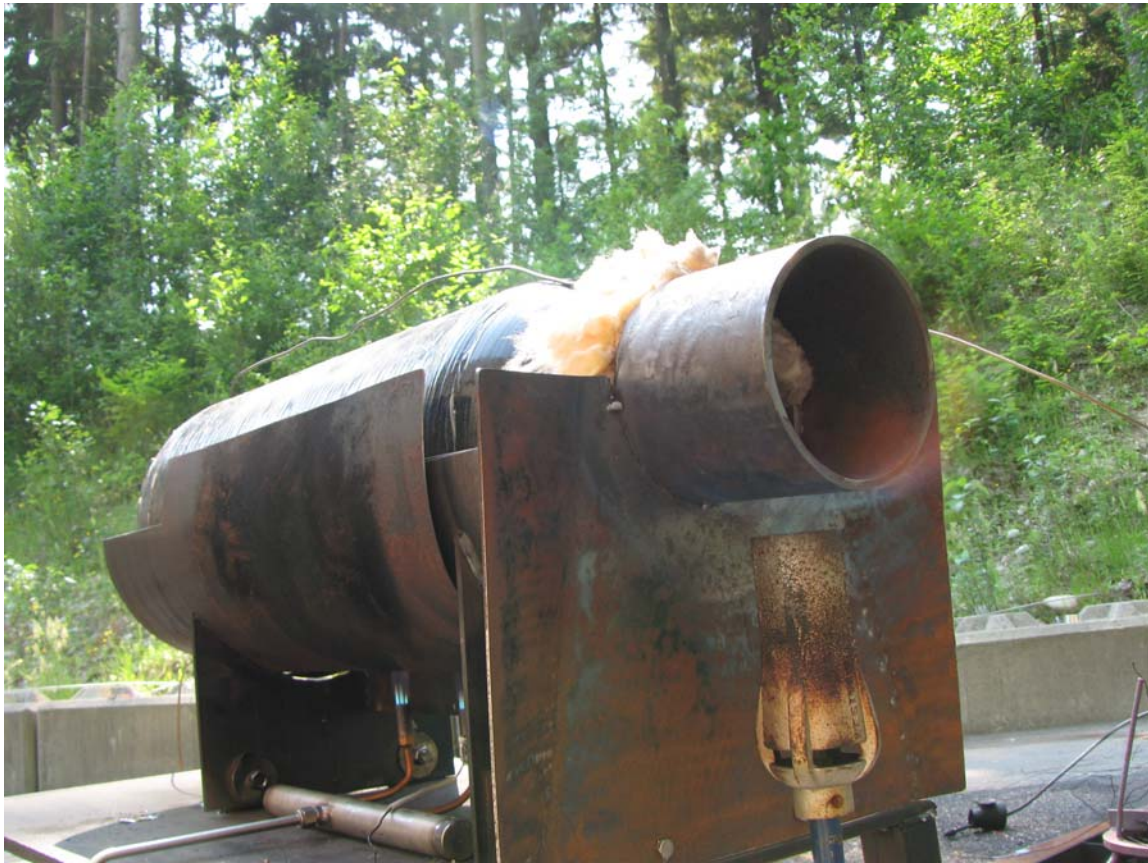
The apparatus was tested in the field on two hydrogen tanks, one unpressurized, and the other pressurized with hydrogen. The unpressurized tank was a Pressed Steel Tank Type II design (24.8 MPa service pressure), with a steel liner hoop-wrapped with carbon fibre reinforcement. The test set-up (illustrated in Figure 5) was for the purpose of demonstrating that the temperature profiles could be achieved. For this reason, the tanks were tested with the valve/TPRD located in an area of heating (Section C of Figure 1), since it was apparent to anyone with bonfire test experience that the pressurized tank would rupture if the TPRD was placed in the ambient air condition (Section A of Figure 1). It was also unknown if a TPRD located in the medium heat area (Section C of Figure 1) would activate before the tank portion exposed to the higher test temperatures (Section B of Figure 1) would rupture.

Figure 5 – Test of Type II tank using oxy-propane burners on sidewall and propane torch on valve end.

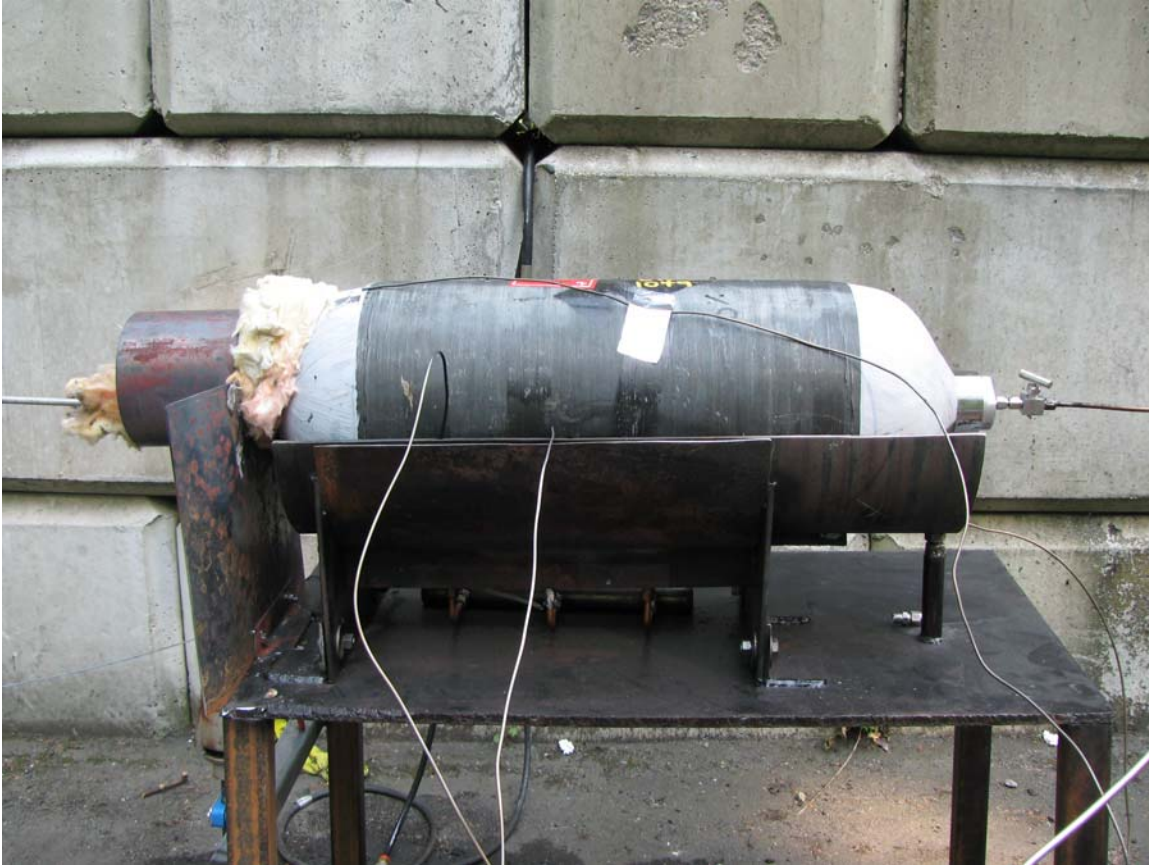
The pressurized tank test was conducted using a Dynetek Type III design (20 MPa working pressure), with an aluminum liner fully-wrapped with carbon fibre reinforcement. The tank was protected by a TPRD made by VTI (glass bulb design) mounted on the valve end.

The test was initially performed with the tank pressurized to 14.5 MPa with hydrogen. However, the failure of a hose connection to the propane burner necessitated termination of the test. The pressure in the tank was reduced to 4.5 MPa for safety reasons, and the test was repeated (see Figure 6).

Figure 6 – Fire test of the Dynetek hydrogen tank.

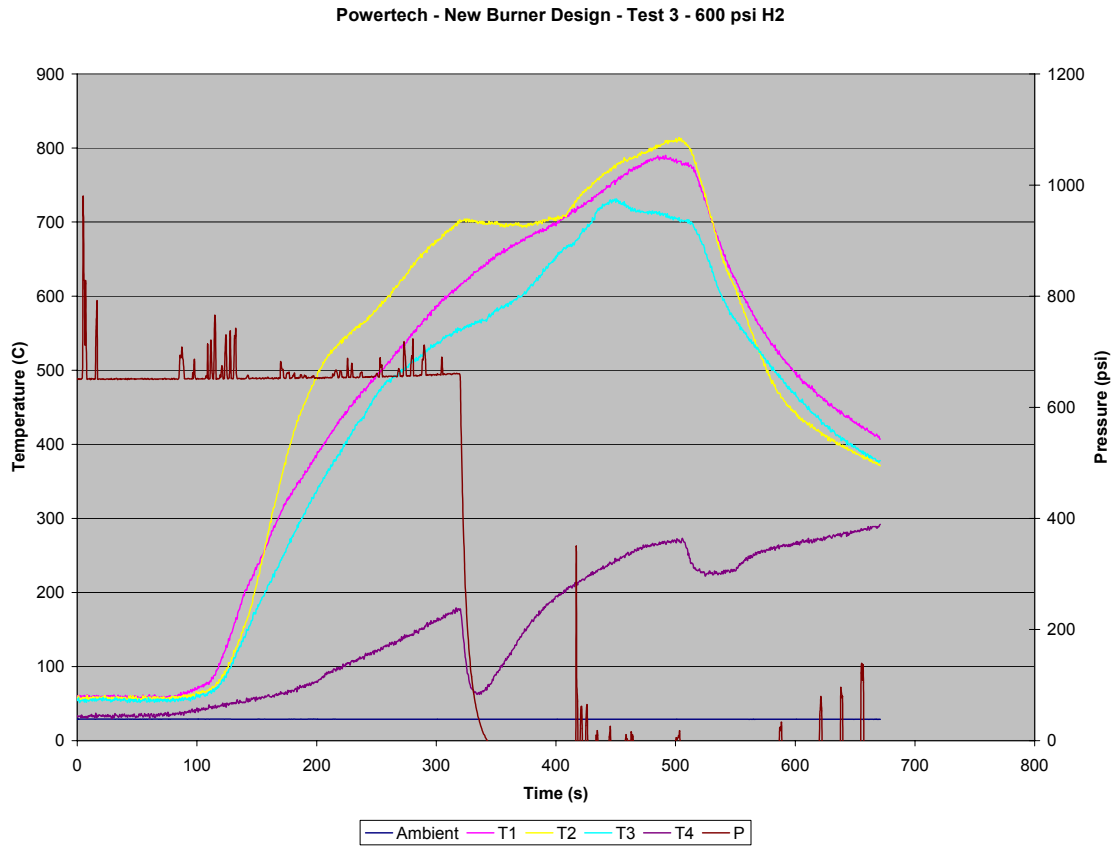
The second test on the pressurized hydrogen tank resulted in the pressure relief device activating some 6 minutes into the test soon after the valve end heating commenced. At the time of activation, the valve temperature was at about 225°C (see Figure 8). Note that the pressure trace has numerous “blip” due to electrical interference from radio transmissions.

Figure 8 - Temperature-time profile for the pressurized tank
