**HYDROGEN VEHICLE FUEL SYSTEMS – LOCALIZED FIRE
PROTECTION CONSIDERATIONS**

Milestone 1

HYDROGEN VEHICLE FIRE SAFETY RESEARCH REPORT

**Transport Canada
Road Safety**

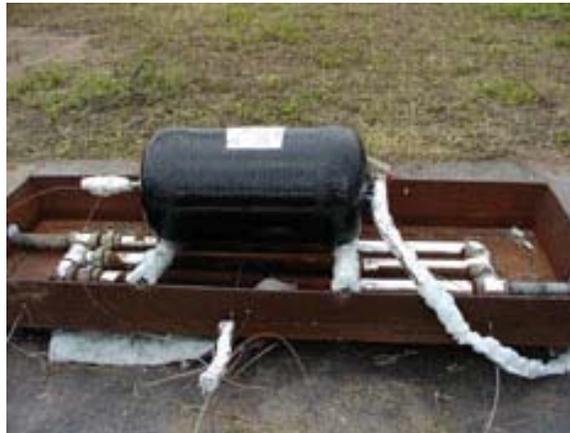
Figure 1: Hydrogen Tank Bonfire Test Apparatus

In a bonfire test (see Figure 1) that Digges conducted without a TPRD, the composite resin on the surface of the tank ignited after approximately 45 seconds. After 6 minutes and 27 seconds, the tank failed catastrophically through the bottom, launching the 14.0 kg main portion 82 m from the test location. Blast pressures were 300 KPa at 190 cm. The internal temperature and pressure of the hydrogen at the time of failure was 39°C and 35.7 MPa, respectively. The pressure inside the tank did not rise sufficiently so that a pressure-activated pressure relief device would have activated to prevent rupture. The temperature inside the tank also did not climb sufficiently to activate a thermally-activated pressure relief device if it used the *internal* temperature as the temperature source. Digges concluded that it was necessary to locate TPRD's such that they would at least experience the same fire as the tank would.

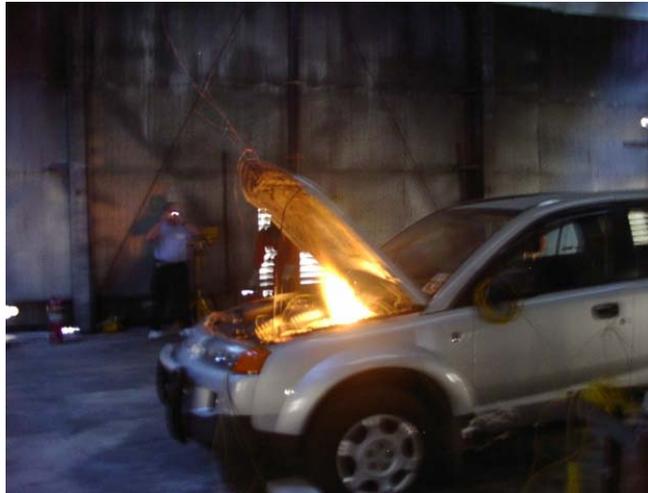
Figure 2: Fuel Line Leakage with Hood Open

In other tests, hydrogen jet-fires impinged directly on the underside of the hood of the engine compartment (see Figure 2). The thermocouple in the direct path of the jet-fire recorded a temperature above 1204°C in each test, but temperatures on the underside of the vehicle did not increase appreciably.

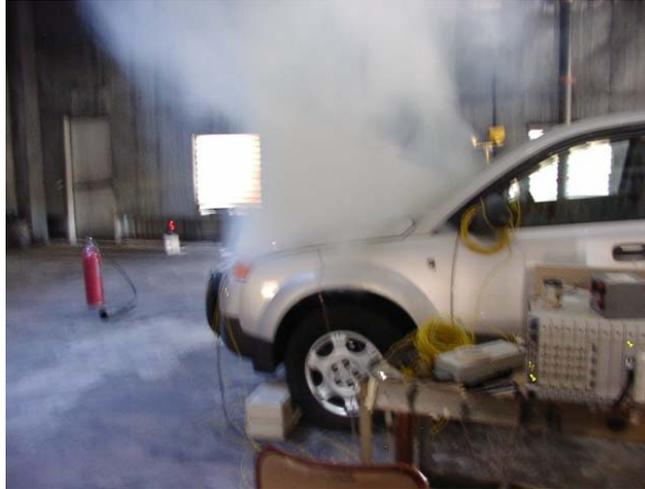
Figure 3: Fuel Line Leakage with Hood Closed

Digges¹⁰ observed that only minor overpressures (less than 0.25 psig) were measured from releases on the underbody of the vehicle, and for the low flow rate (24-g/min) releases in the engine compartment. These pressures are not typically considered high enough to cause bodily harm or window breakage. Overpressures nearest the underbody release remained relatively constant with increased duration due to the lack of confinement areas for hydrogen accumulation. At longer durations, the overpressure on the interior of the engine compartment did increase for the underbody releases, although not enough to cause any apparent damage to the vehicle (see Figure 3).

In fact, in Digges's test damage to the vehicle was minimal for the majority of tests and consisted mainly of burnt plastic components. Temperatures for short-duration delayed-ignition tests were higher in the location of the release, whether on the underside of the vehicle or in the engine compartment. Temperatures for longer duration delayed-ignition tests, however, were consistently higher in the engine compartment, where more hydrogen could accumulate. Heat flux data followed the same trend as temperature data.
