Introduction of the PantoSystem

Magnus Liljegren
International Sales Manager
2016-10-14

How our railway customers can:

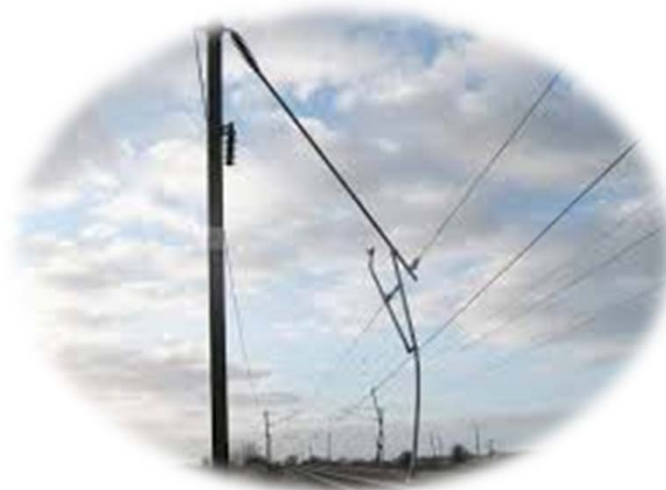
Example of an accident that will cause passenger delays and high costs

- the wire is down (ex. tangled in a train's pantograph)- no trains can run until the broken equipment is cleared away.....
- significant costs are incurred as a result of each de-wirement incident, such as penalties and costs incurred repairing damaged equipment..... and bad press!

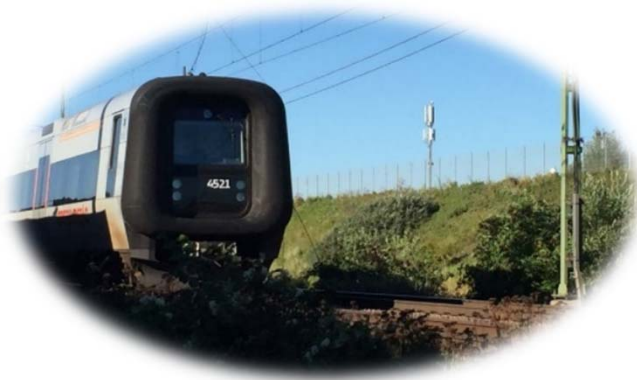
The overhead wire is down

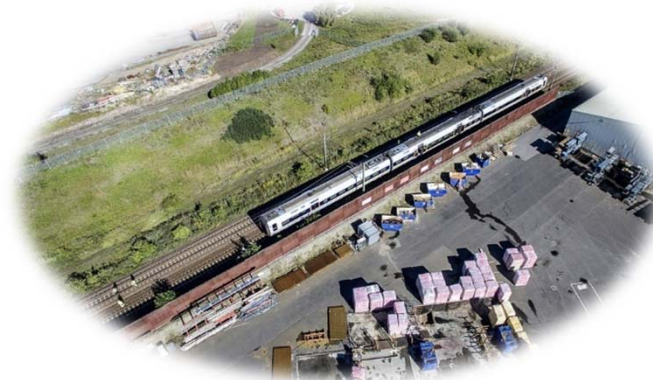
This train had to stand still 3 hours before evacuation

- the total number of incidents in Sweden caused by defect contact overhead wires is 400/year
- the number of delayed hours have increased from 6000 hours 2013 to 8000 hours 2015 caused by increased train traffic

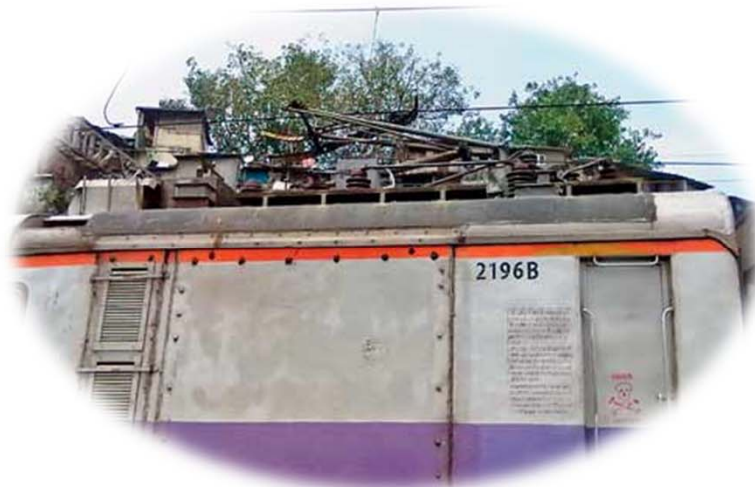
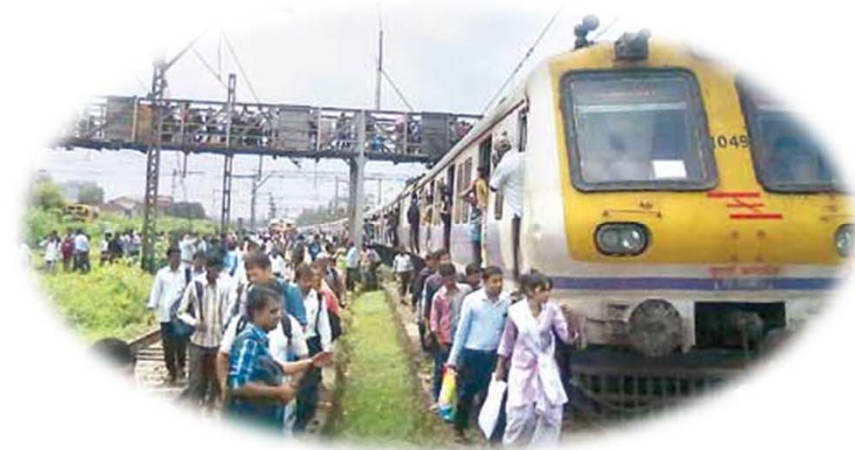
The pantograph got entangled with an overhead

Bringing the train to an abrupt halt

- The incident took place at 12.32 pm, when a pantograph of the Kalyan-CST down train became entangled with an overhead wire between Kurla and Sion stations

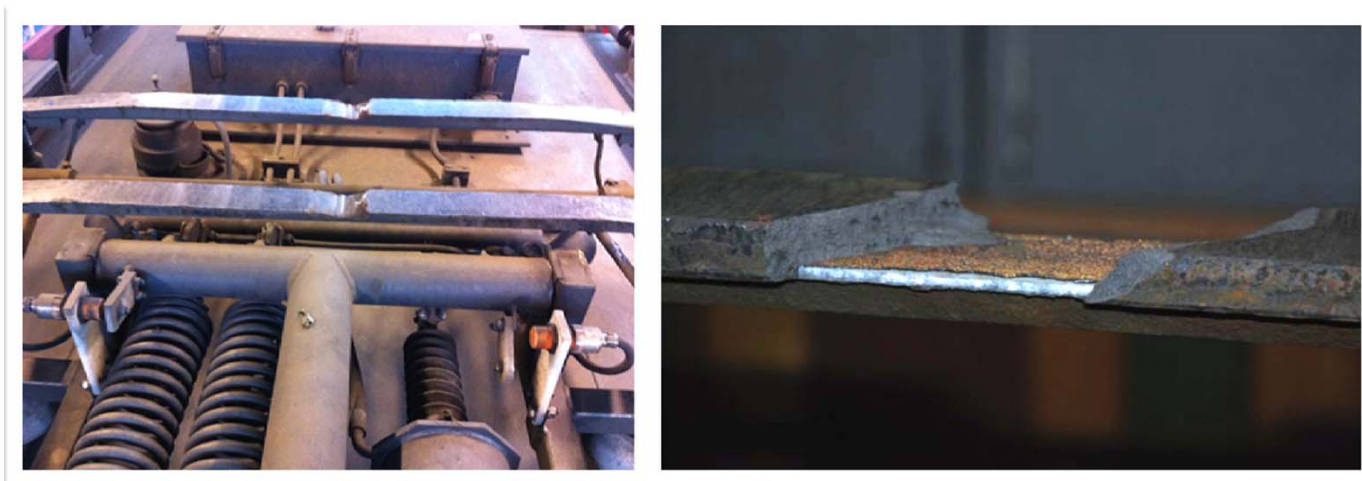
Examples of a pantograph and damaged carbon strips

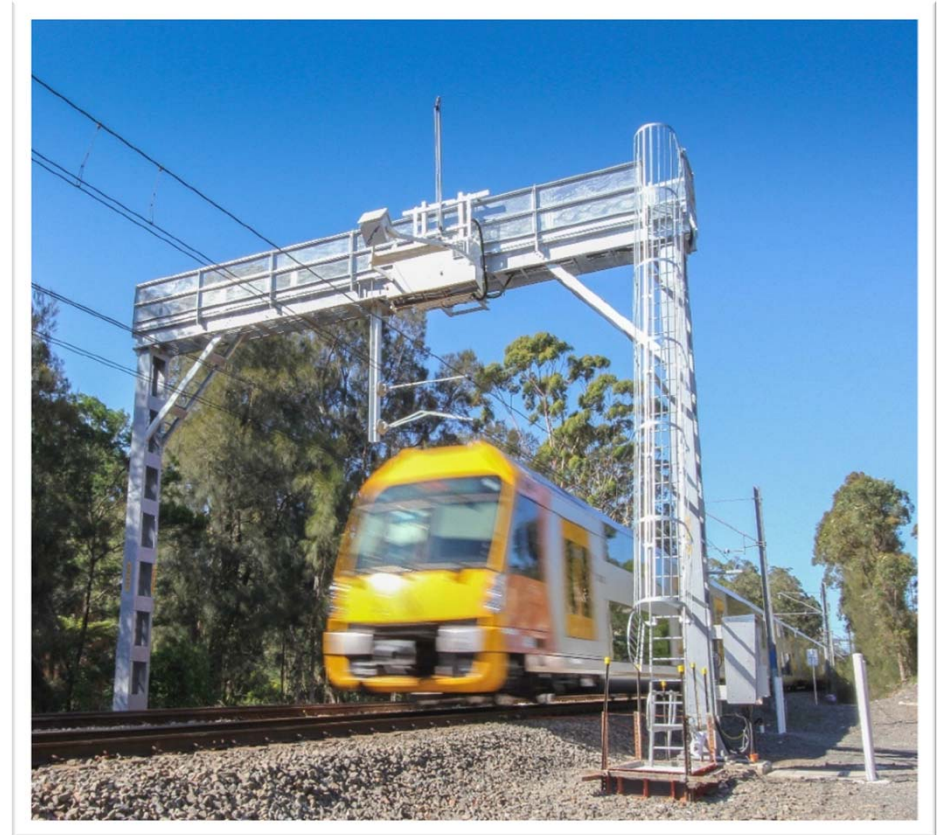
The PantoSystem is Unique in Several Ways

- Delivers real-time condition monitoring of trains during operation
- Designed and proven for outdoor 24/7 use - all year
- Detects large carbon defects, small cracks and measures a rich set of wear features

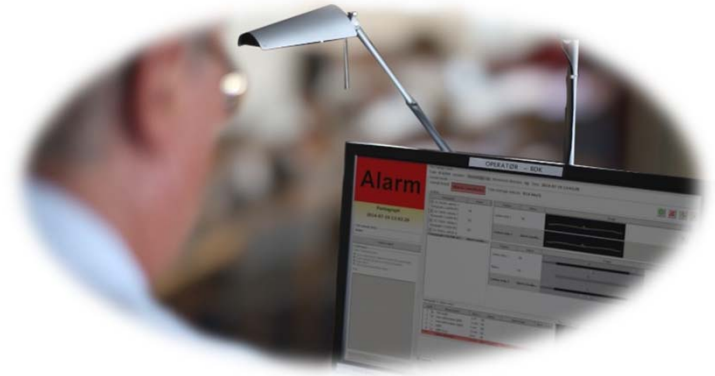
The WEB based PantoClient

- Provides access to measurement data through an easy to use graphical interface
 - Which is prepared for integration to custom IT and maintenance systems
- Allows an individual configuration of thresholds and other settings
- Receives alerts and subsequently manages workflow

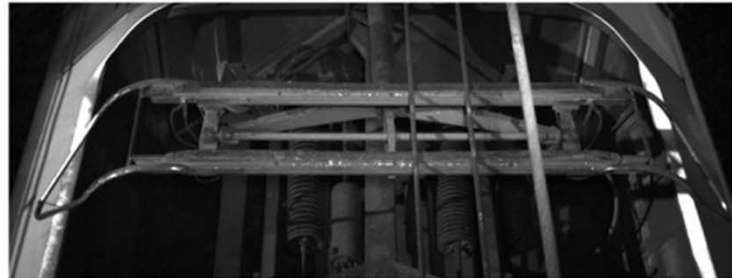
ID: D 6139, vehicle: 1
Pantograph 1
Pantograph type: A/BW-SEG

Pantograph image. Train Average Velocity: 76 km/h = 47 mph.

Status Report	#	Analysis	Status	Value	Alarm rule
	1	Yaw angle	Ok	0.3°	
	2	Horn deformation (left)	Ok	3 mm	
	3	Horn deformation (right)	Ok	-2 mm	
	4	Carbon thickness	Ok	8 mm	
	5	Uplift	Ok	-3 mm	
	6	Uplift force	Ok	97 N	
	7	Edge chip	Alarm (medium severity)	Width: 26 mm Depth: 2 mm	Edge Chip Medium Width: 26 mm Depth: 12 mm
