ICP MATERIALS

Workplan 2018-2019 (ECE/EB.AIR/2017/1)

Balance between corrosion and soiling

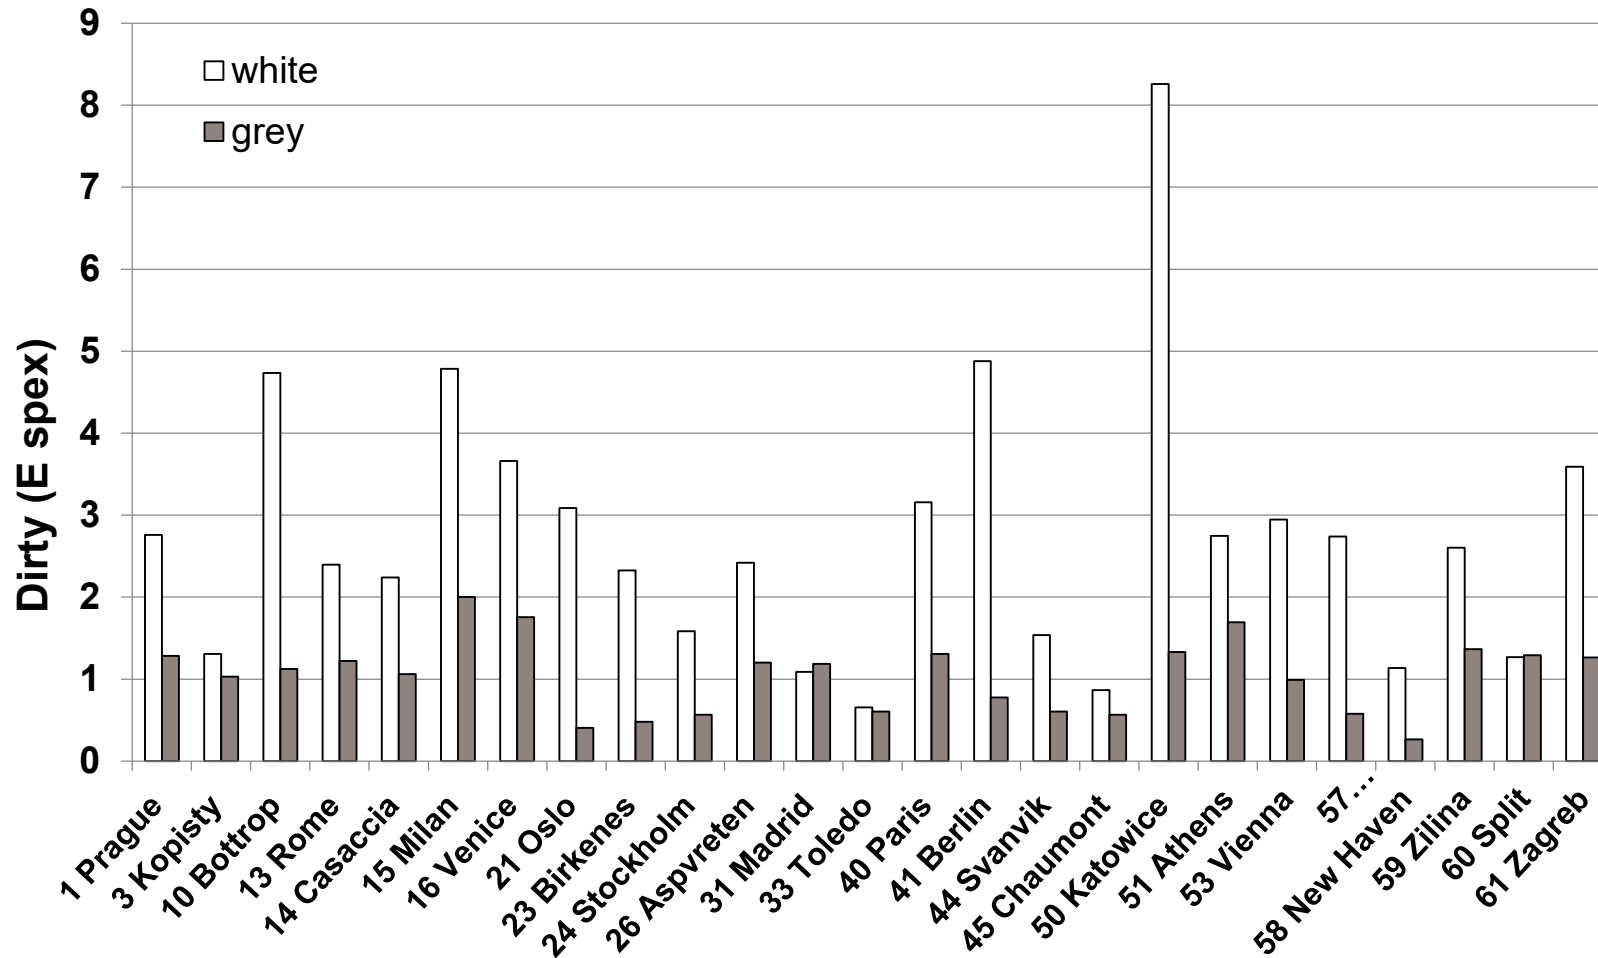
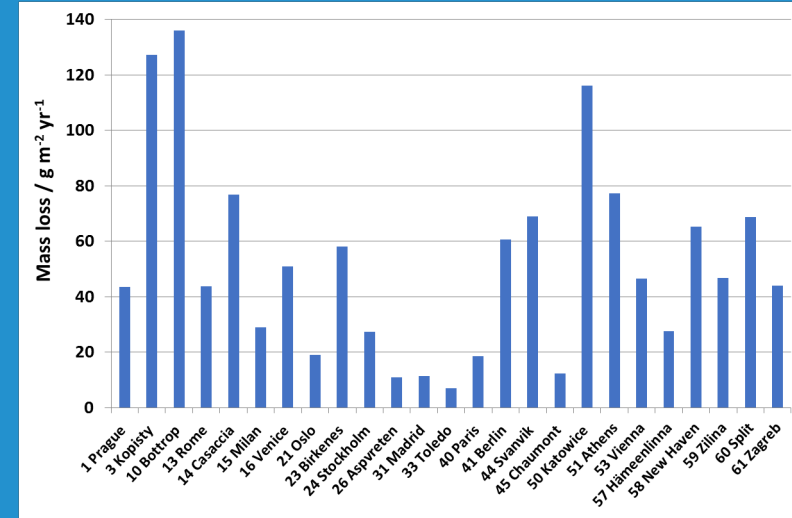
Report 85 (forthcoming):

- Soiling data for coil coated materials (left)
- Corrosion data for carbon steel (top)
- Corrosion data for zinc, weathering steel, copper, limestone
- Soiling data for glass, limestone and marble
