# Status of NHTSA's Motorcoach Safety Efforts

Informal document GRSG-102-27 (102<sup>nd</sup> GRSG, 16-20 April 2012 agenda item 2)

April 17, 2012 GRSG 102<sup>nd</sup> Session Nha Nguyen

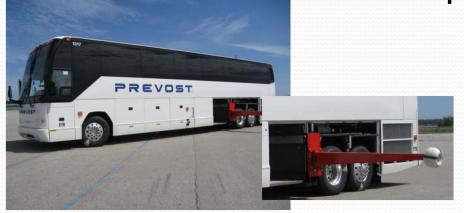
## Stability Control Systems for Heavy and Light Vehicles

- Motorcoaches, Trucks
  - High CG
  - Generally roll unstable
  - Roll Stability Control
  - Yaw (Directional) Stability Control
    - Limit over/under steer

- Light Vehicles (FMVSS No. 126)
  - Low CG
  - Yaw unstable
  - Yaw (Directional) Stability
     Control
    - limit over/under steer
  - Roll Stability Control (Not Required)

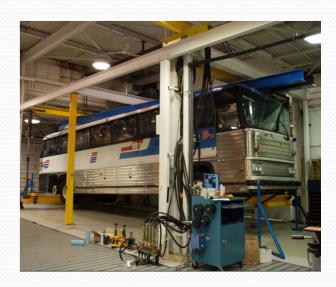
#### Rollover Structural Integrity Tests

- School bus procedure –
   FMVSS No. 220
  - Uniform load applied on roof = 1.5 UVW
  - All emergency exits should be operable during and after the test
  - Roof crush measured should not exceed 130 mm

- European procedure ECE R.66
  - Motorcoach is tipped over on its side from a 800 mm raised platform.
  - Requirement survival space during and after test is unharmed

- Tested two 40 ft. motorcoach models (1991 Prevost and 1992 MCI models) to the requirements in FMVSS No. 220 and ECE R.66 and a 45 ft model (2000 MCI 102EL3).
- Older bus models failed to meet the FMVSS No. 220 and ECE R.66 requirements
- In addition:
  - The roof emergency exits opened during the test on all three buses
  - Luggage rack inboard hangers in the 1991 MCI bus broke during impact
  - Emergency exit windows of the Provost bus unlatched during impact
  - Seats on non-struck side of the Prevost bus detached from their anchorages
  - Windows on the opposite side broke free of its mounting in the 2000 MCI
- NEXT ACTION: NPRM in 2012

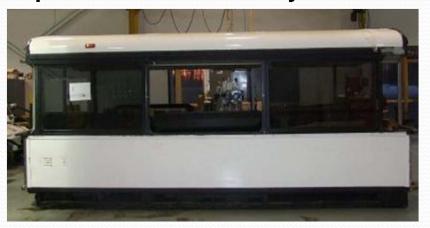
## Glazing and Window Retention

- NHTSA and Transport Canada's joint research in 2006 identified:
  - Effectiveness of advanced glazing in preventing ejections depends on the structural integrity of the bus
- Since the motorcoach rollover structural integrity NPRM is expected in 2012, the agency resumed research on glazing and window retention.
- Status of research:
  - Completed test procedure evaluation based on the Transport Canada approach using a motorcoach section
  - Feasibility test on multiple motorcoach glazing designs to establish performance requirements is underway
