NBS to Mine Tailings

Results of a field research

Tobias Praamstra, Ellen Verboom

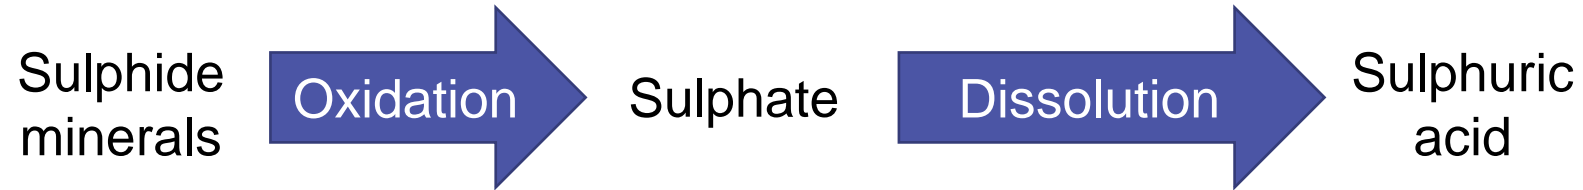
Impacts: Acid Mine Drainage (AMD)

- Natural process
- Mine tailings: Increased exposure to oxygen, water and microorganisms

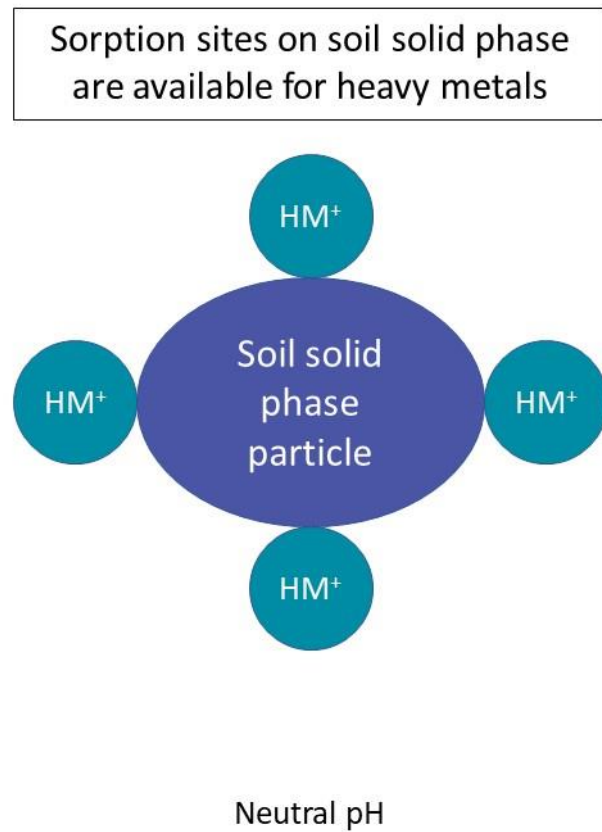
Impacts: Heavy metals

- AMD causes mobilization of heavy metals
- Higher bioavailability
- Higher mobility

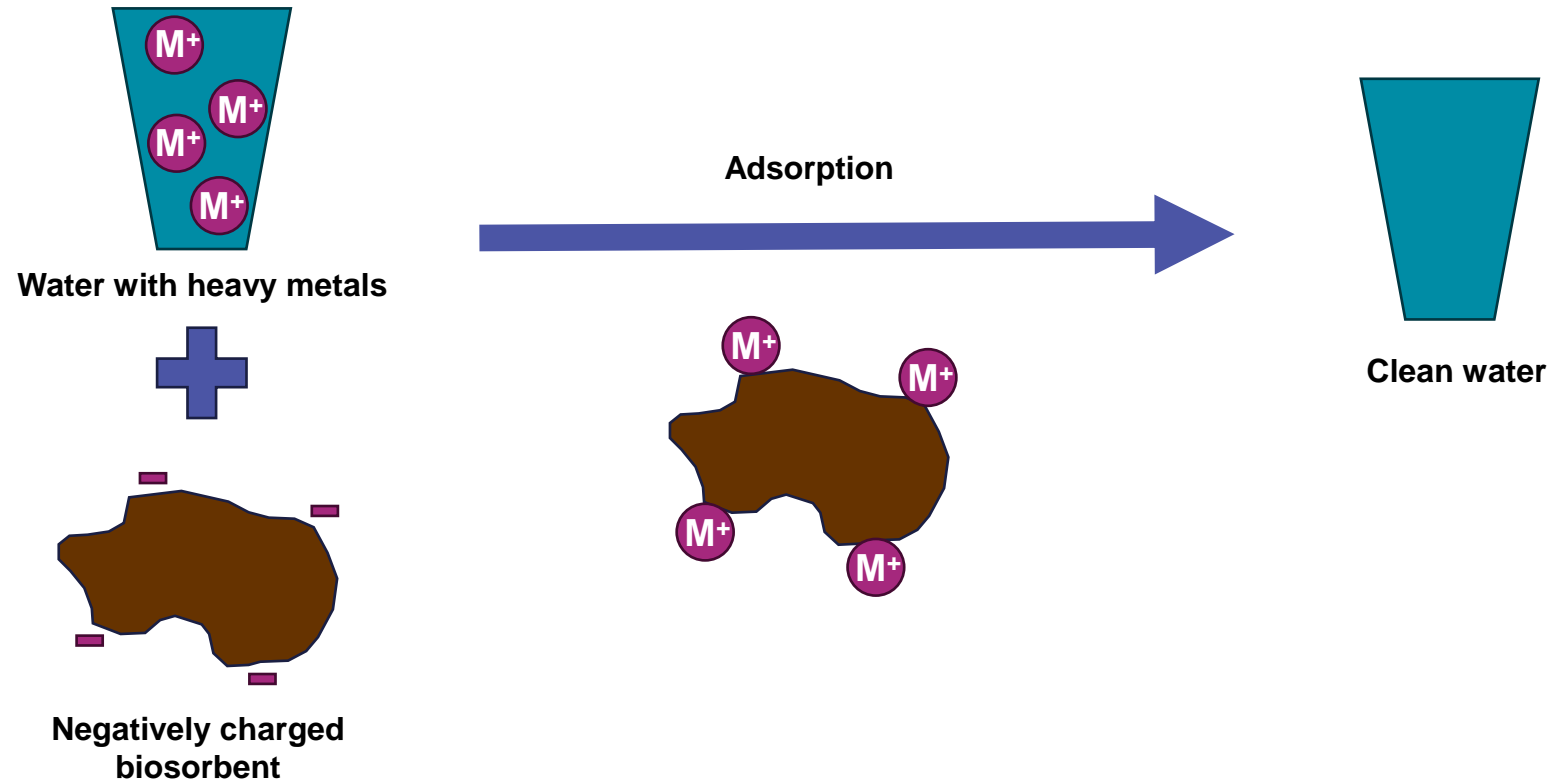
Solutions: Heavy metal filters

- Offer binding sites for adsorption
 - pH increase

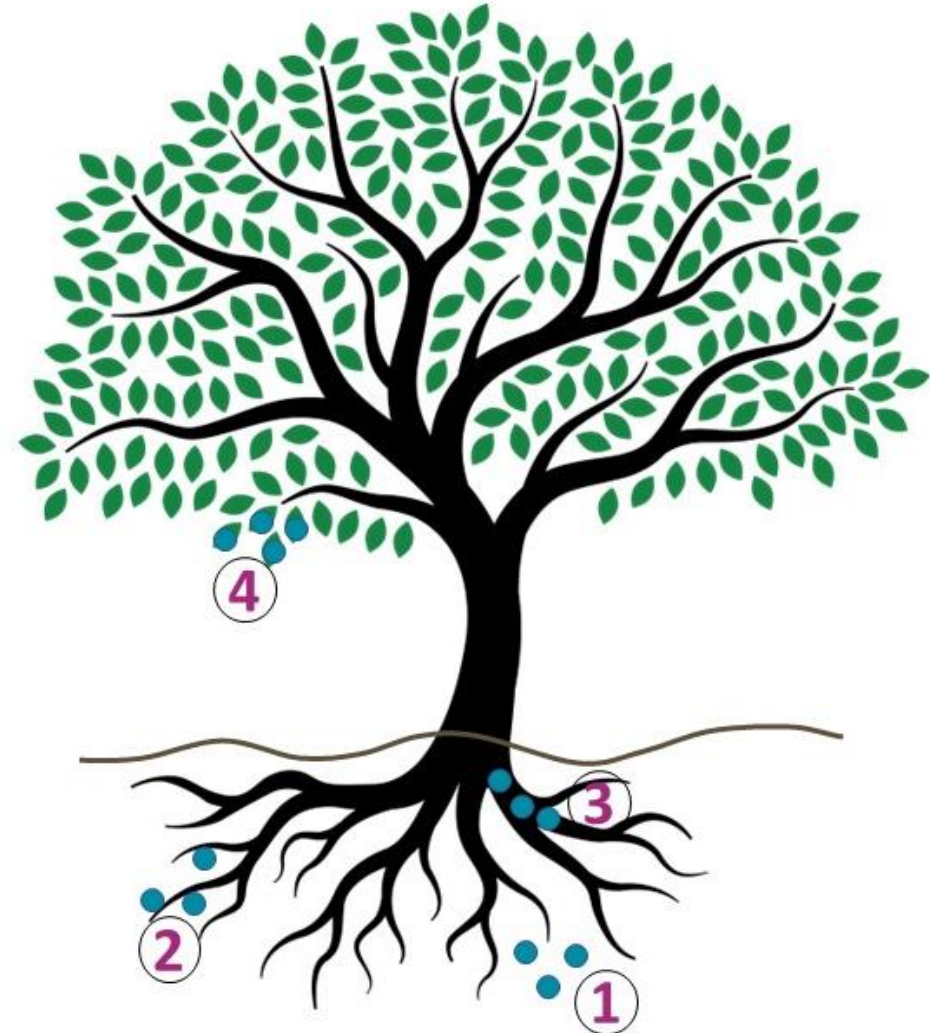
Solutions: Phytoremediation

Remediation of pollutants with the use of plants

- **Phytostabilization:** Immobilization of pollutants in the soil
 - 1) Precipitation of pollutants
 - 2) Adsorption of pollutants to root system
- **Phytoextraction:** Uptake of pollutants from soil into plant tissue
→ Permanent removal of pollutants with harvest
 - 3) Uptake of pollutants by roots
 - 4) Translocation to aboveground biomass

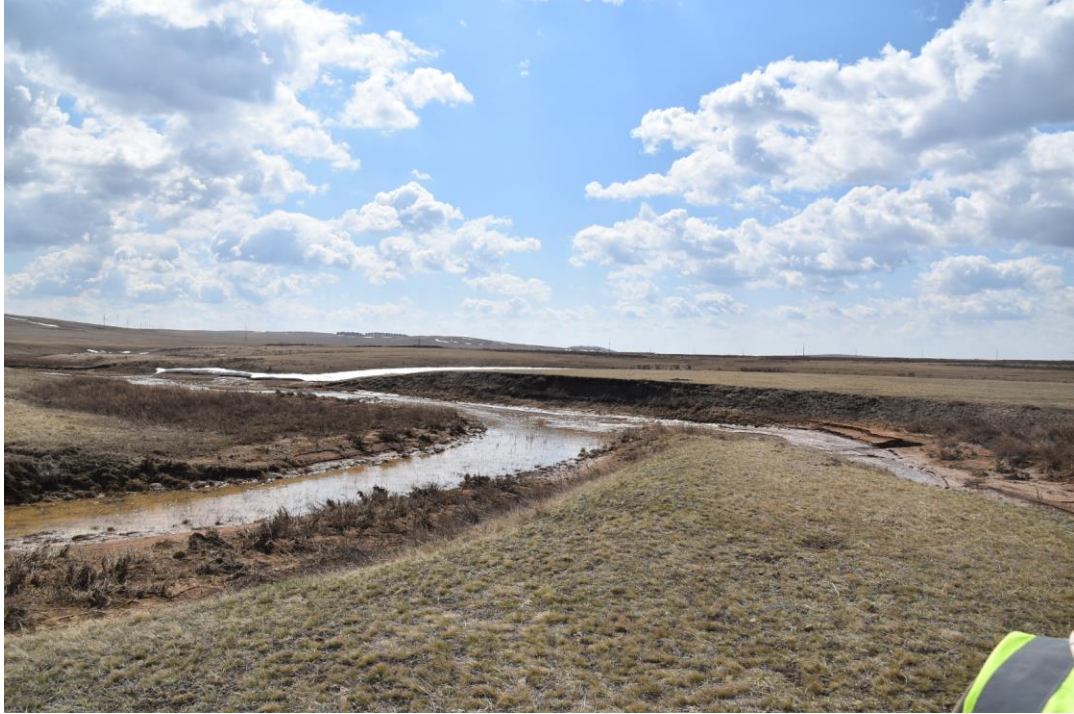
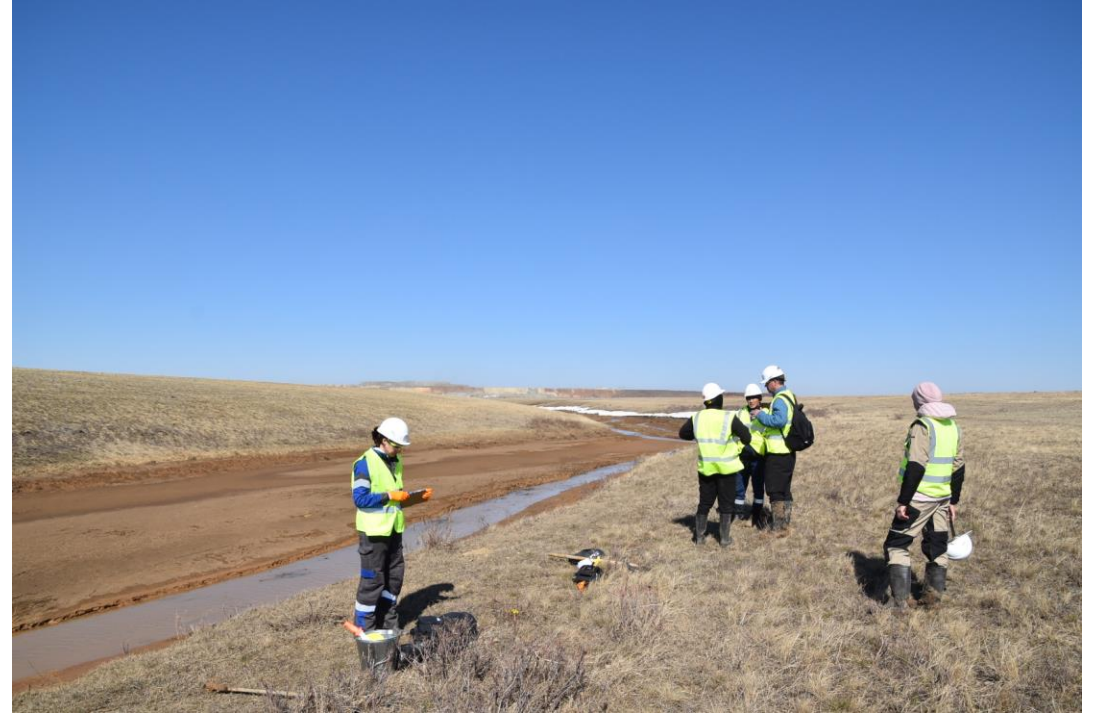
Fieldwork

- No evidence for soil contamination → all tested heavy metals were below Dutch intervention values

- Increased above Dutch legislative values for surface water:
 - Chromium, copper and zinc (copper 20 – 240 x legislative value)
 - Sulphate (8.5 x legislative value)
 - Cyanide (6 x legislative value)

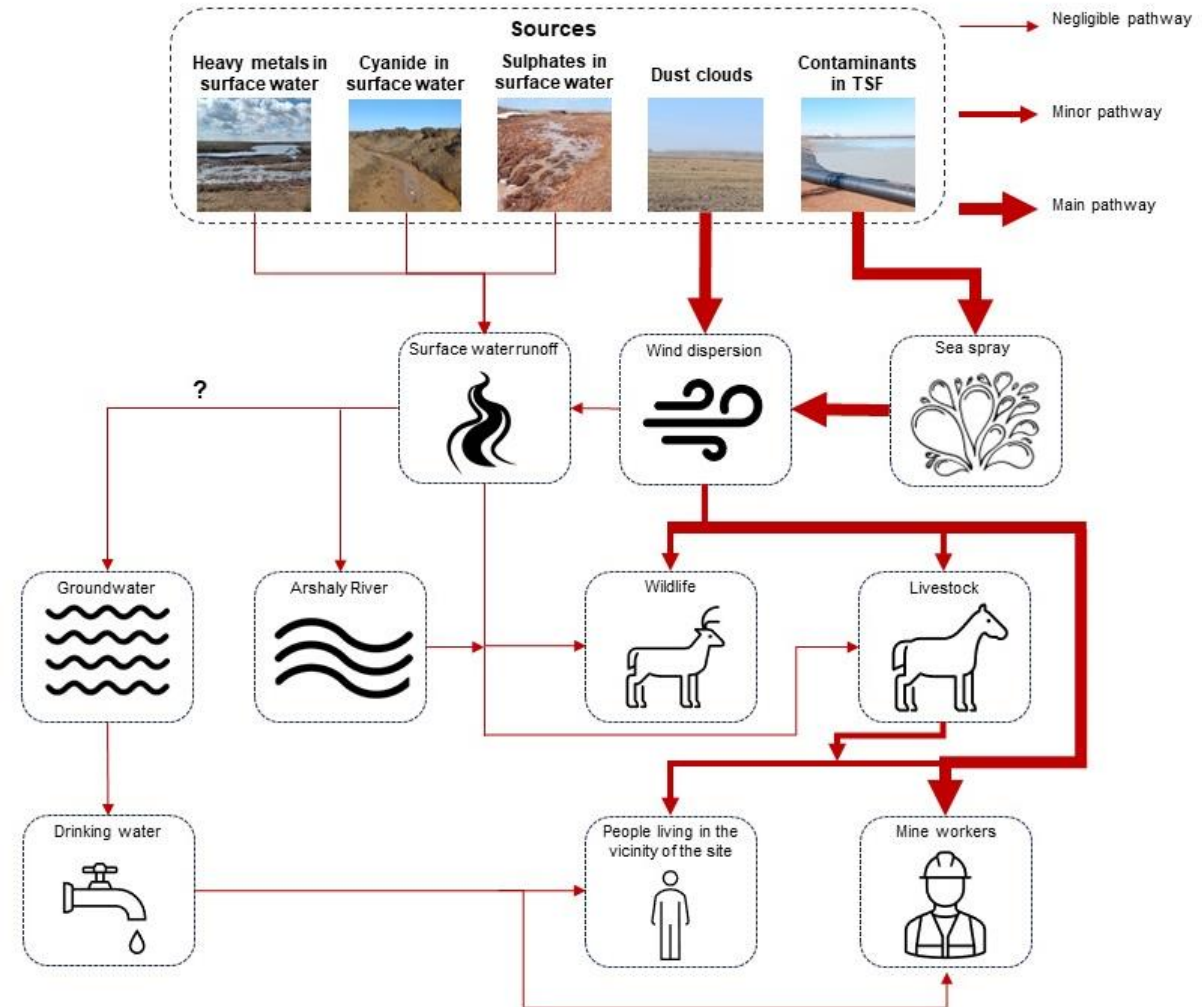
Identified issues and Conceptual Site Model

- Contaminated surface water
- Sea spray from tailing facilities (process water basin)
- Dust clouds (Included in previous project NBS Narxoz University)

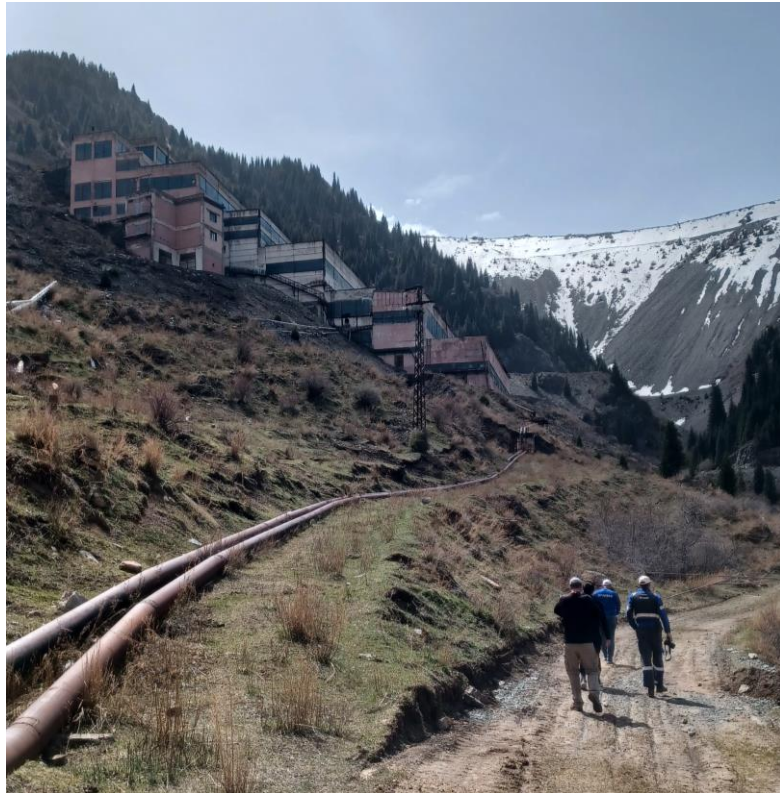
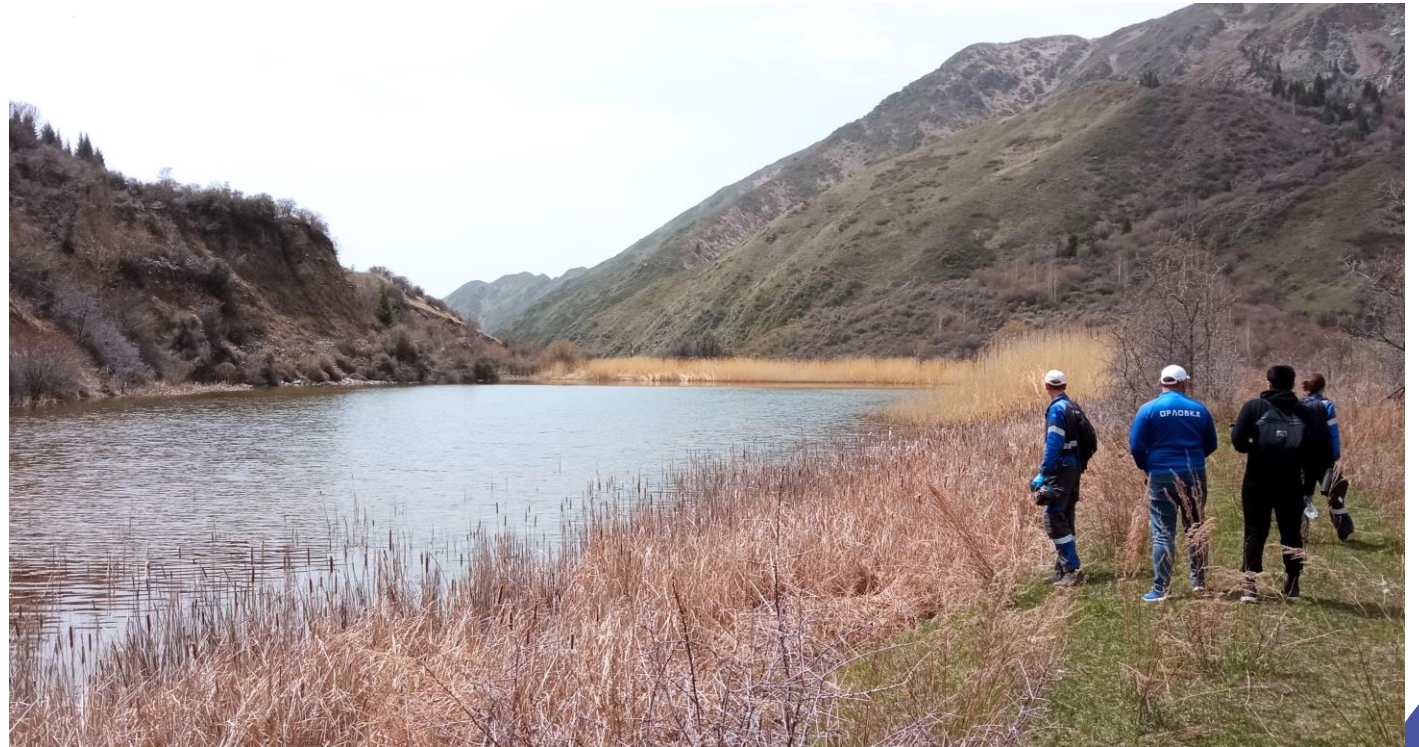
Fieldwork

- Increased levels above Dutch intervention values for:
 - Arsenic, lead and zinc (lead 7x intervention value)
- Locally increased levels in comparison to other sediment samples:
 - Yttrium and zirconium

- One sampling location with slightly increased concentrations of arsenic, sulphate and ammonium

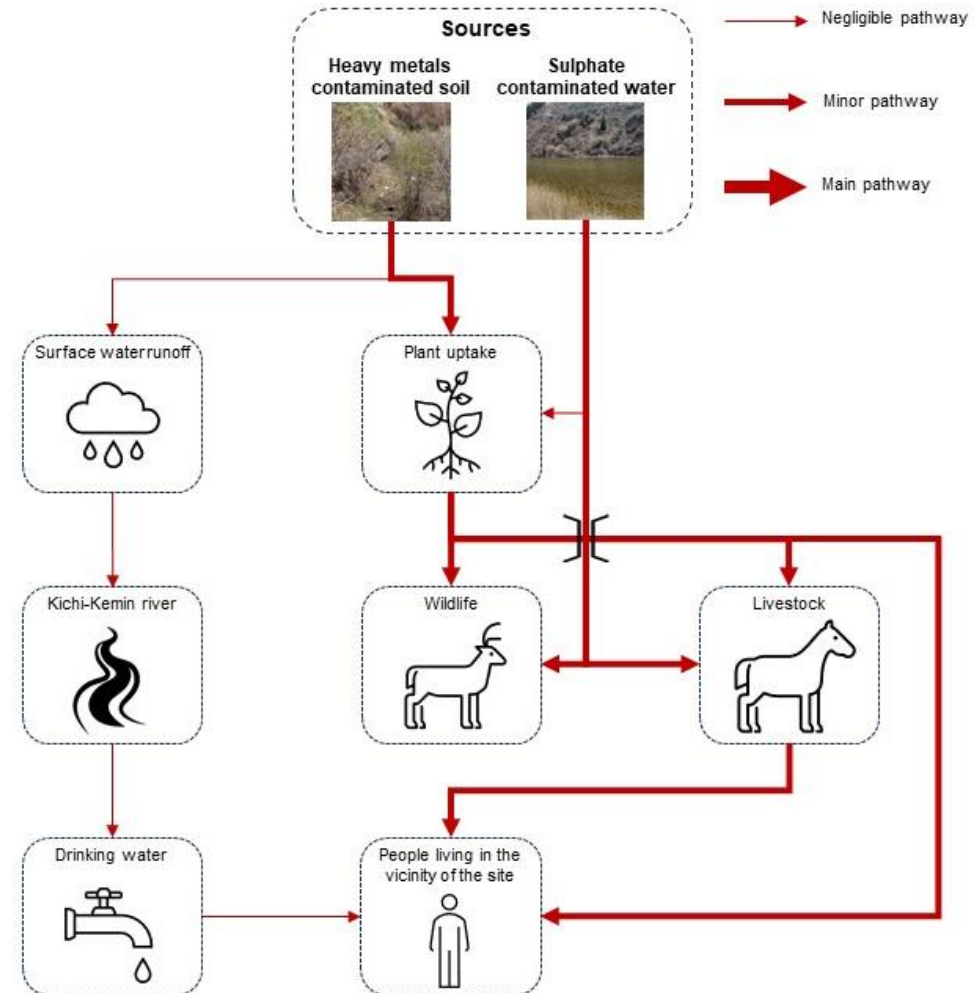
Identified issues and Conceptual Site Model

- Heavy metals contaminated soil
- Sulphate contaminated water
- Lifespan of isolation constructions

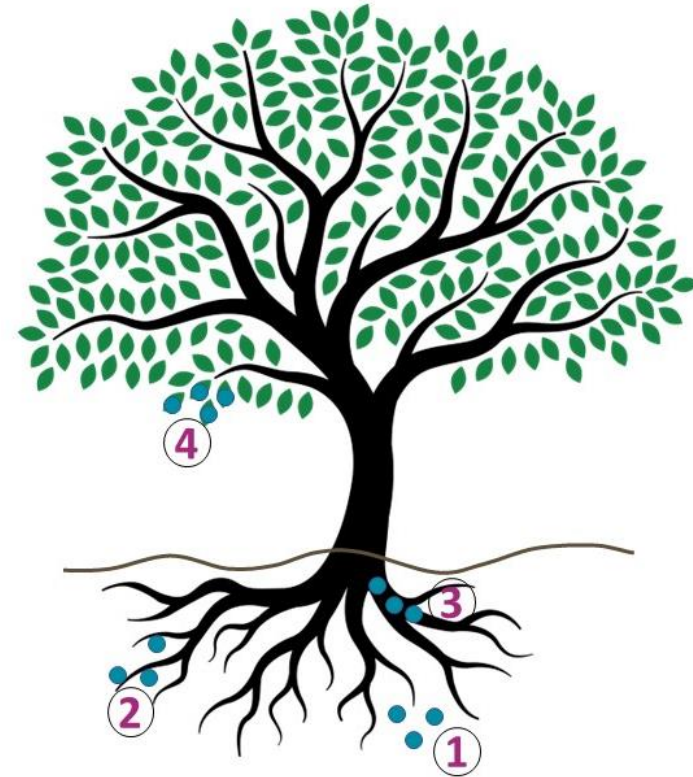
- Combination of phytoextraction and phytostabilization
- Additional research needed for selection of plant species
- Preferably native plant species

Figure: Phytoremediation of contaminated soil through
1) precipitation
2) root adsorption
3) root uptake
4) translocation
