Sustainability and nature based solutions with an illustrative case study

- Paul Bardos, r3 environmental technology ltd, UK
- Presented at 'Global Nature Based Solutions to Mine Tailing Waste Water: Nov. 2nd 2023, Narxoz University, Kazakhstan.

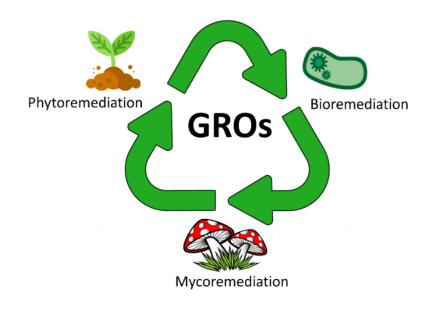
Gentle remediation options

From Purkis et al. 2022,

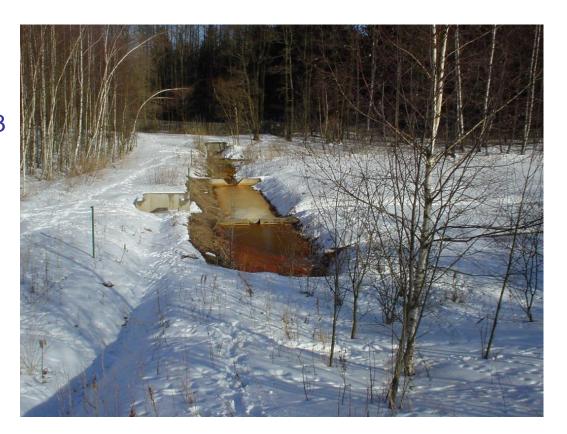
Low input remediation context

- Between 1999 and 2002, the site owner commissioned Phase I remediation work, consisting of a cover layer (0.3 m bentonite with a 0.45 m thick covering of heap material).
- The drainage from the site remains polluted with lindane, chlorobenzenes and iron.
- In 2015 a remediation option appraisal was carried out and concluded in favour of *in situ* treatment and engineered wetland

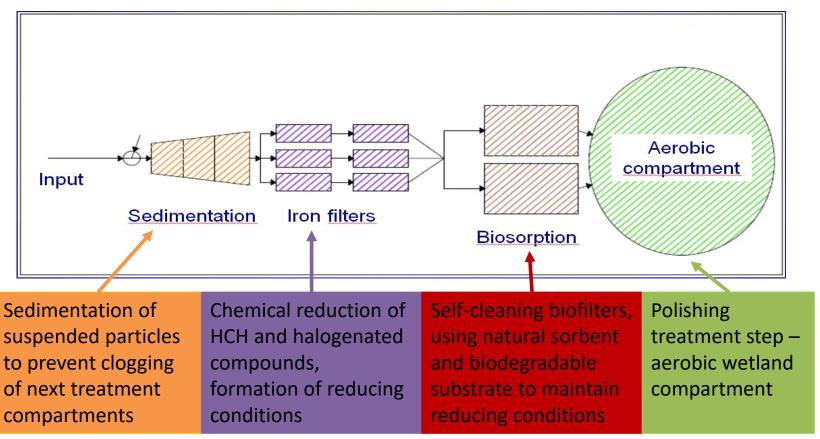
"Wetland+ system"

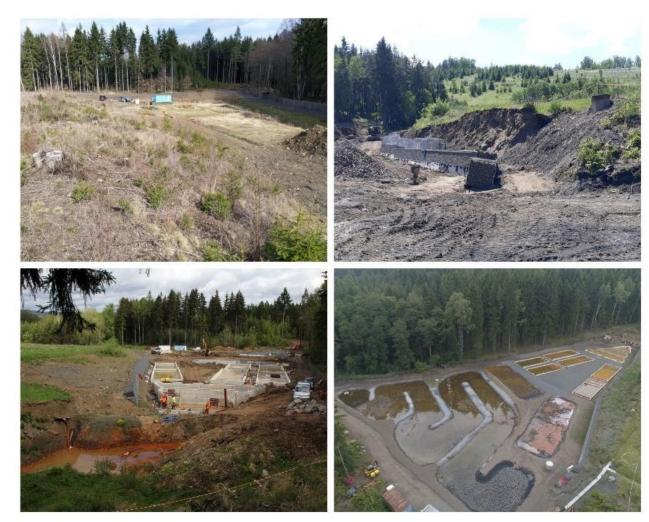
Installation

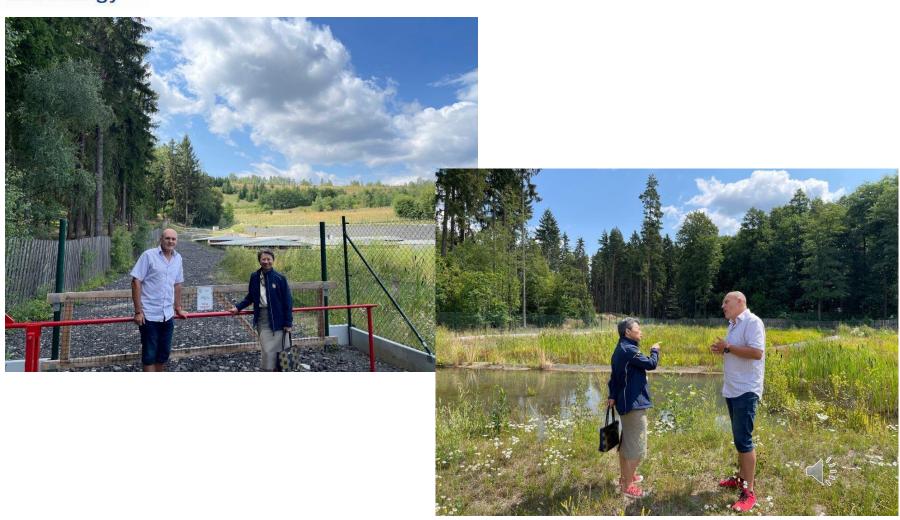
July 2023 appearance
