BRIEF DESCRIPTION ABOUT A SERIOUS BUS ROLLOVER ACCIDENT
(Presented by Hungary)

Date: 1. July, 2002 early morning hours, gloom

The scene of the accident: close to Balatonszentgyörgy, Hungary, main road No.7. a roundabout

The coach: 3 years old HD coach. License number: LB 02930. Berkhof "Excellence 3000" body on DAF chassis, type DE 33WS. Max total mass 18600 kg

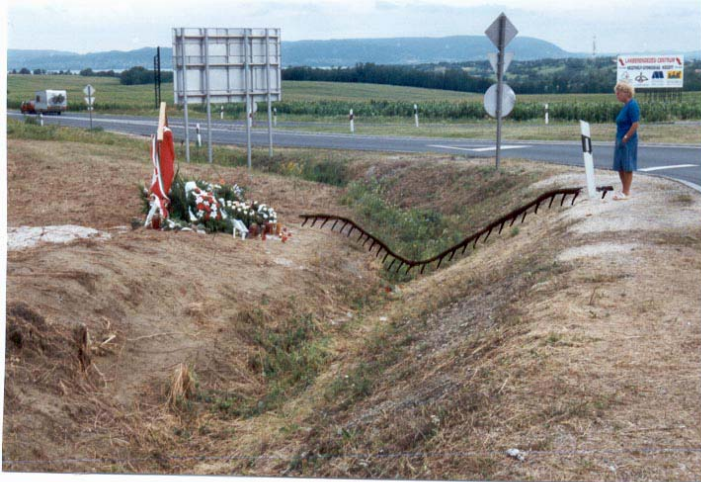
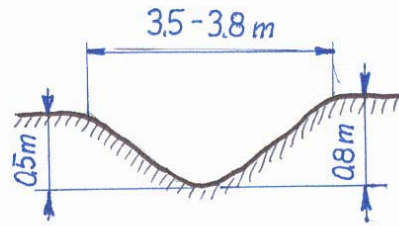
Figure A1.

- the approaching of the roundabout with the traffic signs
- the other side of the roundabout with the ditch, where Polish bus stopped on its roof. A bus is in the approaching way, entering into the roundabout.
- the bus is in the roundabout.

The ditch
