Detailed technical analysis of a severe bus rollover accident

The accident happened on 17. 04. 2005 in the morning hours (9⁴⁵) at the Grand St. Bernard Pass with a tourist coach (operator: a Swiss company MARTI) driving from Switzerland to Italy. The information about the accident was collected from the media listed below. The accident was a typical, severe rollover accident.

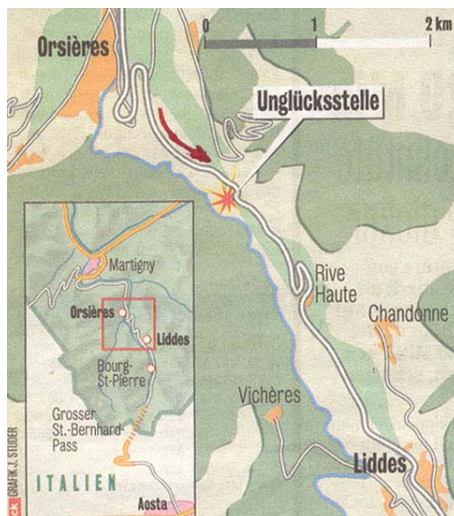
The road was a serpentine mountain road with a wet, but not a slippery surface. Fig.1. shows the map of the event. The total width of the road was 6 m (see Fig.2.) The bus drove upwards the hill and the accident happened after a left curve. From these two reasons the speed of the bus could not be too high. On the right side of the road there was a guide rail on the left rock wall.

Fig.1. The map of the accident's scene
