Observation of different windscreen glass fracture modes

during headform impactor tests

OICA

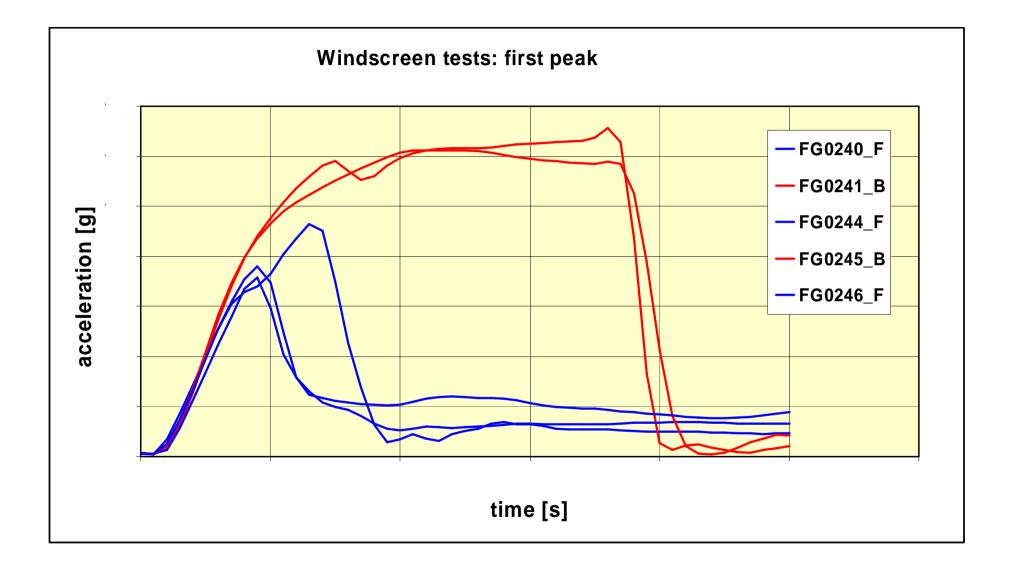
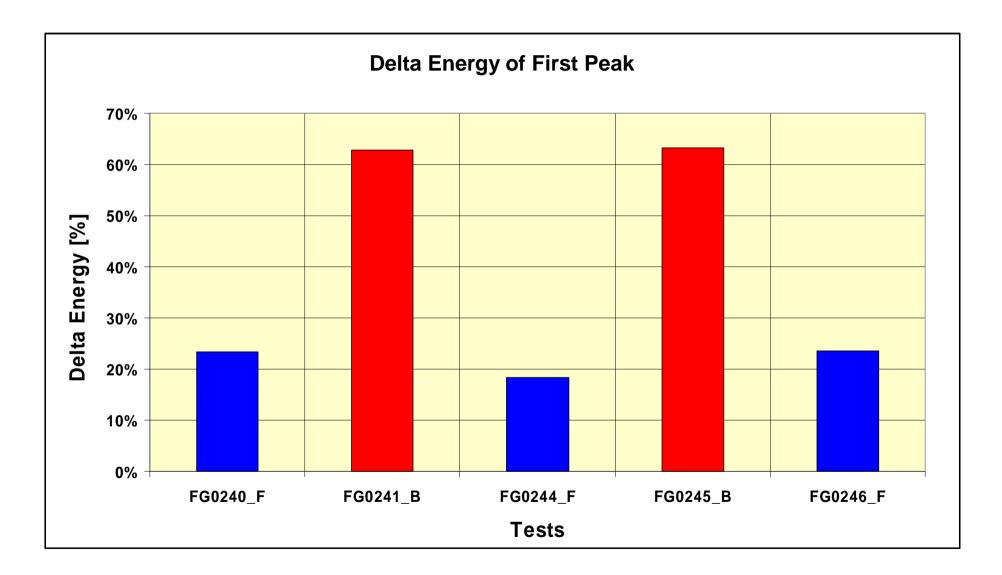
Impact angle = 35°

Observation of two different fracture modes:

- 1. Fracture begins after contact of impactor on windscreen short bending phase
- 2. Sudden fracture occurs after a longer bending phase

Different fracture modes occur independent of impact angle

Fracture modes are not predictable

Fracture modes result in different shapes of the first acceleration peak

Energy absorption is up to three time higher for long bending / sudden fracture

Fracture behaviour is probably dependent on internal stress of the glass, micro scratches etc.

Fracture modes influence the scatter of HIC results

Currently no design solutions available

More research of glass manufacturing process etc. needed
