Needs and challenges in managing tailings by operators in Central Asia (Republic of Kyrgyzstan)

Kyrgyz Chemical and Metallurgical Plant
(KCMP OJSC)

Information on tailing dumps of KCMP OJSC

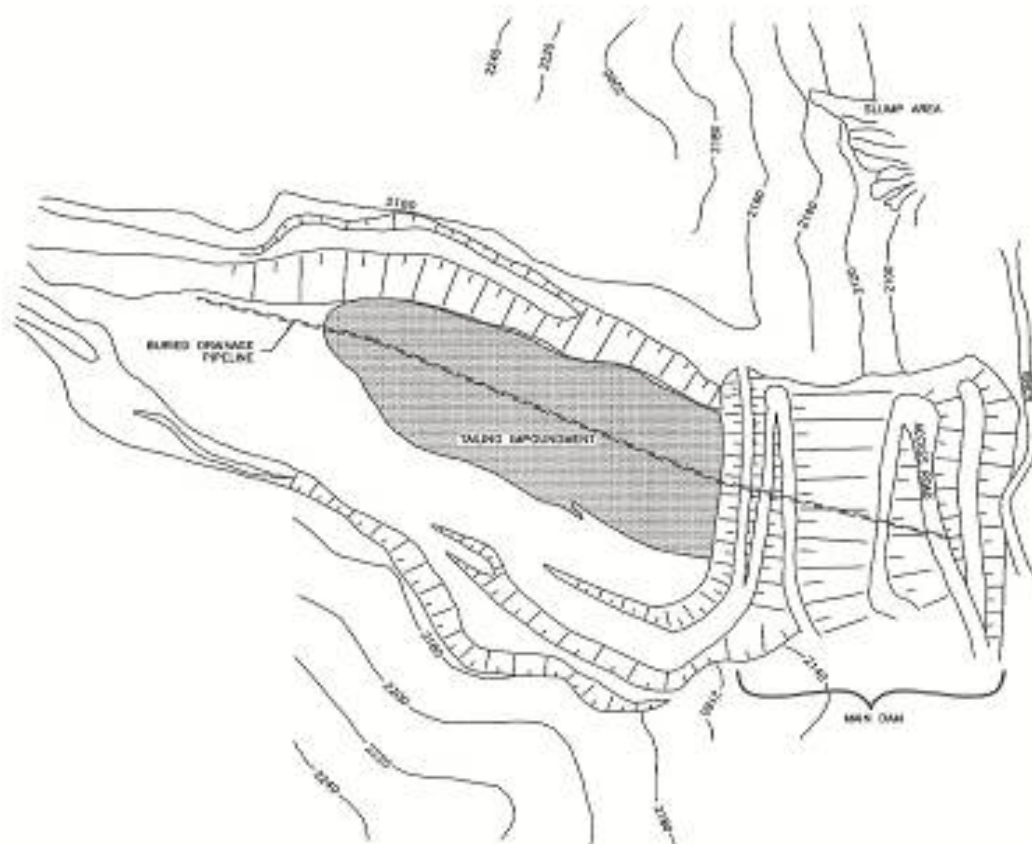
Tailings Plan No. 2

- Tailings storage facility No. 2 - located on the right side of the Kichi-Kemin river valley, in Kulagan-Tash sai, at elevations of 2070-2150 m. The dam height is 72 m, the tailing area is 13 hectares.

- The tailing dump was operated from 1951 to 1972. Until 1964, the volume of waste disposed was 1,050,000 m³.
- In December 1964, as a result of an earthquake, a retaining dam broke and more than 600 thousand m³ of radioactive and toxic waste (60% of its accumulated volume) flowed from the tailing dump into the channel and valley of the Kichi-Kemin River. Tail flows containing elevated concentrations of thorium and heavy metals, in the form of radioactive mudflow, spread throughout the riverbed and valley. Kichi-Kemin at a distance of 40 km, up to its confluence with the Chu River in neighboring Kazakhstan. The waste laid on a site of 13 hectares contaminated agricultural land, settlements on the removal cone of the river. Kichi-Kemin with a total area of 3600 ha. The consequences of this cross-border disaster were eliminated for many years.

- The tailing dump has not been recultivated; a technological road has been laid along the lower slope and ledges of the dam.

- For tailing ponds No. 2 and 3 and the Bordun tailing pond - as experience in the construction and operation of tailing ponds under the difficult mountainous conditions of Kyrgyzstan shows, alluvial-type dams are less stable in comparison with bulk dams. Under adverse external weather conditions (heavy rainfall, mudflows), an earthquake there is a risk of breaking dams, which can lead to the ingress of tailings, including elevated concentrations of thorium and heavy metals, in the form of radioactive mudflow along the channel and the river valley. Kichi-Kemin n. Ak-Tuz, the Berkut river of the city of Orlovka, until they get into the Chu river, which is a transboundary river with neighboring Kazakhstan.

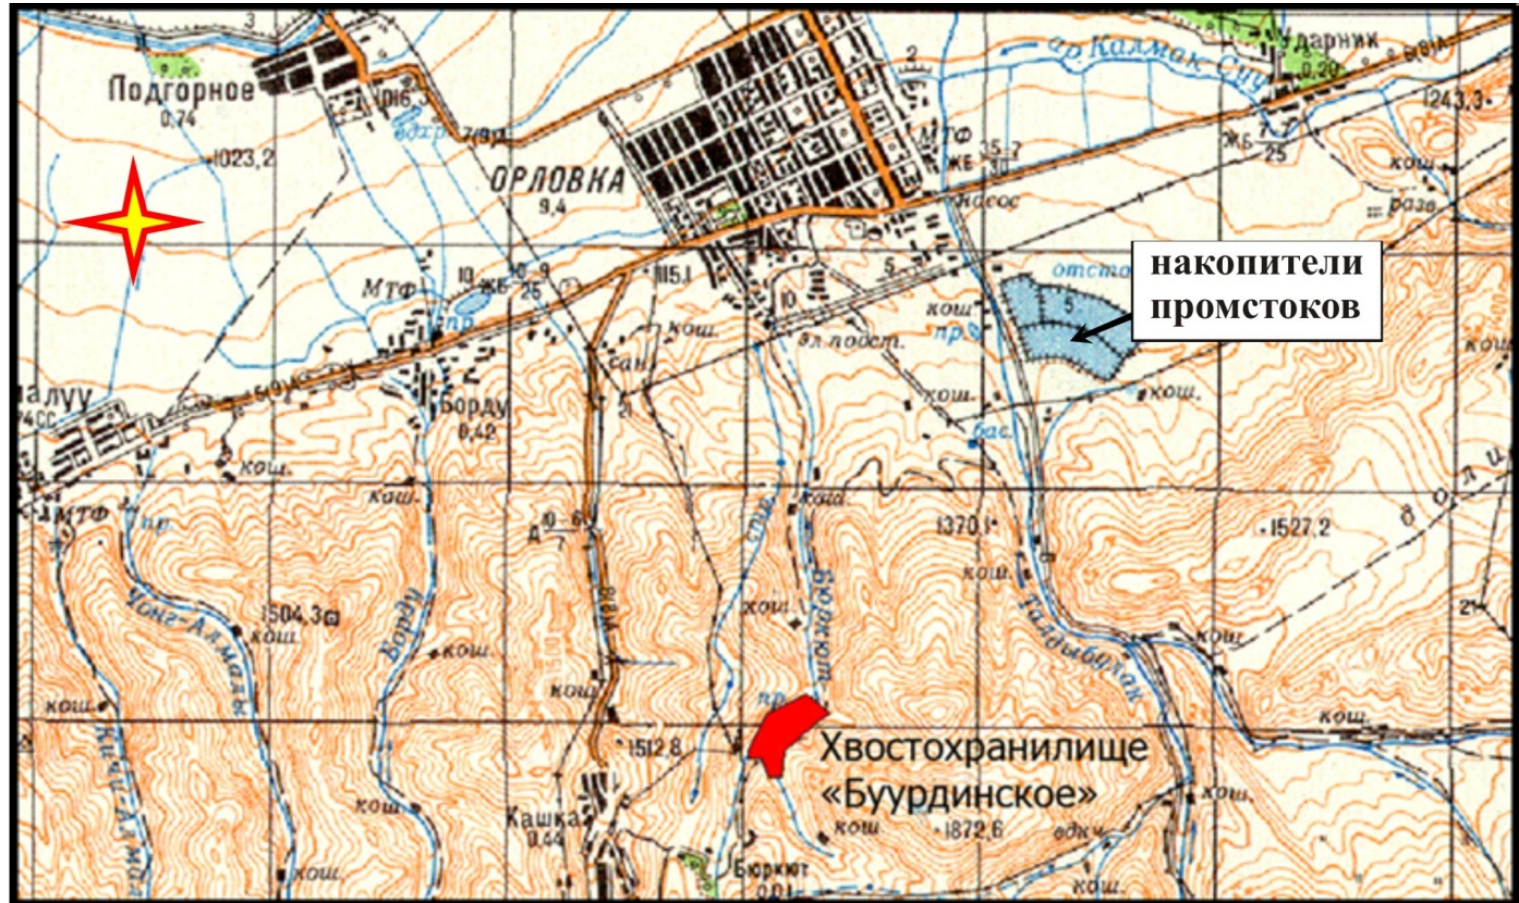
Location of the Bordun tailing dump and industrial waste storage

- The Bordun tailing dump is located in the mountain frame of the Chuy Depression, 3.8 km south of the village of Orlovka.
- The tailing dump is located in the valley of the Burkut stream, at altitudes of 1412-1525 m above sea level. The geographic coordinates of the central part of the tailings are as follows: $\phi = 42^{\circ}39'$ north latitude; $\lambda = 75^{\circ}37'$ East.

- At present, drainage channels have been laid on both sides of the tailing dump for the removal of storm and flood waters of the Burkut stream and its tributaries. The canals are concrete trays, on the eastern side, for the most part blocked, on the western - passing into a steel pipe with the subsequent discharge of water into the lower tail of the tailings dam.

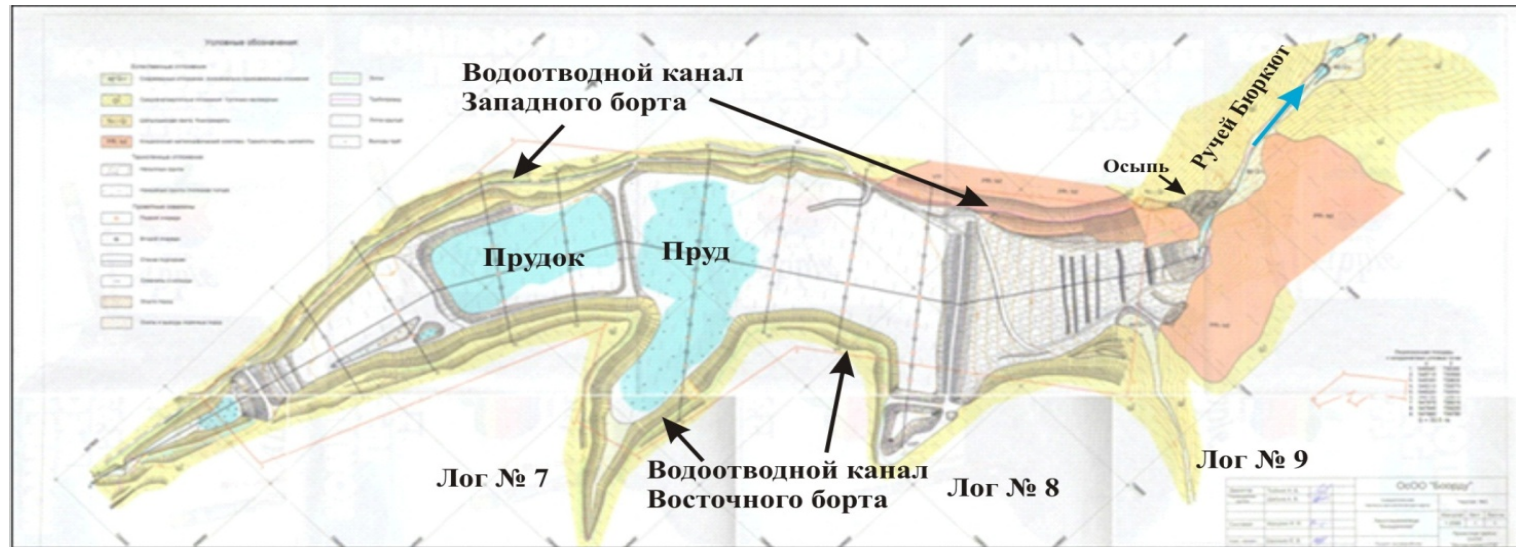
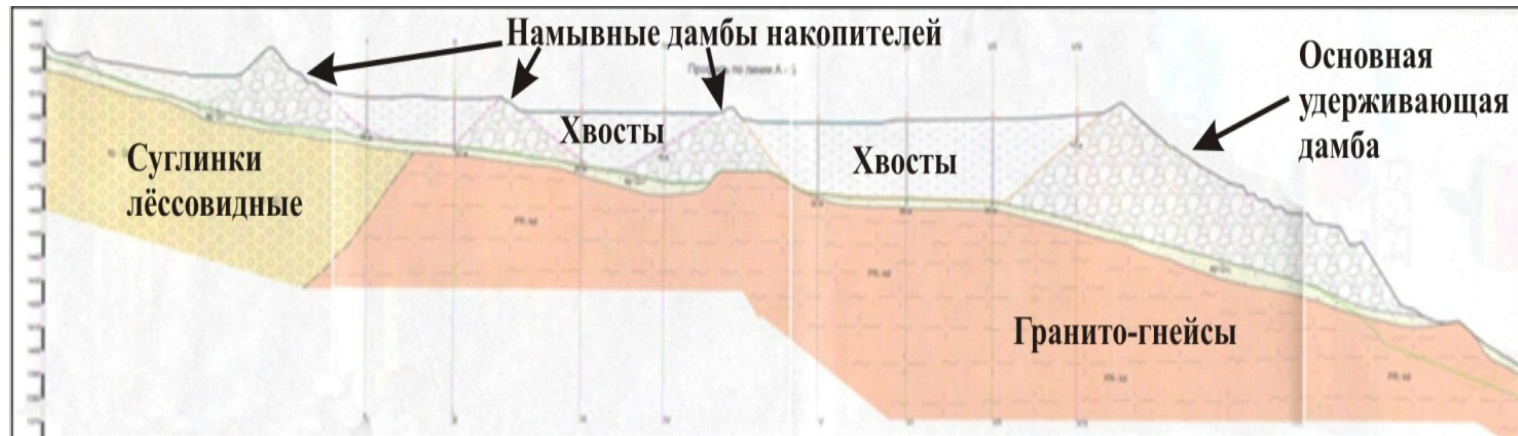
Plan and longitudinal section of the Bordun tailing dump

- The tailing dump contains tailings (waste) of flotation concentration of polymetallic (lead-zinc) and rare-earth ores. As a result of the activities of BGOK, KGMZ and KCMP, the total amount of lead and rare-earth ore dressing waste stored in the Bordun tailing dump, according to various estimates, is from 3.2 to 3.7 million m³, and the occupied area is 130 thousand m².

- The particle size distribution of the tailings according to the research of KAZMEKHANOBK (1985) is represented mainly by dusty particles of the following particle sizes: 1.0-0.5 mm (8.2%); 0.5-0.25 mm (36.6%); 0.25-0.10 mm (26.7%); 0.10-0.05 mm (17%); 0.05-0.01 mm (5.6%); 0.001-0.005 mm (1.5%); less than 0.005 mm (4.1%). The weighted average particle size is 0.17 mm, and the average density is 1.65 g / cm³.
