REPORT

Road 2020/07

REPORT ON A HEAD-ON COLLISION BETWEEN A PASSENGER CAR AND A VAN ON THE E39 AT AUSTEFJORDEN, VOLDA, MØRE OG ROMSDAL ON 20 OCTOBER 2019

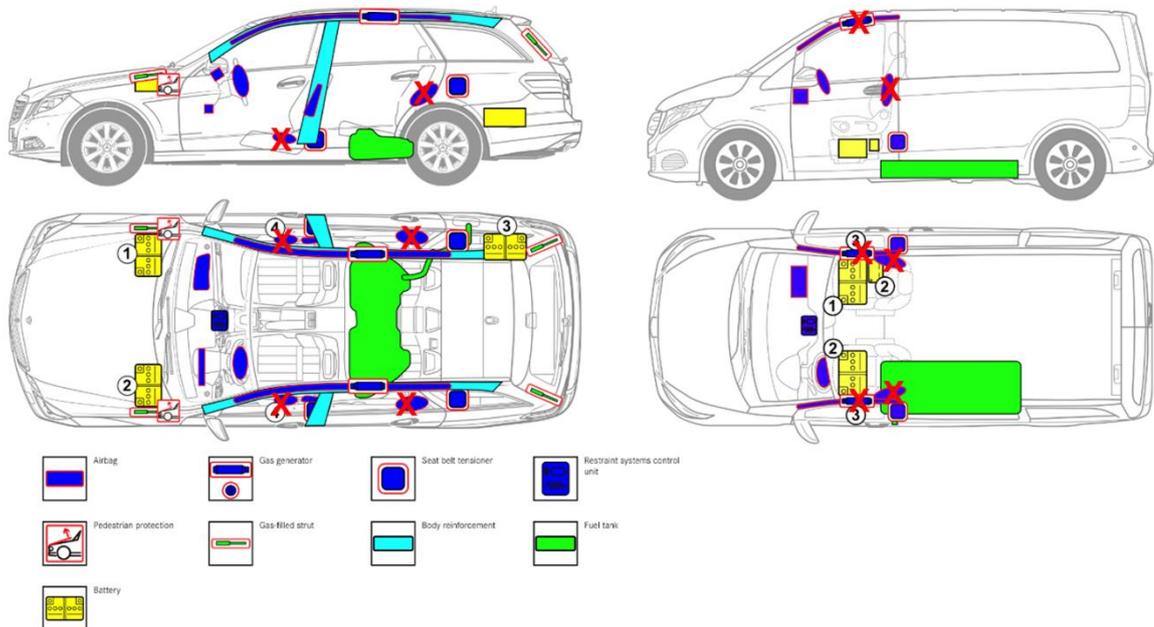
Both vehicles were transported to the NSIA's premises for examination after the accident. The passenger compartments in both vehicles had survival space¹ in all seat locations. The vehicles were equipped with safety equipment as illustrated in Figure 3.

Figure 3: Diagram showing body reinforcement, airbags and seat belts with pretensioners in the estate car (left) and van (right). Safety equipment that was not installed is marked with a red cross. Illustration: «Euro Rescue» / NSIA

There was a total of two airbags in the van. Both the front airbag on the driver's side and the right front seat passenger's dashboard airbag were activated in the collision. The van had no side curtain airbags or chest airbags; these are optional extras. There were three-point seat belts with belt pretensioners and force limiters for the driver's seat and right-hand passenger side. Both persons in the van were wearing seat belts, and both belt pretensioners and force limiters were activated in the collision.

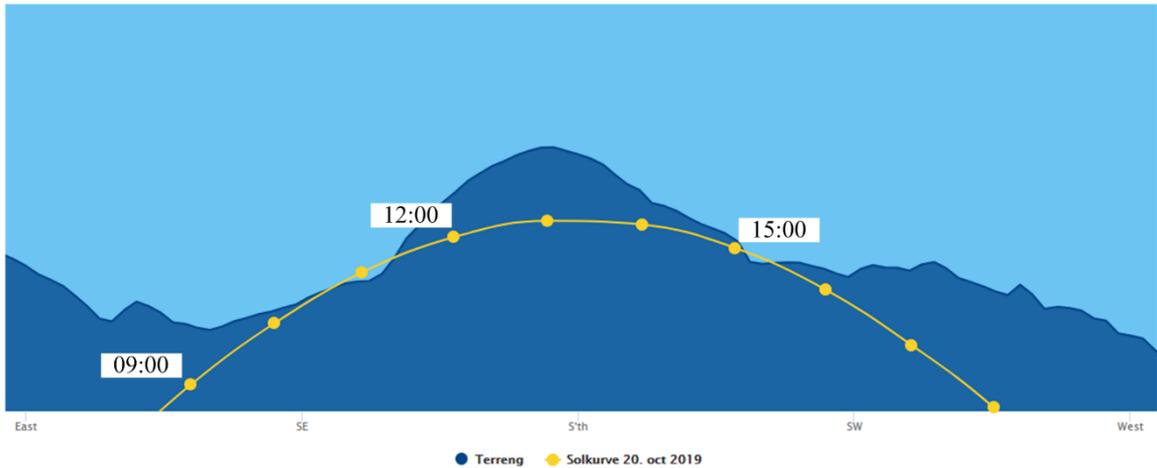
At the time of the accident, the roadway at the accident site was still in the shadow of the mountains to the south-east. Sun conditions at the accident site are shown in Figure 9.

Figure 9: Sun conditions at Kvikvsvegen, looking SE towards the mountains. Source: Suncurves

At the time of the accident, the area had mist from Storvatnet lake, and there was hoar frost on the ground beside the road. Both the persons involved and the response personnel at the scene described the road conditions as very slippery. Descriptions of the road surface at the accident site included 'like a skating rink', and it was so slippery that several of them had to hold on to one another to avoid falling.

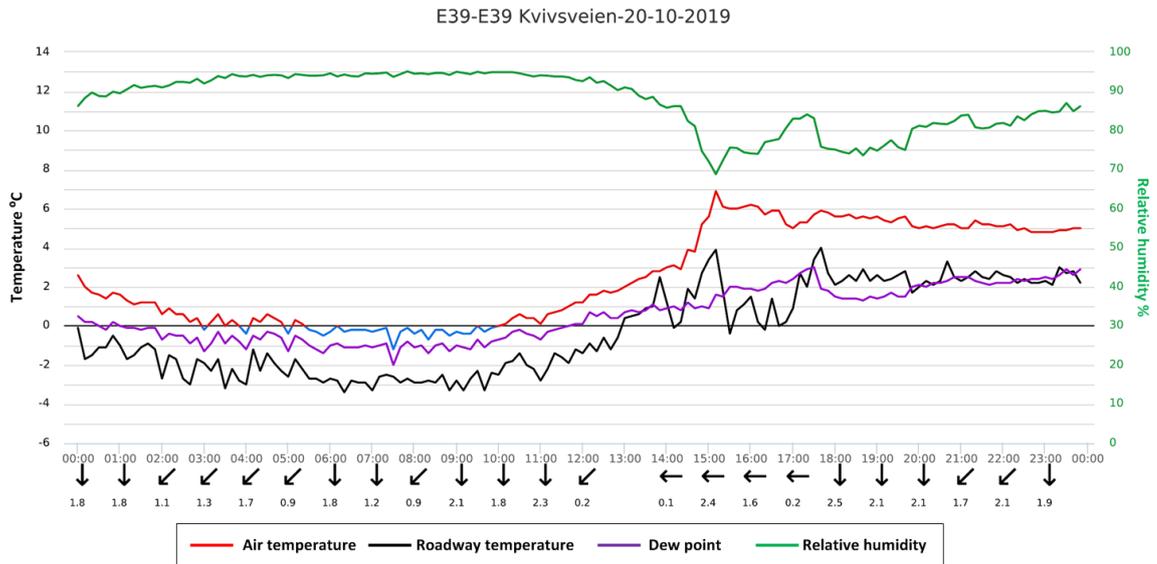
There was light cloud cover, no precipitation, and the air temperature in Volda in the early hours of Sunday 20 October 2019 was above zero. During the night and up to 09:00, the cloud cover at altitude cleared. The nearest weather station to the accident site that measured roadway temperature was E39 Kvikvsvegen, approx. 3.5 km from the site. This showed that the road temperature was below 0 °C, the dew point was higher than the road temperature and the air temperature was around 0 °C at the time of the accident, see Figure 10. It is well-known that in these weather conditions a film of ice is likely to form on the road surface as the moisture freezes.

Figure 10: Measurements from the E39 Kvivsvegen weather station for 20 October 2019. Source: NPRA

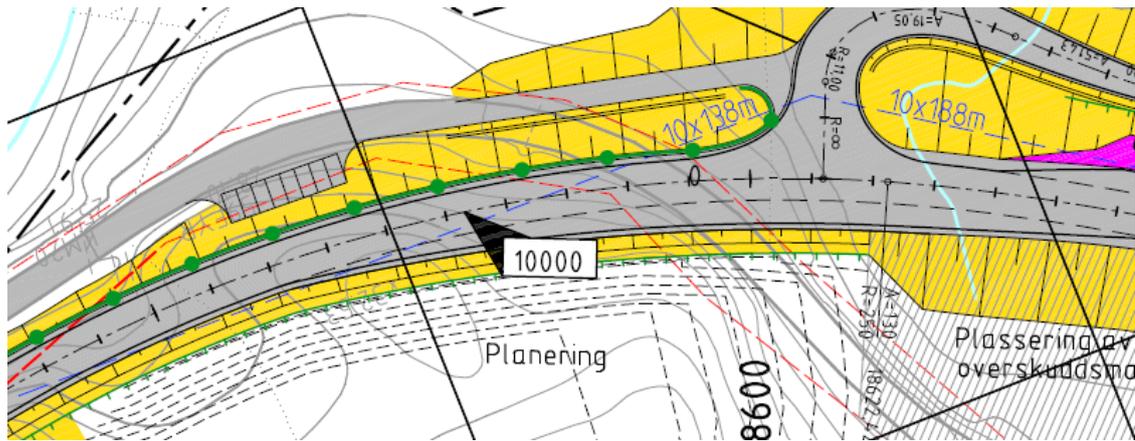
Figure 11: Map of the bend where the accident happened and the nearside passing bay by the exit road. Illustration: NPRA

The NPRA measured the camber of the road to 6.1% in the inner lane in the area where the van probably lost its grip. N100 stipulates that the camber through a bend on road type H1 with a radius of 250 m shall be 8%, which was the plan for this bend. The NPRA has informed the NSIA that, according to the road designers, the camber was reduced to 6% during development, in order to provide room for a nearside passing bay in the planned road junction area immediately south of the tunnel.

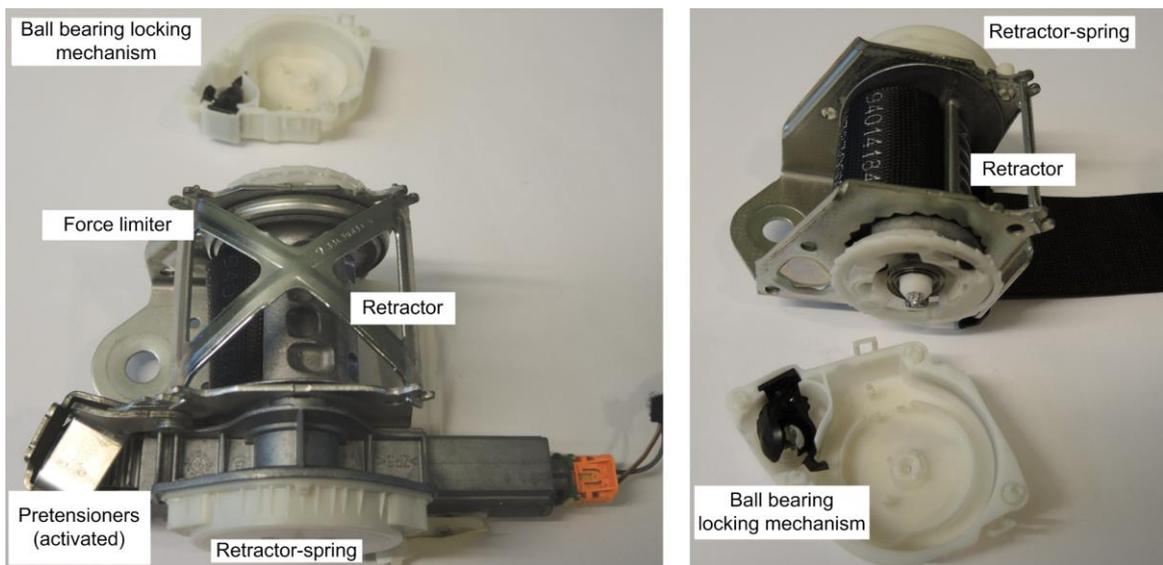
The seat belts on the right and left rear seats had pretensioners and force limiters in the retractor, see Figure 12. The pretensioner consisted of a bar that tightens the retractor using a pyrotechnic charge. The force limiter lets out the seat belt by one turn of the retractor at a given mechanical overload.

Figure 12: Rear seat belt functions at the sides (left) and the rear middle seat belt (right).
Illustration: NSIA

The seat belt in the middle rear seat did not have a pretensioner and force limiter, and it locked with a ball bearing locking mechanism. The belt was anchored to two points on the body of the vehicle beneath the seat squab and to one point integrated into the front side of the rear seat-back. This seat belt was the only seat belt where the shoulder belt was not anchored to the vehicle's body, B or C pillar. The passive safety of the middle rear seat is described in more detail in Section 1.13.2, and all the seats are analysed in Section 2.4.

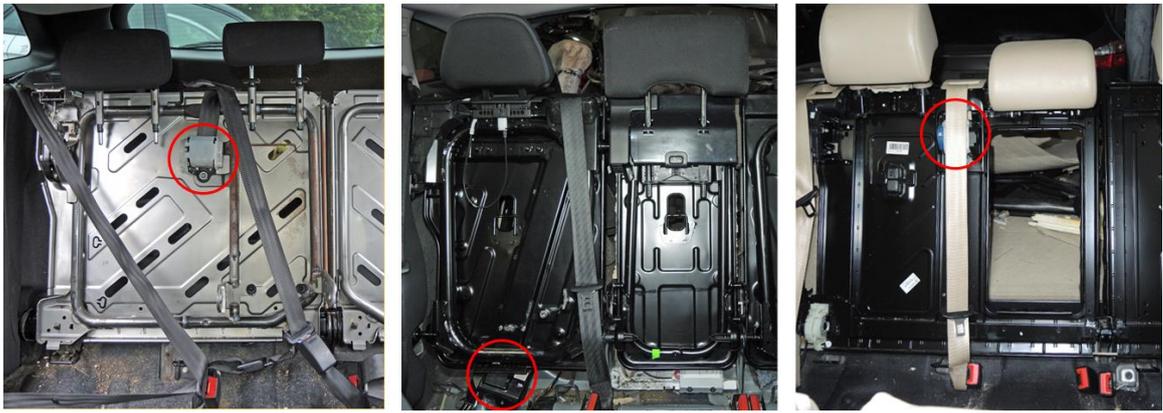
Figure 18: Design of seat belt integrated into rear seat-back for several manufacturers. The retractors are marked by red circles. Illustration: NSIA

All seat-backs that were examined consisted of welded sheet metal and a frame. The frames were either made of round tubes or u-profile struts. Reinforcement of the rear seat-back towards the retractor for the middle seat varied, and the retractors were of different types. Many retractors were fitted at the front edge, with or without a metal housing; others were floor-mounted and had a pretensioner and force limiter. The width of the seat belt across the pelvis in the rear middle seat was consistently narrower than for the other seat belts in the same vehicle.

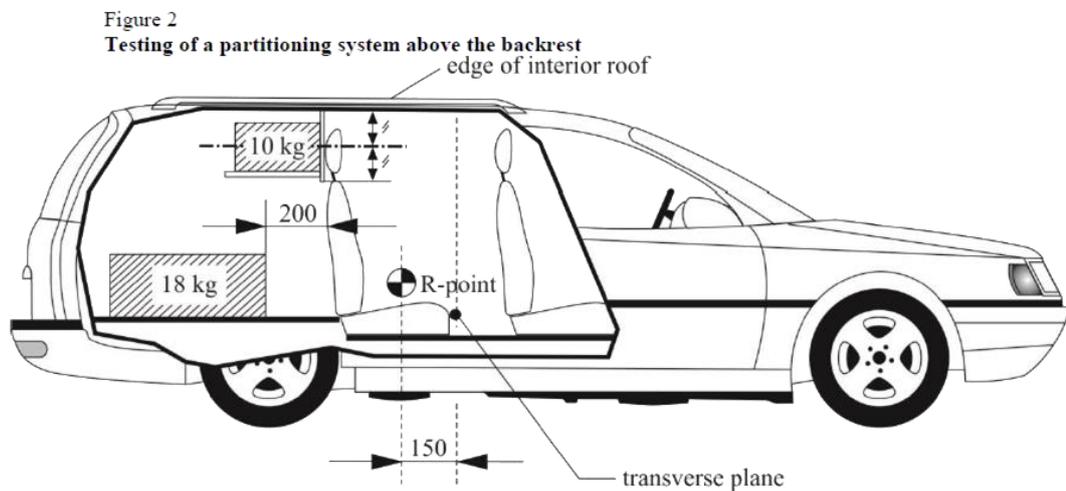
Annex 9, in UN-ECE R 17 describes a strength test for split rear seat-backs. This requirement was introduced in 1998 and has applied to all new cars since 2002. The test requirements are a minimum requirement that apply to split rear seat backs in all types of vehicles. The test involves placing 2 suitcase-like 18 kg blocks in the boot 20 cm from the seat-back, and a 10 kg block up against the head restraint. It is then run on a test sled that simulates a head-on collision at 50 km/h, giving a maximum retardation of 20–28 G. The test is passed if none of the blocks in the boot penetrate the passenger compartment and the seat-back is not deformed by more than 100 mm in front of the R point and the head restraint not by more than 150 mm. The manufacturer defines the R point.

Figure 19: Test of seat-back with 2 x 18 kg luggage and 10 kg against the head restraint in a sled test at 50 km/h. The minimum requirement for forward deformation of the seat-back is described below. Source: UN-ECE R17

This test was carried out without crash-test dummies in the rear seat and does not describe how the seat belts in the rear seat shall be designed. No requirement is specified for the way in which a seat-back can or should be deformed, nor for oscillation of the seat-back.

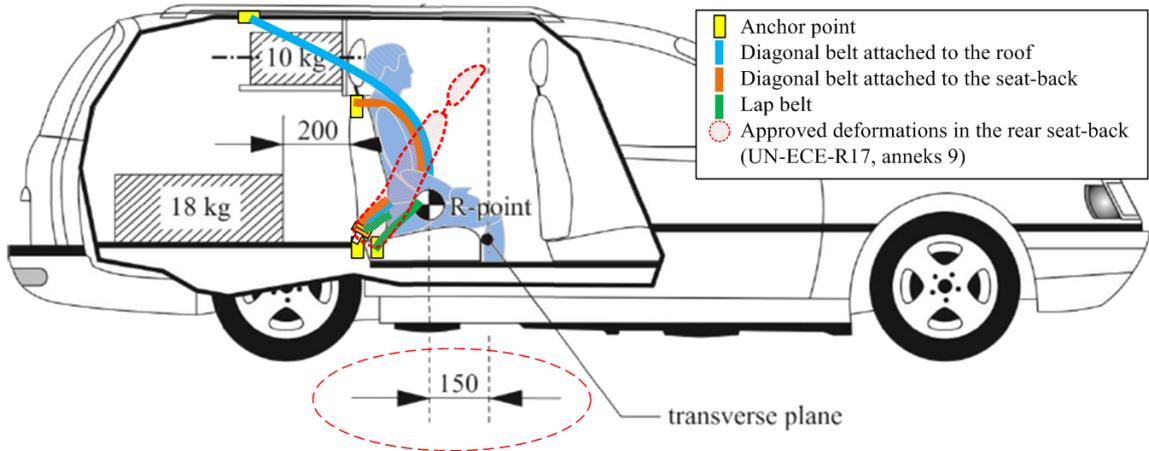
Figure 25 illustrates a passenger in the middle rear seat with alternative anchorages for the shoulder belt; in the roof, and integrated into the rear seat-back. The approved deformation is also shown, in red.

Figure 25: Strength requirements for rear seat-backs - showing middle rear passenger and seat belts with alternative shoulder belt anchorages. (Note: R-point is determined by the car manufacturer and will vary). Illustration: NSIA

In the context of this test, the alternative middle rear seat belt anchorages present different problems in relation to deformation of the rear seat-back. When the shoulder belt anchorage is in the roof, the rear seat-back must be strong enough for a deformation not to jam the passenger between the shoulder belt and the rear seat-back. When the shoulder belt anchorage is integrated into the rear seat-back, the movement of a secured passenger's body will be determined by the movement of the rear seat-back and the configuration of the belt, described in Figure 15.
