## Description of the Tous Dam break case study (Spain)

F. ALCRUDO, *Area de Mecánica de Fluidos, CPS-Universidad de Zaragoza, 50.018-Zaragoza, Spain*

J. MULET, *Area de Mecánica de Fluidos, CPS-Universidad de Zaragoza, 50.018-Zaragoza, Spain*

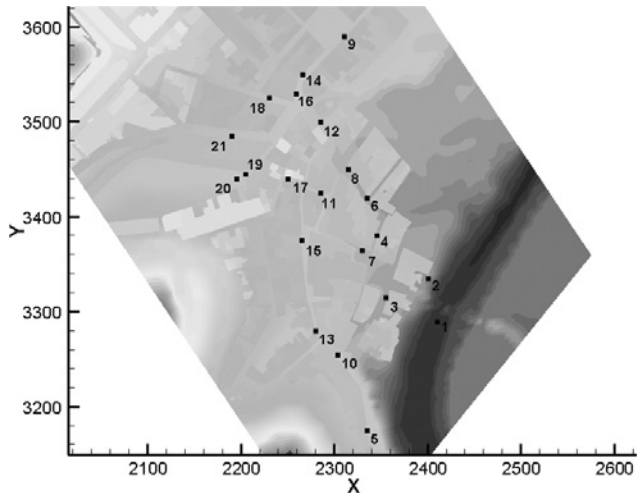
Maximum water elevation marks were recorded at 21 locations within or very close to Sumacárcel. These will be called probes or gauging points in the rest of this paper. In three places a rough evolution of water depth with time could also be estimated. It is important to note that the ground in the town area was fully paved with concrete and the flood did not erode it. Hence there is no concern about topography uncertainties due to sediment movement in the town area. Table 4 lists the position ( $X, Y$ ) of the selected points in the co-ordinates consistent with those of the topography files, together with the corresponding maximum water depth records. Figure 7 shows the location of the gauging points in a plot of the DTM.

Figure 7 Probe locations in the streets of Sumacárcel.

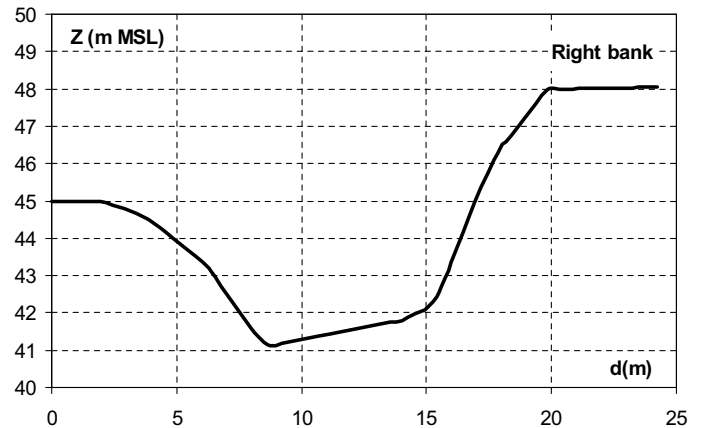
Figure 8 depicts water depth evolution at gauging point number 1 (bridge) according to two different sources. The corresponding river cross section is displayed in Fig. 9. As can be seen from both figures water largely overflowed the river banks flooding the town. According to witnesses and statements quoted in the reports, the town was already flooded before the dam break due to the intense rain and river flow. At about 18:00 on October 20

Figure 9 River cross section at Gauge 1 (bridge). November 1982 data.

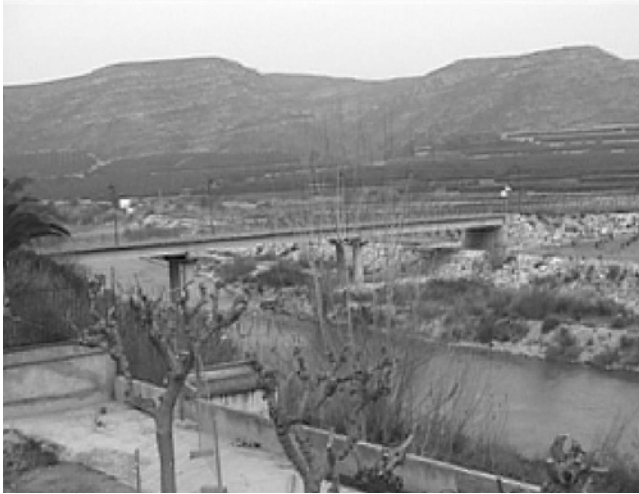
Figure 11 Present day view of Gauge 1 location (riverbed at the bridge) looking upstream.

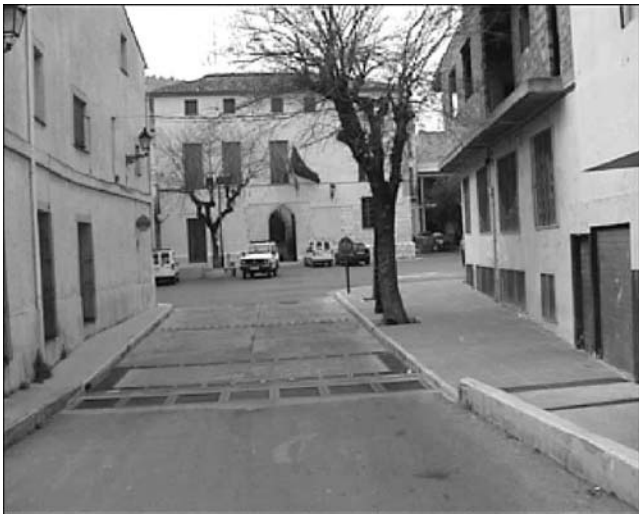
Figure 12 A view of Sumacárcel main square from its access across the bridge.

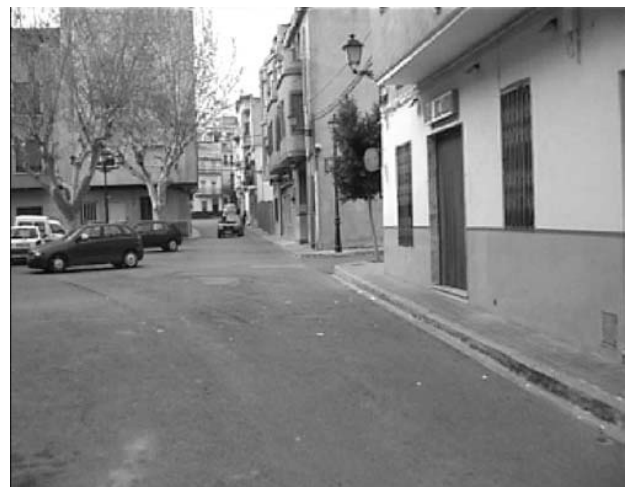
Figure 16 View of the location of Probe 8.

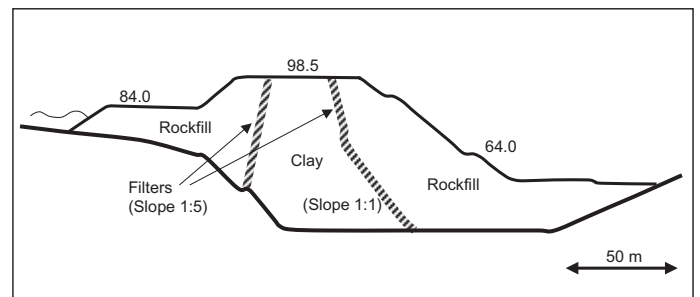
Figure 19 shows a sketch of a standard cross section of the old Tous Dam where the three parts in which it is divided are very clear: the clay core, the filters around the core and finally the rock-fill body that surrounds the other two zones. The slope in the upstream side of the core is uniform (1 : 5), but it changes in the downstream side at the elevation of 64 m (1 : 5 to 1 : 1). The crest level of the first phase was set at 98.5 m with a Normal Reservoir Operation level at 84 m. The berms in the downstream face of the dam are situated at two different elevations, 64.00 and 90.50 m.

Figure 19 Tous Dam cross section. Vertical and horizontal scales are equal.

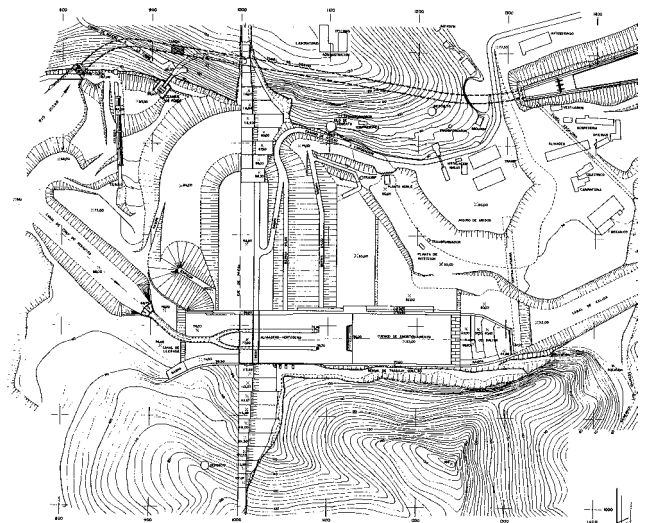
A top view of the old Tous Dam can be seen in the Fig. 20. The surrounding terrain, the concrete blocks in both sides of the dam, the spillway, the berms and some important elevations are

Figure 20 Tous Dam top view.

indicated in this view that supplement the information on Tous Dam provided in Table 1. Figure 20 is reproduced in the joint DVD-ROM with very high resolution.

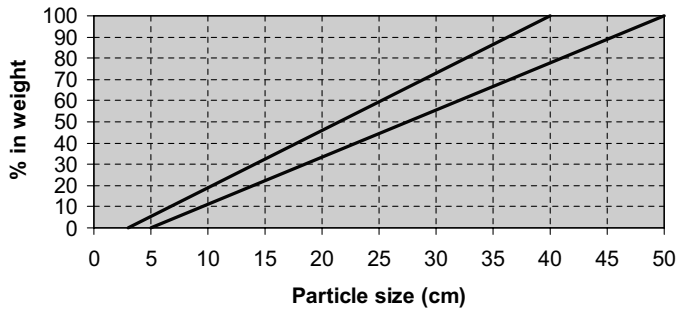
Figure 21 Rock-fill estimated size distribution during construction of old Tous dam.

It can be assumed as a good approximation that the actual grading of the rock-fill of Tous Dam followed a uniform distribution between a particle size of 3–5 cm and a particle size of 40–50 cm. Figure 21 shows a plot of the two estimated boundaries of the rock-fill grading. It is supposed that the actual grading of the rock-fill falls between the two lines.
