# **REPORT**

## **from the on-site training and results of the application of the Checklists B.1 and B.2 of the tailings management facilities (TMF) Methodology**

*based on the safety evaluation of the TMF of JV «Zarafshon»  
(Penjikent, Republic of Tajikistan)*

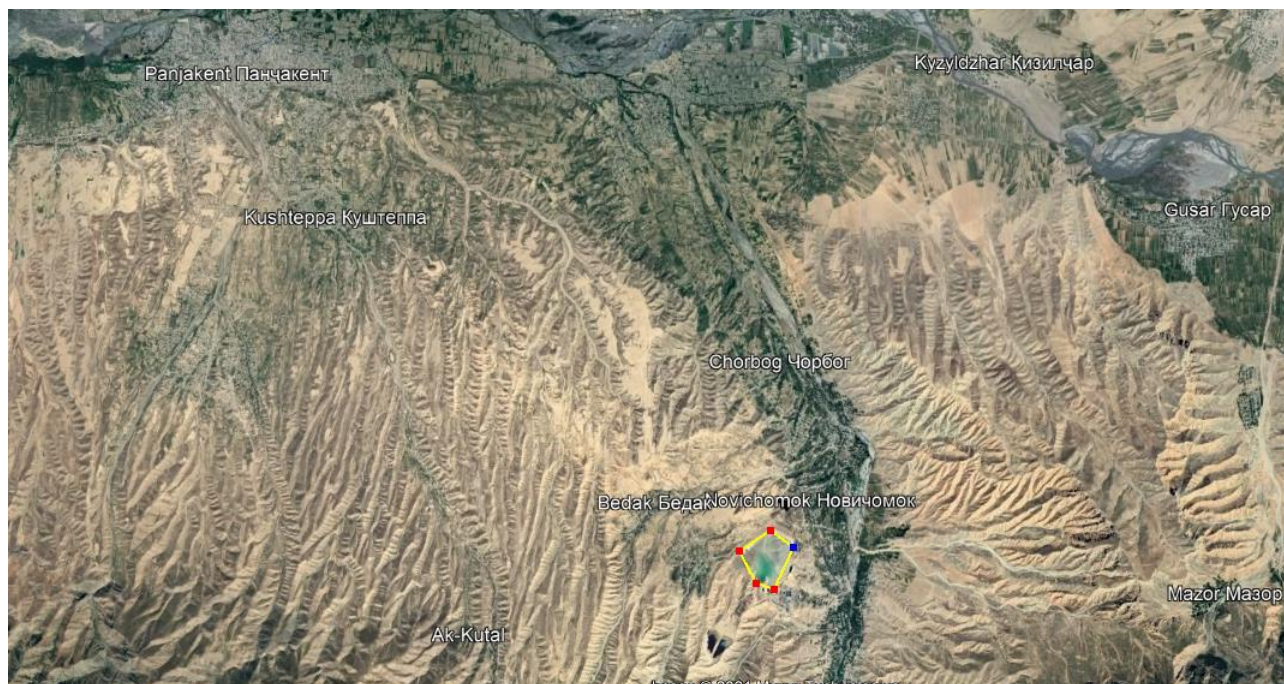
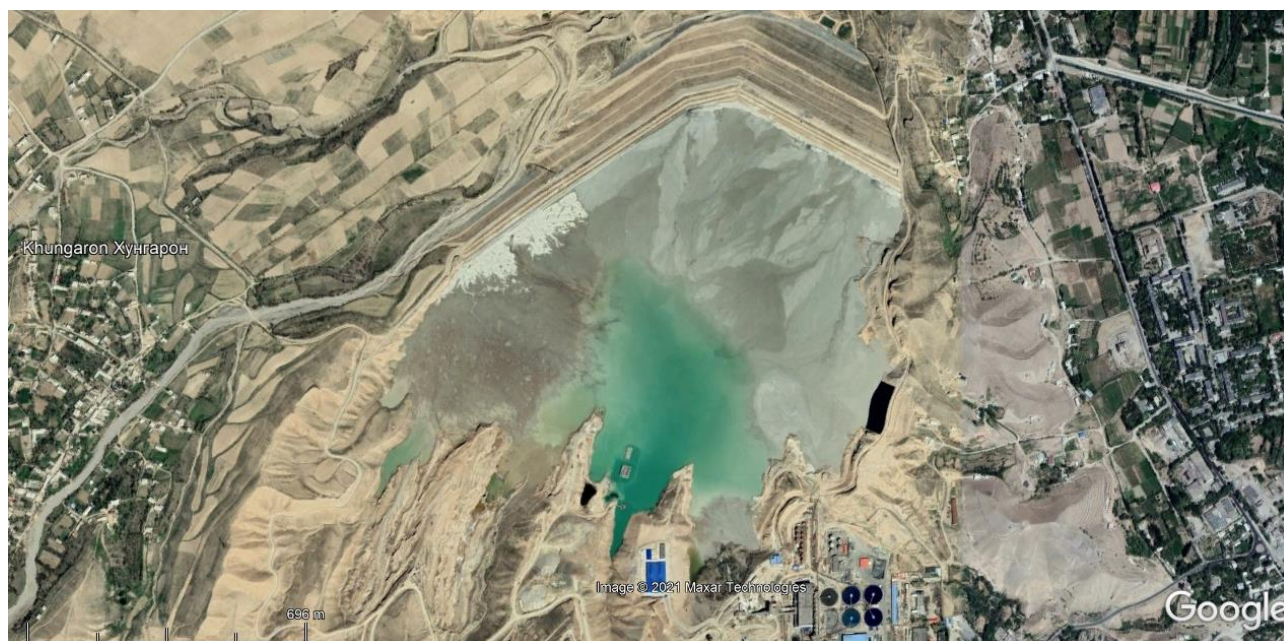
The TMF is located in the Penjikent district of the Sughd region of the Republic of Tajikistan (Fig. 1). The views of the TMF (see Fig. 1,b) are shown in Fig. 2. General information on the facility and its production is prepared by the company personnel. Please see Annex 1 to this report.

Figure 2: Views of the TMF from its northern side

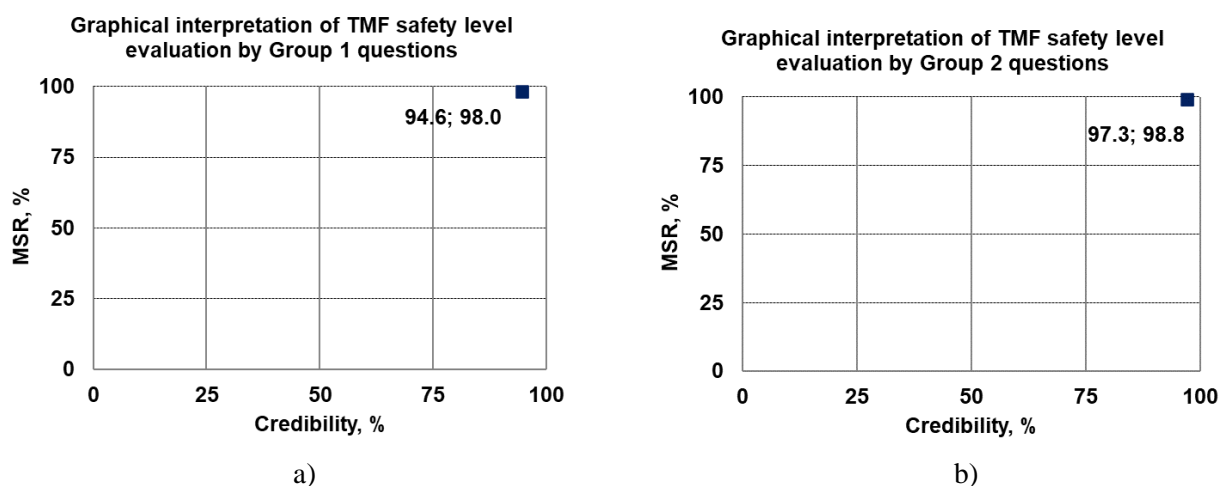
Figure 3: Overall TMF safety evaluation: a) the visual inspection results, b) the results of document check. MSR = Meeting safety requirements.

The overall evaluation results (Table 1, Fig. 3) showed a relatively high level of compliance of this TMF with the safety requirements defined in the UNECE Safety Guidelines and Good Practices for TMFs [1]. As a result of the visual inspection, with the results of which the trainers agreed, the TMF safety level was rated very highly: the parameter “Compliance with safety requirements” was 98% and “Credibility” at 94,6%; the minor discrepancies in two evaluations are explained in Annex 2. The trainers estimated the same parameters for the Checklist B Group 2 at 98,8% and 97,3%, respectively.

Despite the sufficiently high degree of compliance with the safety requirements defined in the above UNECE Safety Guidelines, the overall TMF safety level has been identified as unacceptable, which follows from the criteria for the safety level evaluation recommended in the [TMF Methodology](#) [1, page 67]. According to the Methodology, a TMF can only have an acceptable safety level if 100% of the minimum safety requirements are met (“Compliance with safety requirements” (MSR) is 100%); the other option “Acceptable with conditions” is applied if all answers are “yes” or “mostly yes”. The safety level is considered unacceptable in all other cases ( $MSR < 100\%$ ). Both training participants and trainers gave at least one answer, “mostly no” (see question 34 in Annex 2), thus, the conclusion on the “unacceptable safety level” has been drawn. This approach was adopted to encourage the operator to take measures to improve the TMF safety level until 100% of the requirements from the minimum set are met.

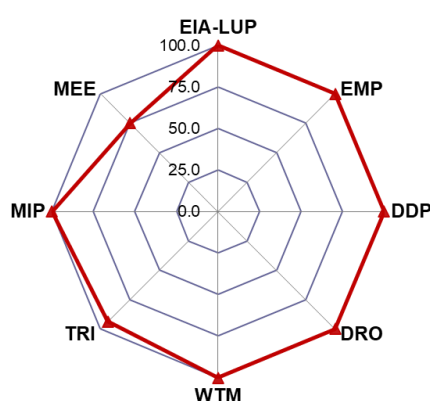
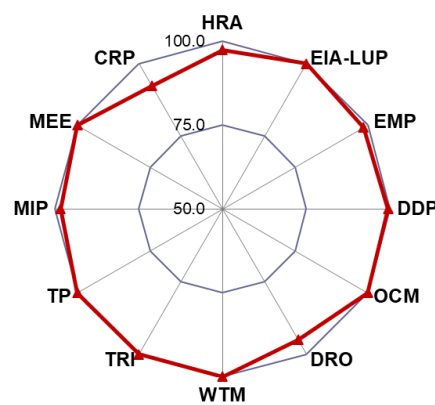
Figure 4:                      Categorial evaluation of TMF safety for visual inspection (a) and document verification (b)

The categorical evaluation (Fig. 4) revealed aspects of the TMF functioning with lower safety indicators, which should be addressed first by the appropriate safety improvement measures: monitoring, including the dam and infrastructure condition, closure and rehabilitation plan.
