SATELLITE BASED RISK ASSESSMENTS AND MONITORING

SOUTH AFRICA, JAGERSFONTEIN, DIAMOND MINE TSF

SARDOBA TAILINGS STORAGE FACILITY (TSF), UZBEKISTAN

RIDDER-SOKOLNOE TAILINGS STORAGE FACILITY (TSF), KAZAKHSTAN

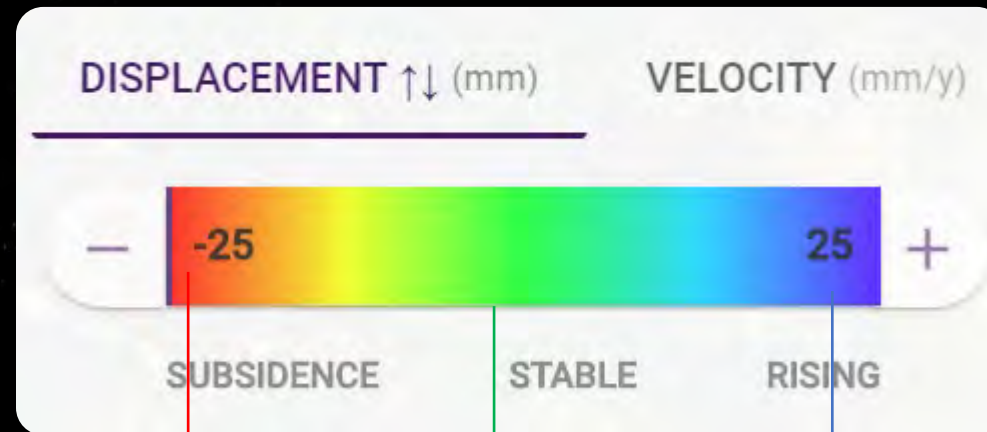
Deformation Gauge

Several risk markers could have been foreseen at least a year and a half before the loss event, likely longer if it would have been monitored regularly.

- 1 Find 1: Bidirectional movement cluster
- 2 Find 2: Bidirectional movement cluster
- 3 Find 3: Bidirectional movement cluster
- 4 Find 4: Bidirectional movement cluster

5 Find 5: area without stable reflection

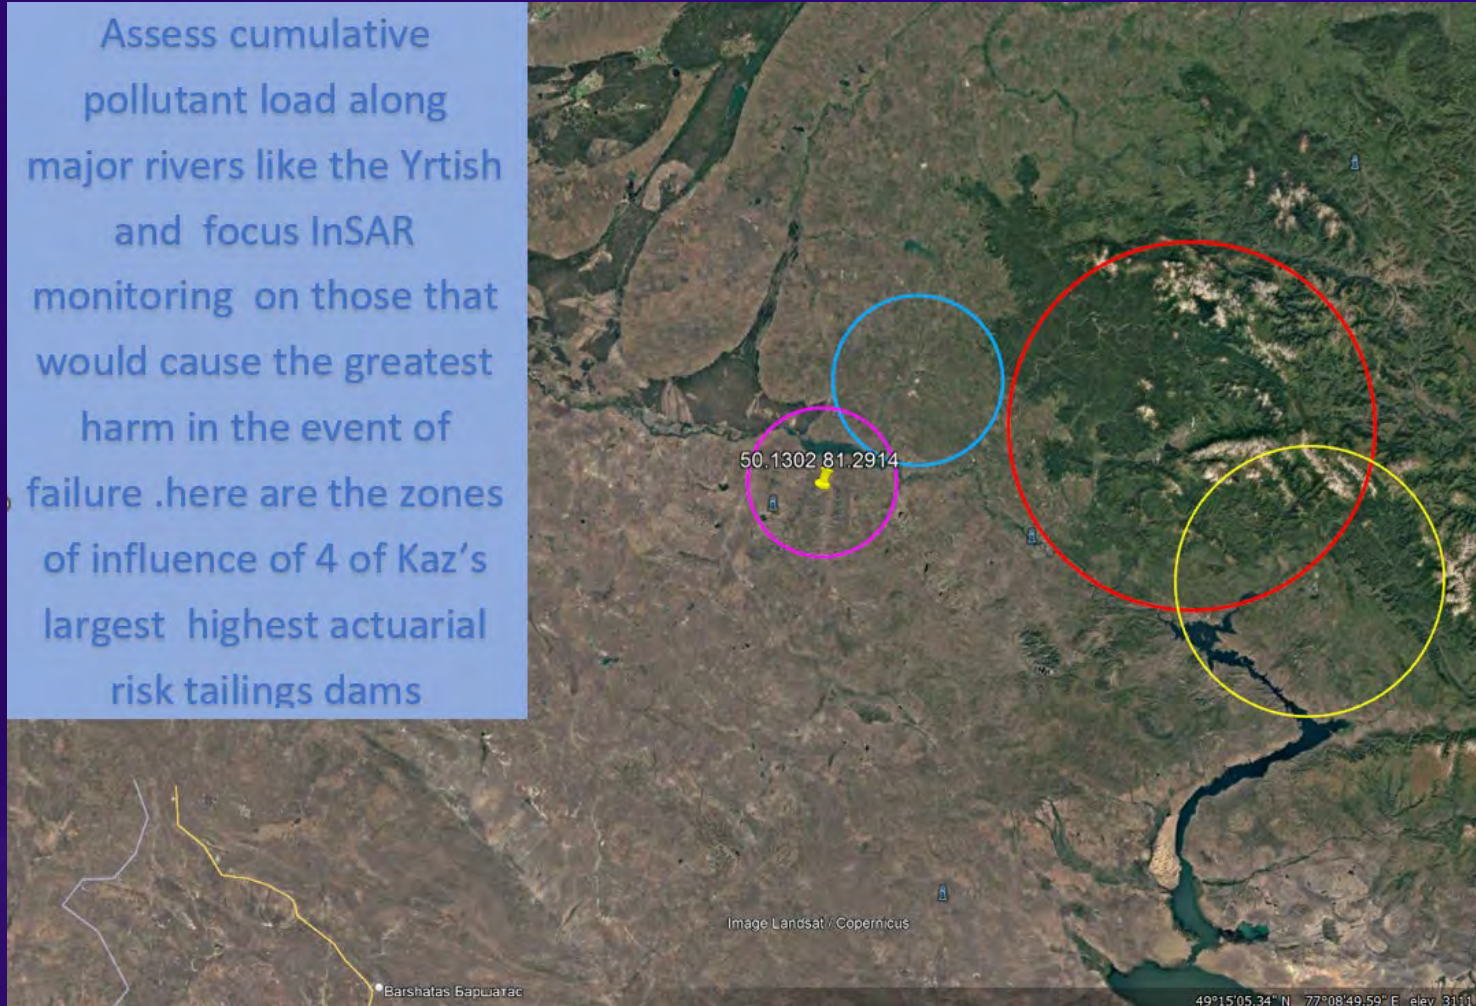
Severity and range in event of failure

World Mine Tailings Failures (WMTF) – Calculated runout, radius impact in a failure event.

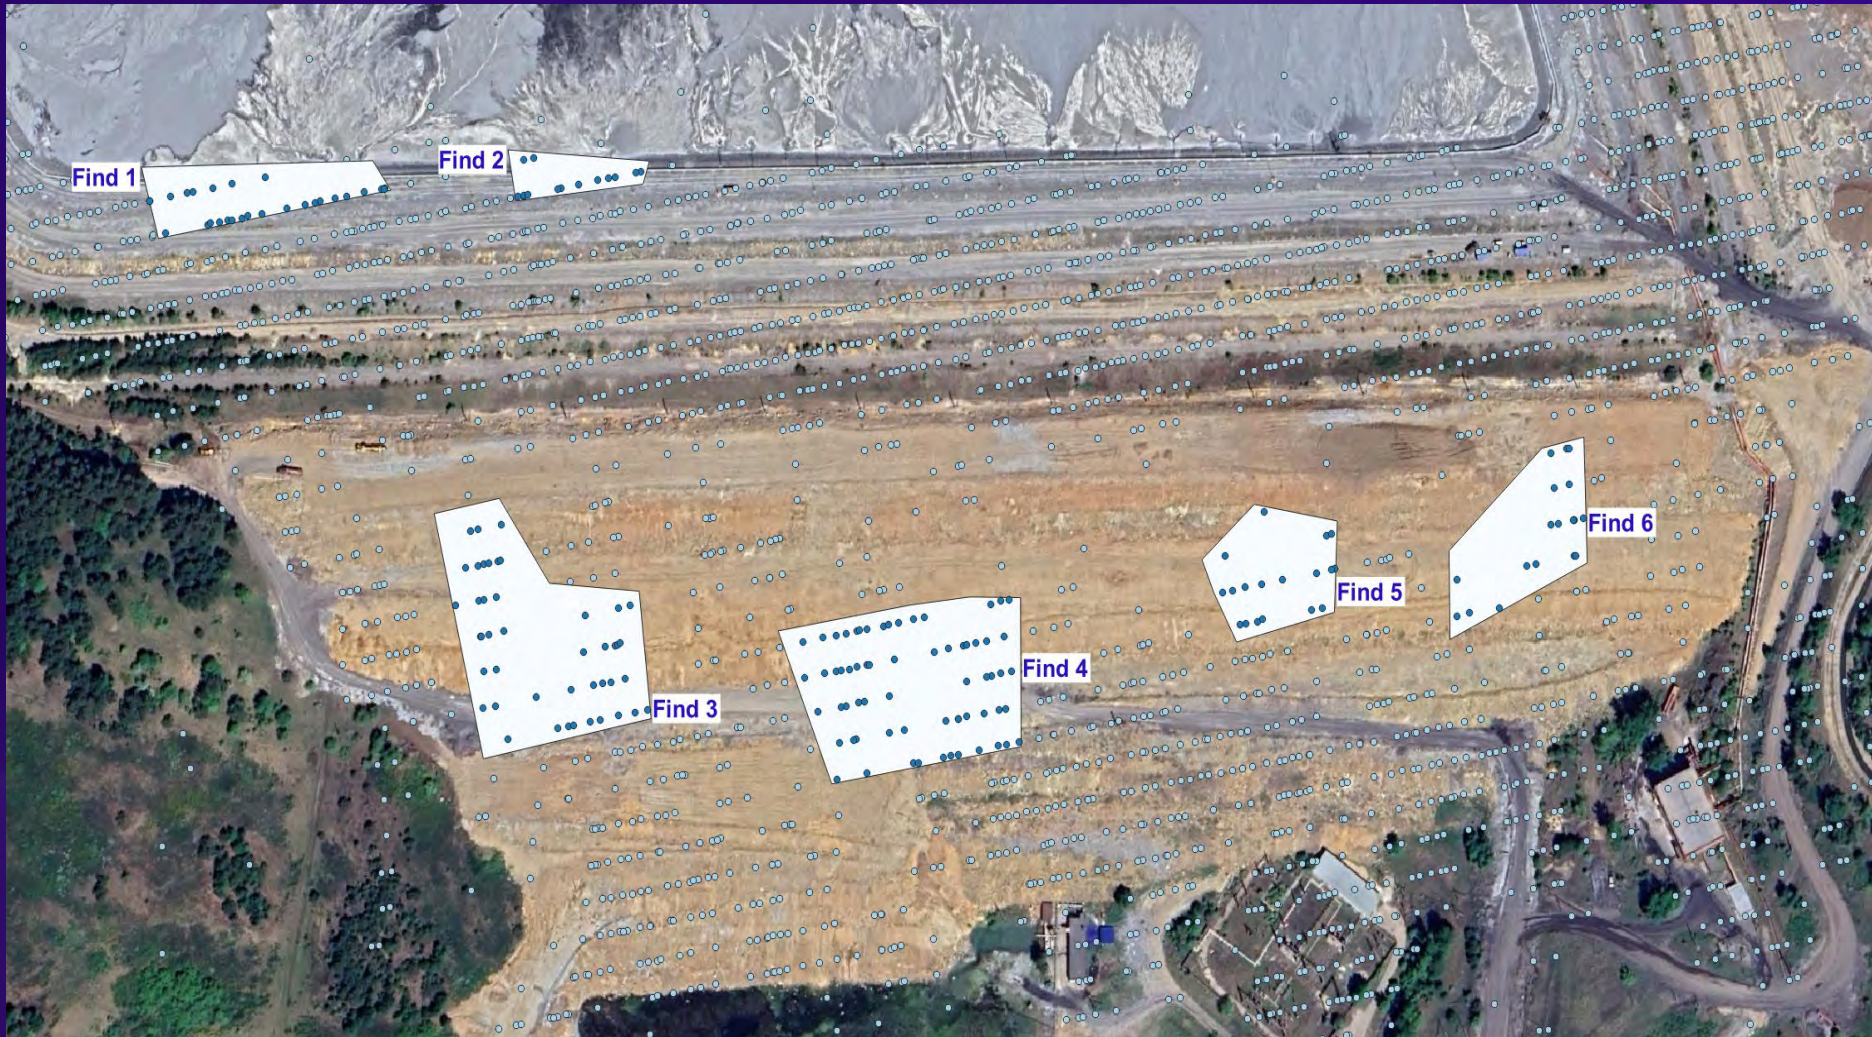
Site A - South Dam Detailed Overview

Findings 1 - 6

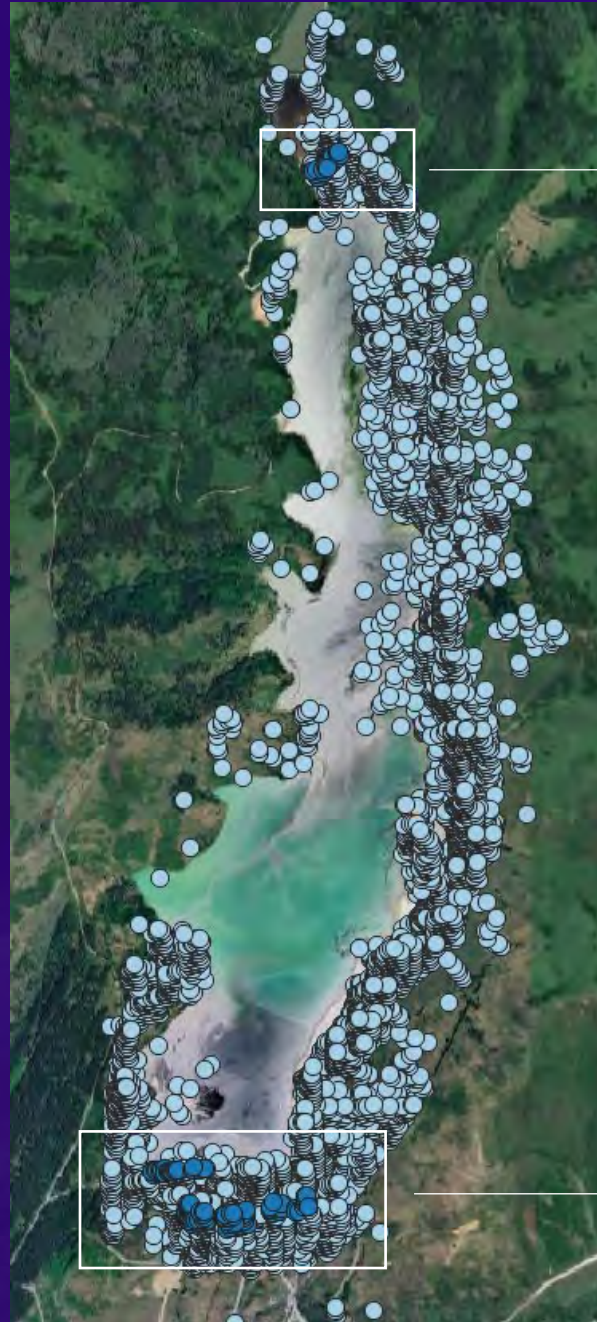
Ridder TSF - Macro Overview

Site B – North Dam
Find 7

Site A – South Dam
Finds 1, 2, 3, 4, 5, 6
