Madrid meeting
WD.3.

TYPICAL BUS FRONTAL COLLISIONS

Presented by Hungary

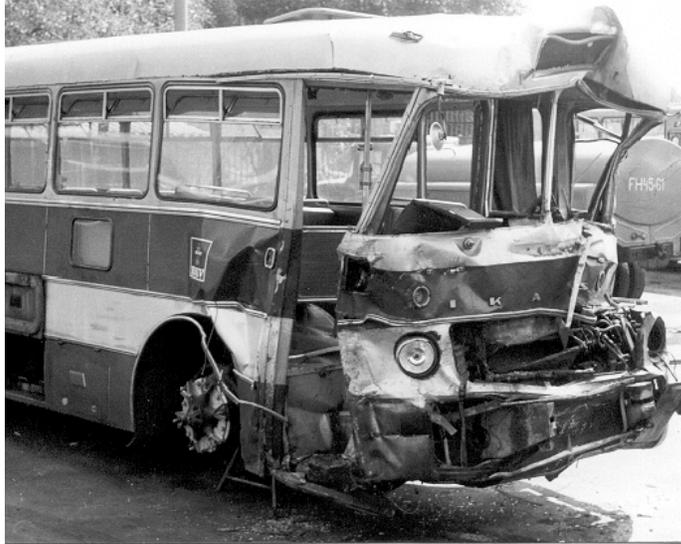
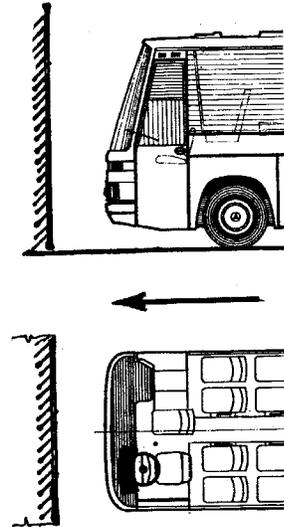
Full frontal collision

The full front wall of the bus is hitting the object, the impact speed (therefore the impact force) is closely perpendicular to the impacted wall-like object, the structural deformation (damage) of the bus front wall is closely evenly distributed

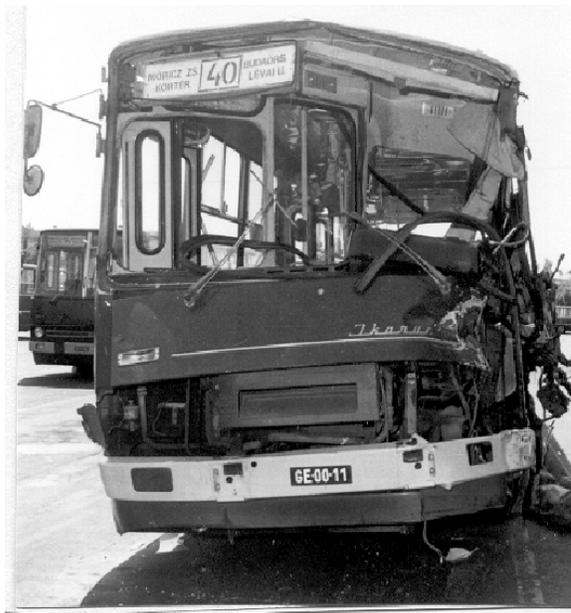
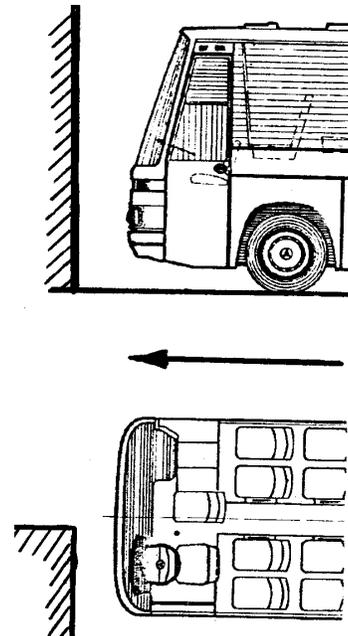
1.2. Offset collision on the driver compartment (DC) side

The wall-like object hits only a certain part of the bus front wall. The measure of the offset could be expressed as % of the width of the front wall. The damage is concentrated to the hit part of the front wall, it is partial. The impact speed (and force) is closely perpendicular to the impacted wall like object.

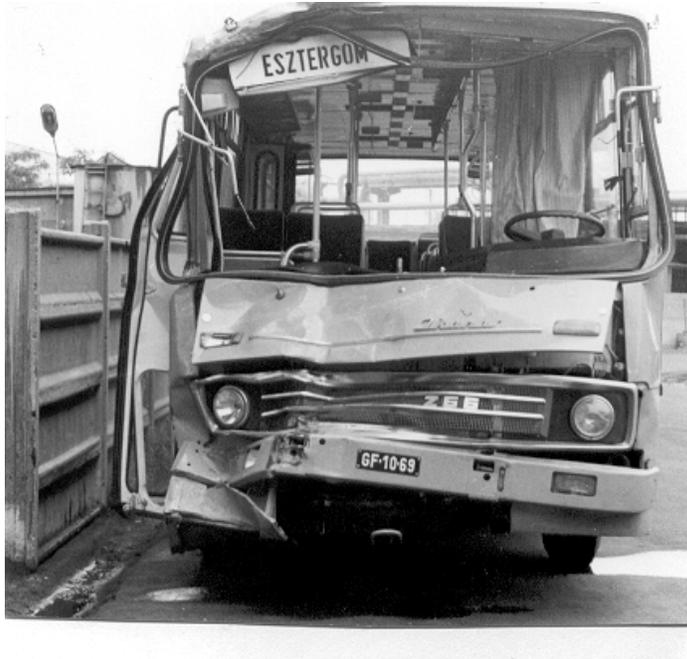
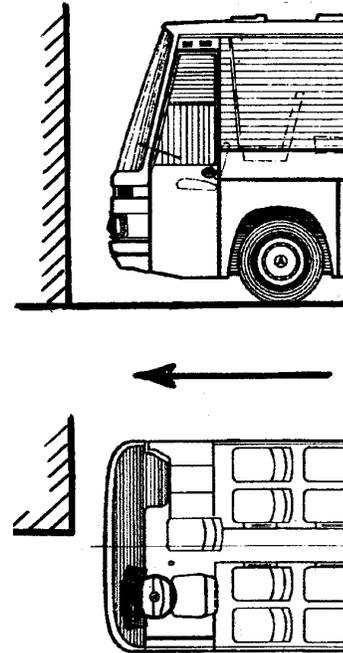
1.3. Offset collision on the service door side

Similar (symmetrical) arrangement to the situation described in para 1.2., but on the other side

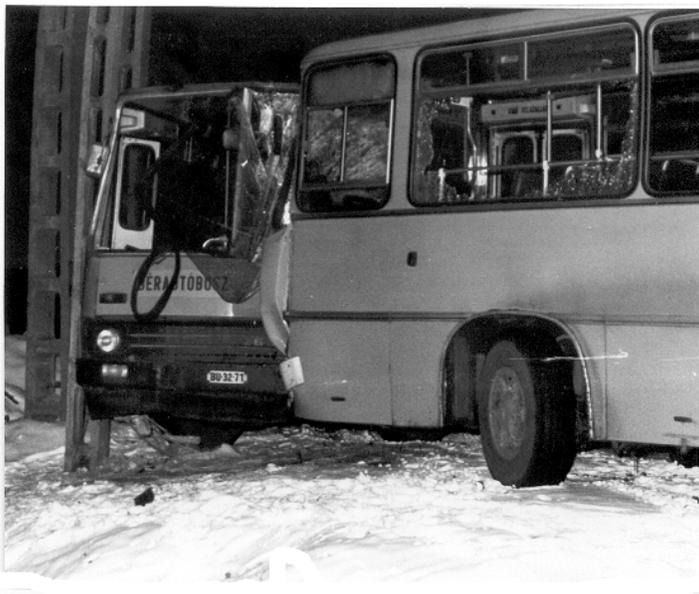
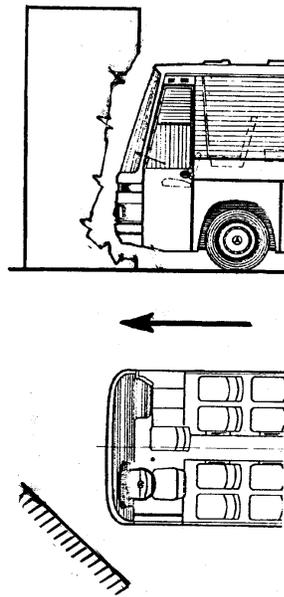
1.4. Collision on the DC side under angle

The bus hits the wall-like object under a certain angle (not perpendicularly) so the front wall corner gets the impact force. The front wall deformation (damage) is concentrated on the DC, it is partial. The result apparently could be similar to deformation described in para. 1.2. but the impact process is different.

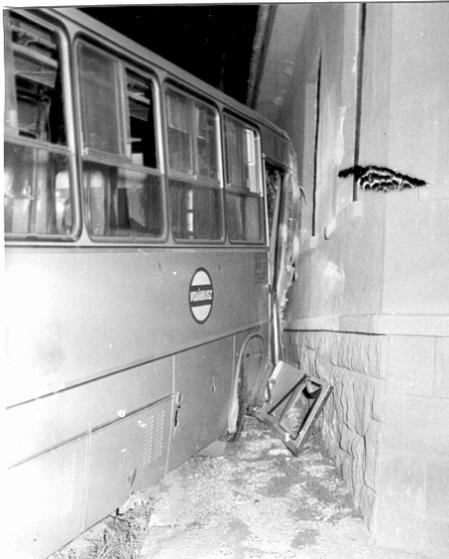
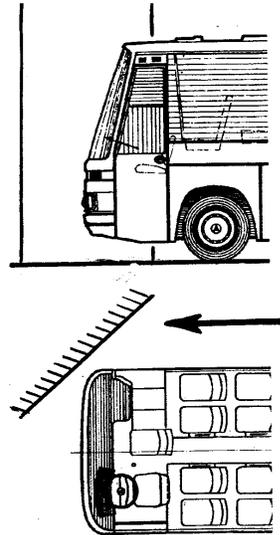
1.5. Collision on the service door side under angle

Similar (symmetrical) arrangement to the situation described in para. 1.4.

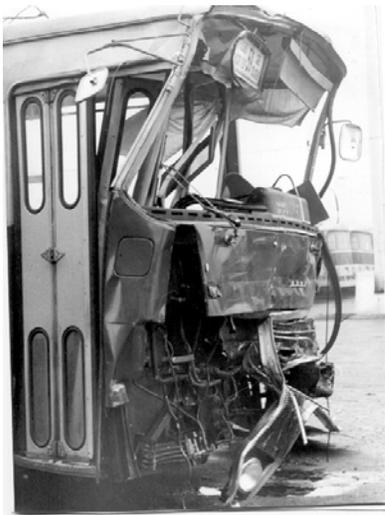
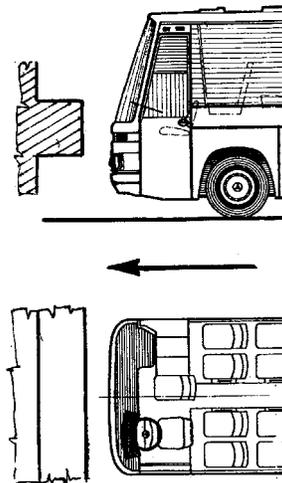
2.1. Full- width collision with HPO

The HPO horizontally covers the full width of the bus front wall, so the deformation zone is extended to the full width of the front wall.

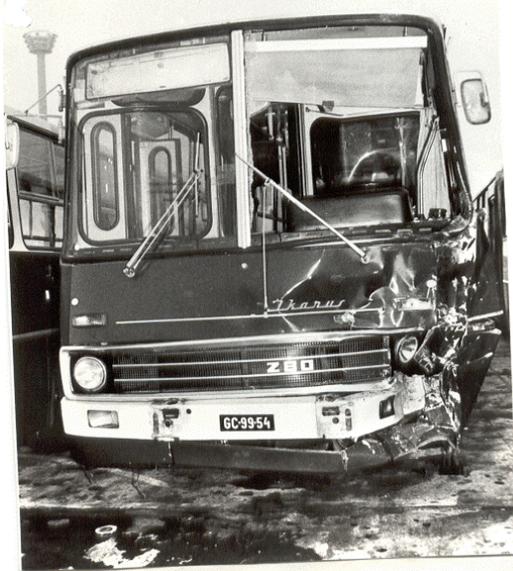
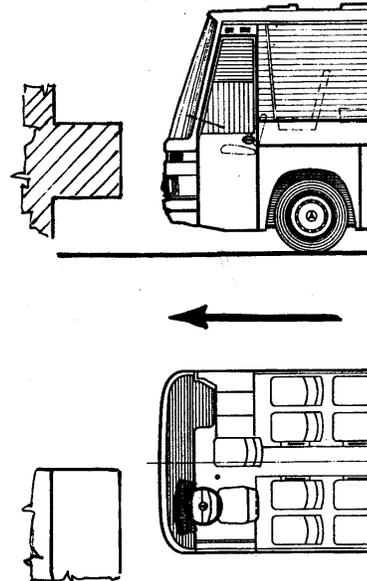
2.2. Collision on the DC side with HPO

The impact force may act parallel to the longitudinal central plane of the bus or under a certain angle to that. The deformation (damage) is local, partial, concentrated mainly on the DC and the corner of front wall.

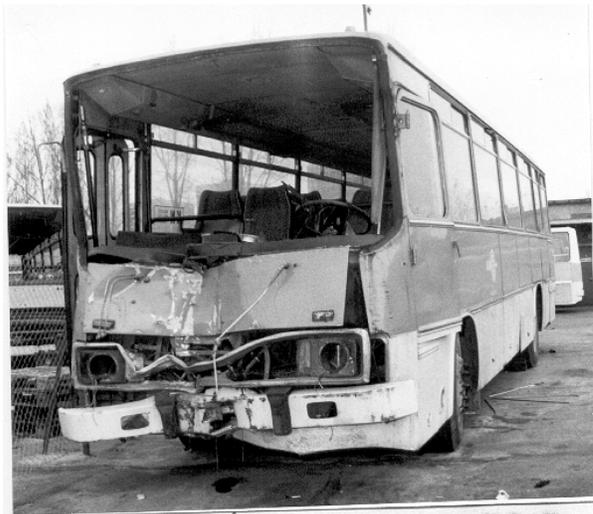
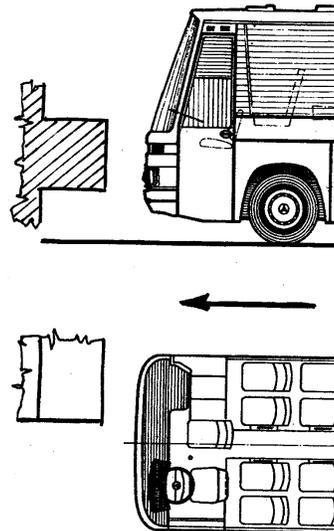
2.3. Collision on the service door side with HPO

Similar (symmetrical) situation as it is described in para. 2.2. but on the other side

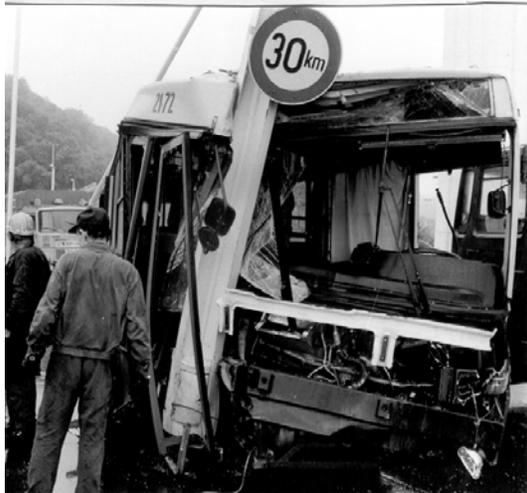
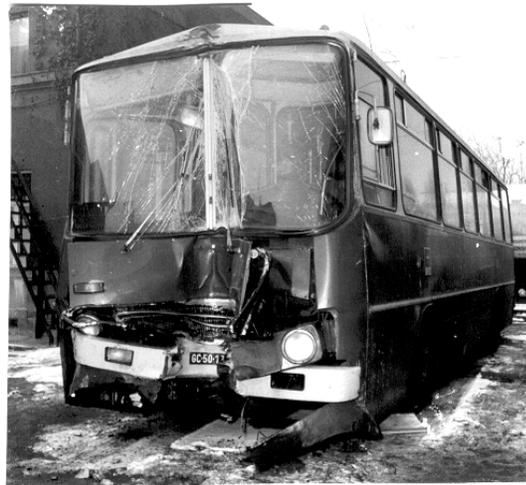
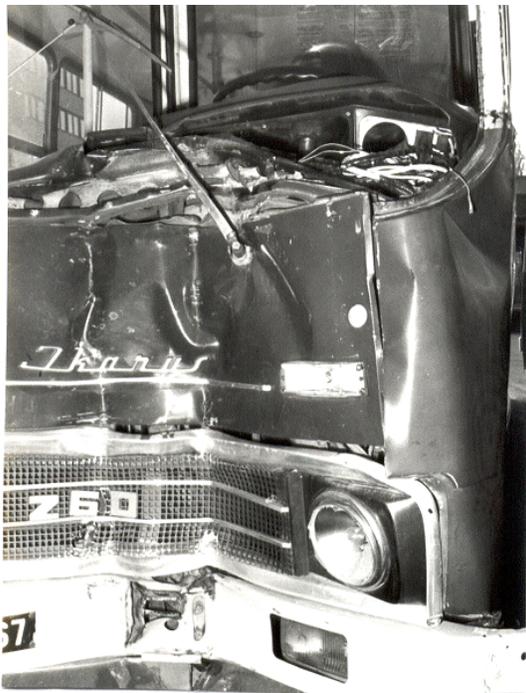
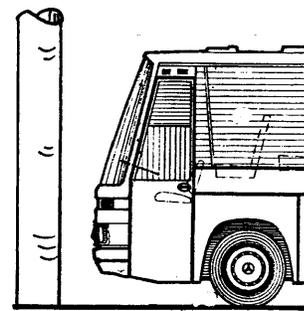
3. Collision with pole-like objects (PLO)

The pole-like object is a rigid, strong vertical object, higher than the front wall of the bus having the width (diameter) in the range of 150-300 mm. There are three characteristic hitting position: between the longitudinal members of the underframe structure (central position "B") and side positions either on the DC (position "C") or on the service door side (position "A"). The deformation of the front wall caused by PLO is a special, deep intrusion, so it is local, partial one. These type of objects in the practice: three, concrete or steel pillars, pylons, poles supporting electric or telephone cables, etc.

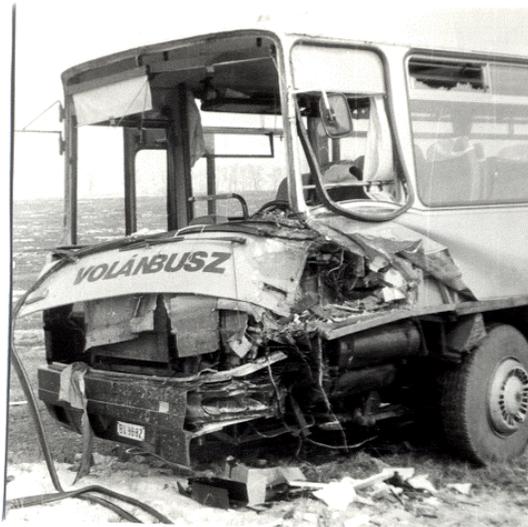
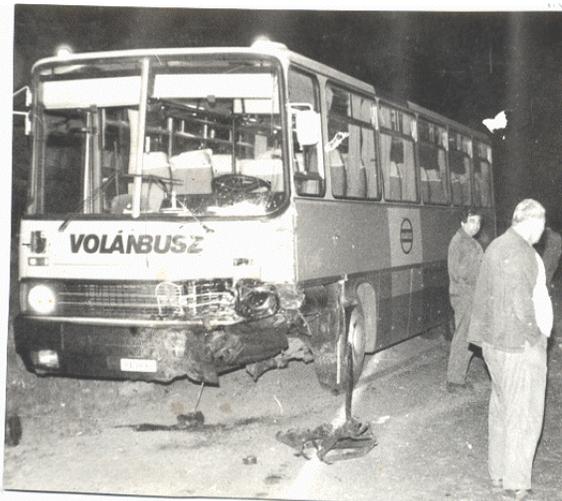
4. Underrun-like collisions

The hitting object is smaller, lower than in the previous cases, but it represents a considerable impact force and energy. The impacting surface is limited in width and height, the important situation is when it is on the DC side. The impact force may act parallel to the longitudinal central plane of the bus or under a certain angle to that. (Sometimes the symmetrical situation on the service door side should be also considered) In this case the main impact is concentrated in the bumper zone, the damage is local, mainly under or in the floor level of the DC.
