**National Highway
Traffic Safety
Administration**

Informal document No. GRSG-93-06
(93d GRSG, 23-26 October 2007,
agenda item 3 (a))

Subject: "NHTSA's Approach to Motorcoach Safety" Date: AUG 6 2007

NHTSA's Approach to Motorcoach Safety

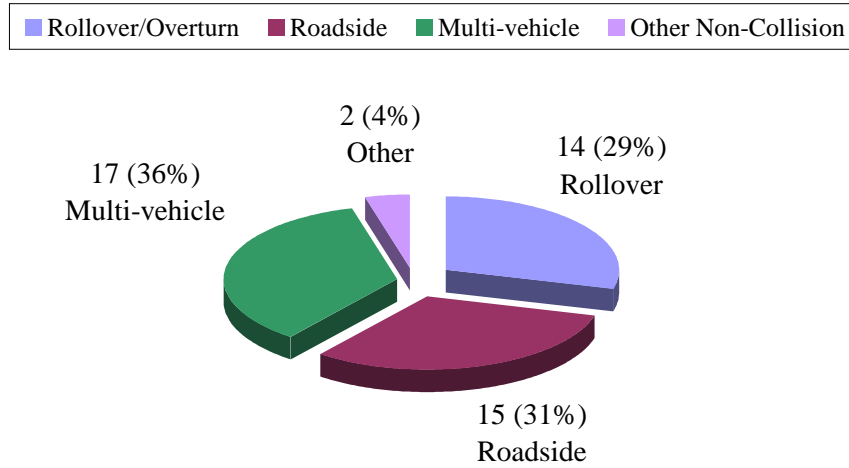
Most Harmful Event, Motorcoach Crashes (FARS 1996-2005)
48 Events, 146 Fatalities

Figure 2: Motorcoach crashes by most harmful event.

Figure 2 shows motorcoach crashes by most harmful event over the years 1996-2005. Multi-vehicle crashes, roadside objects, and rollover/overturn are all within 7% of each other for percentage of fatal crashes where these are the most harmful events.

⁴ In one rollover crash, impact with a tree was the most harmful event. That event has been included in Figure 4 even though it was included in the “Other” category in Figure 2.
