Informal document **GRSP-57-12**
(57th GRSP, 18-22 May 2015,
agenda items 3(a) and 13)

Pedestrian Safety

Bumper Test Area

Presented by the experts of OICA
for the discussion on gtr No. 9 and UN R127

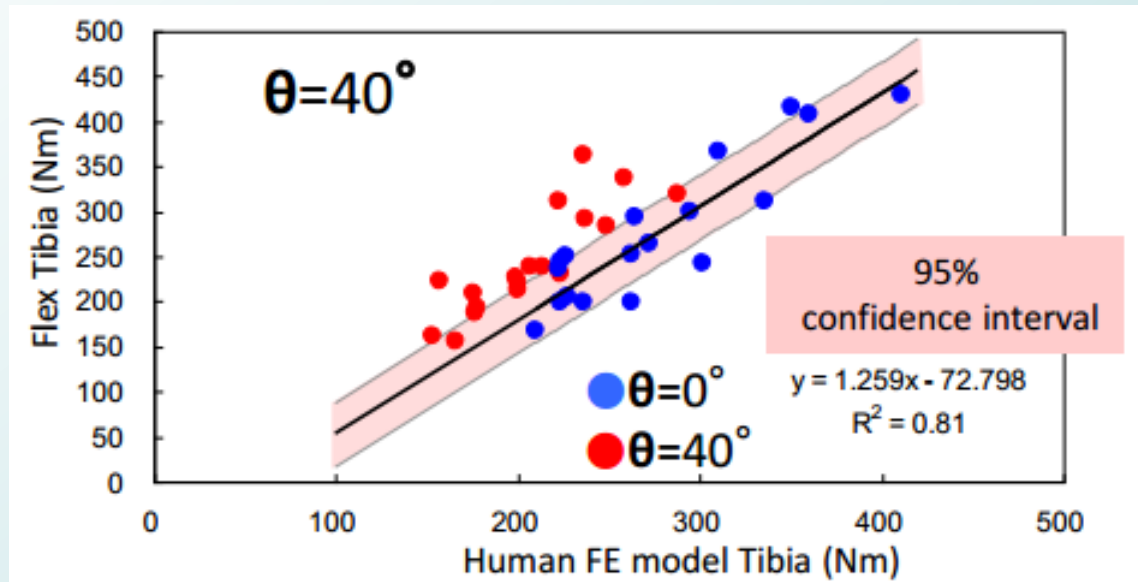
Reference: GRSP-56-03
(Japan for GRSP)

Issue: Test Result Confidence

- At impact angles above 30°, FlexPLI test results have a limited confidence
- There is no specific angle outside 30° to be identified from which the degradation occurs
- It is generally agreed that FlexPLI confidence level and reproducibility are acceptable in areas with surface sweep less than 30° to the lateral plane

- Confidence of FlexPLI at impact angles $> 30^\circ$ is deteriorating
- Test scatter at impact angles $> 30^\circ$ is increasing, resulting in much reduced repeatability and reproducibility
- Behavior of FlexPLI at impact angles $> 30^\circ$ is not biofidelic
- Data shows that the effectiveness of design measures addressing FlexPLI impact behavior at impact angles $> 30^\circ$ is limited
- Reliable, reproducible and repeatable tests require engagement of full width of the legform against bumper beam
- The Bumper Test Area decided on in the previous session of GRSP lacks a sufficient cost benefit analysis

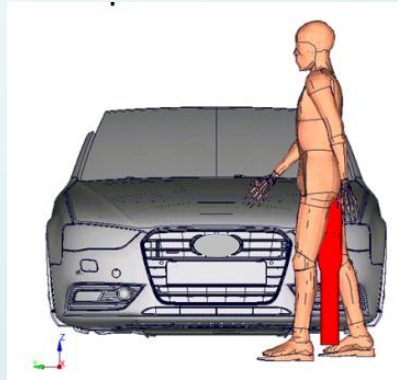
- The FlexPLI is designed to have a two-dimensional behavior to assess surfaces impacted or swept close to the normal angle (which was also observed with the EEVC LFI)
- Rotation of and within the flexible legform impactor has never been proven to be compliant in terms of biofidelity and differs to full body simulation kinematics

Comparison of human model and impactor model simulation; reference: TF-BTA-3-03r1 (OICA for IG sub-group)

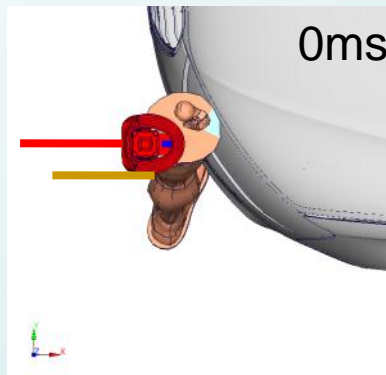
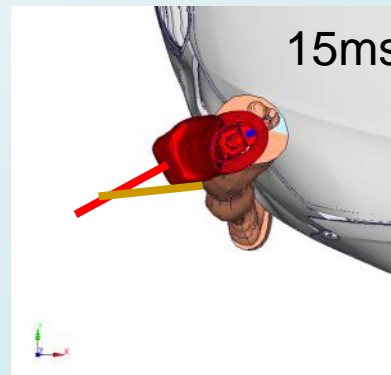
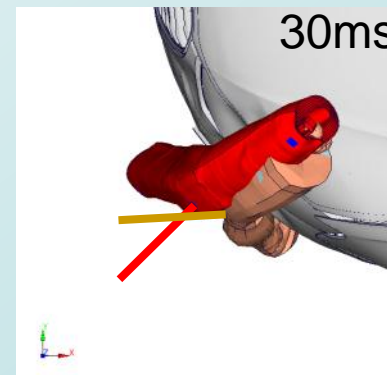
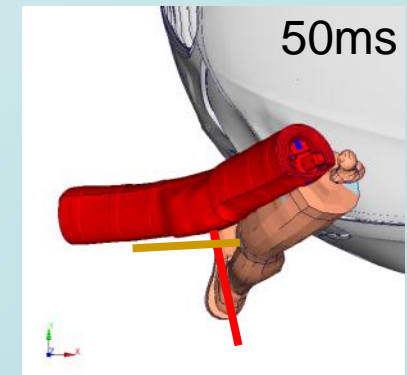
Issue: Impactor Behavior @ High Angles (Simulation)

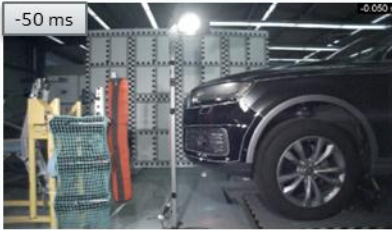
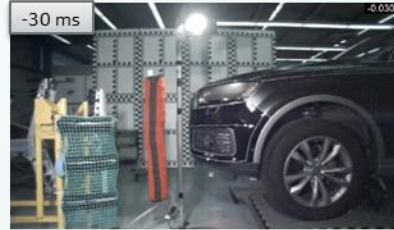
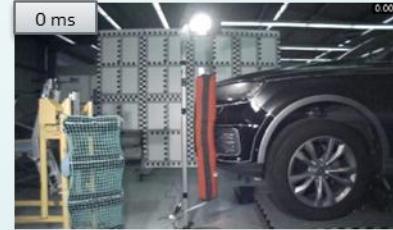
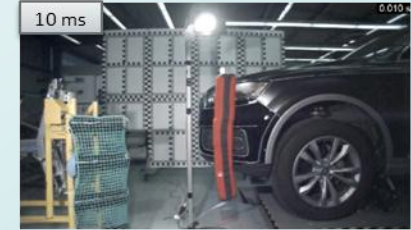
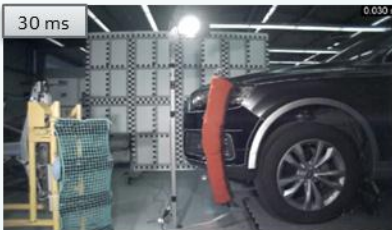
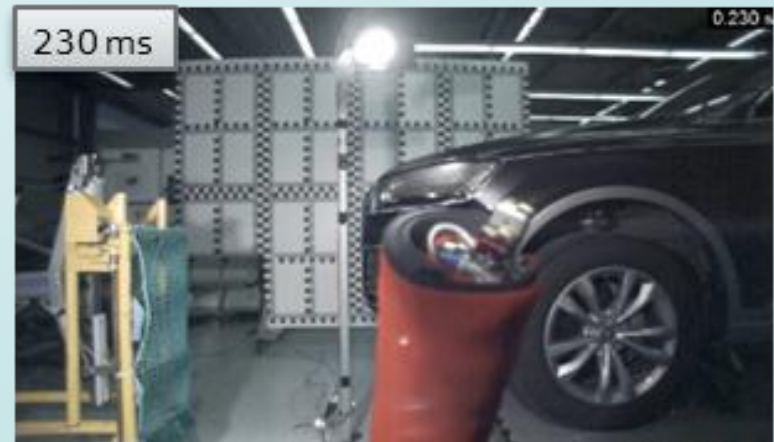
Issue: Impactor Behavior @ High Angles (Testing)

- Testing of surfaces with extreme angles results in an uncontrollable behavior of the impactor which creates the risk of equipment damages

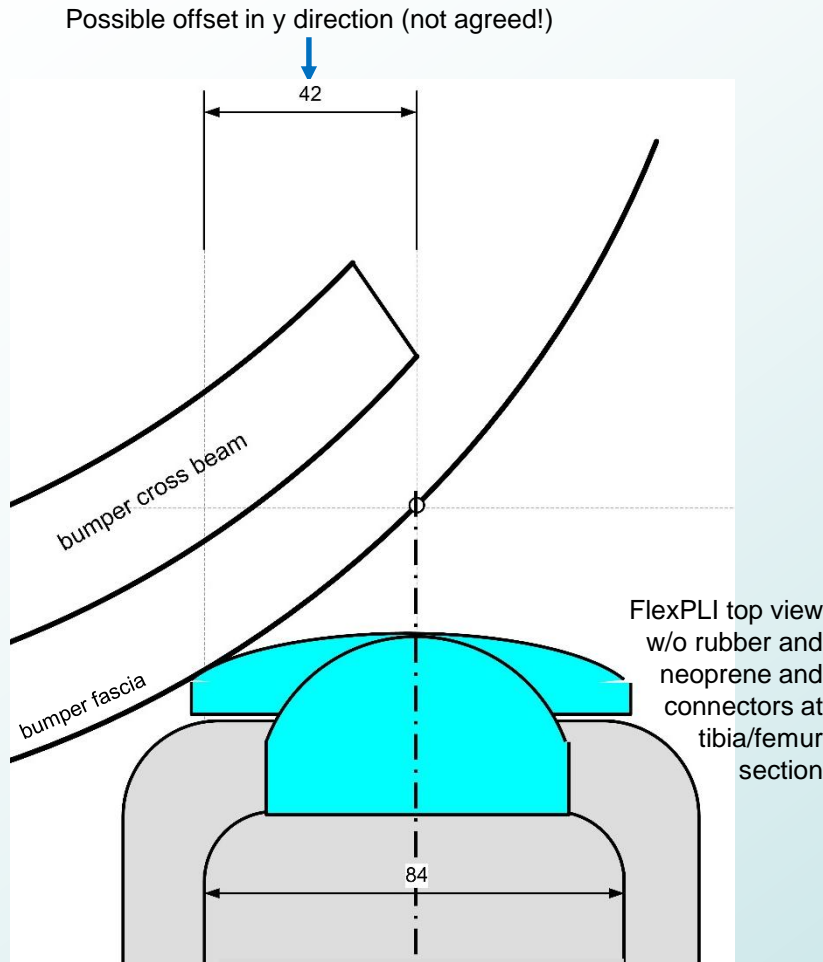
- Due to the new definition of the test area to reach as far as bumper beam the FlexPLI impacts the surface at an angle greater than the justified 30°
- Areas result with limited contact of the vehicle to the legform
- This may result in occurrence of total and relative rotation of the leg as well as sliding along the surface
- This may also result in glancing blows outside the 30 degree area which produce inconstant, non-repeatable data
- Reliable, reproducible and repeatable tests require engagement of full width of the legform against bumper beam

Example: Bumper beam ends at a FlexPLI impact angle of about 45°

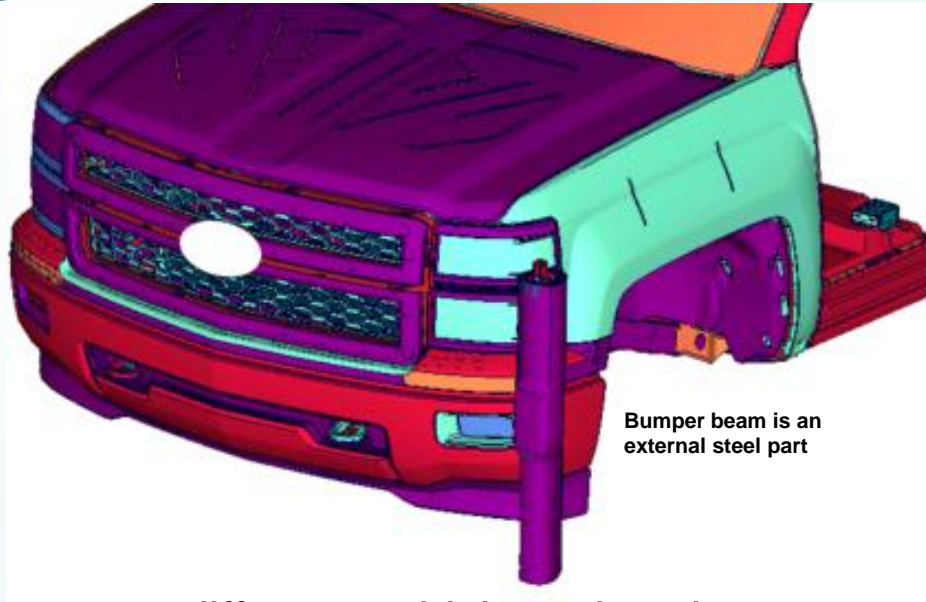
- To respect different vehicles other than consumer metric optimized fleet of European vehicles other markets with specific needs should also be reflected
- Assuming the bumper beam to be the limit of the zone the very outer end will be assessed by glancing blows
- Also, a pedestrian hit by that area of the vehicle is unlikely to have head contact on the bonnet
- Gain in protection in percent is even less than for Europe but assessment of those front ends is even more ambiguous

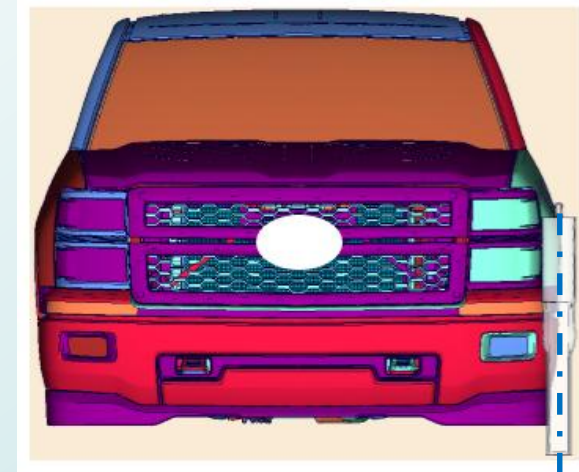
For this vehicle, an offset of 42 mm along the contour (as discussed in TF-BTA) would change the measuring point by 4 mm in y-direction

- In order to mitigate the test tool limitations, it is suggested to at least come back to the proposal already discussed in TF-BTA and GRSP:
For the measuring point, an offset of 42 mm in y-direction into the test area should be generally acceptable
- Given the technical uncertainties shown in this presentation, compliance with the new bumper test area definition would need changes to the bumper shape, requiring a full duration of vehicle development for transitional provisions. Thus, OICA proposes the transitional provisions of 1 Sept. 2019 for new models
- GRSP may think about disregarding test results outside 30° impact angle when achieved with the FlexPLI in its current build level
