Informal document GRSG-107-22,  
(107th GRSG, 30. Sept.-3 Oct., 2014  
agenda item 5)

# **Panoramic Sunroof Issue**

**OICA/CLEPA-comment on the national defect investigation and the proposed amendments to toughened glazing by the Republic of Korea**

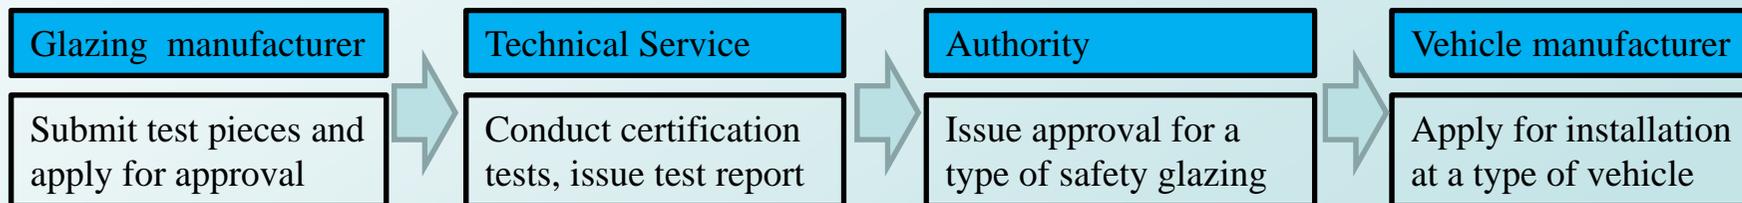
- Certification Tests to be passed by toughened glass according to ECE-R 43 and other international regulations:
  1. Fragmentation test → to avoid injuries by sharp edges of a broken glass
  2. Light Transmission
  3. Mechanical strength (227 g ball-impact test) → to ensure that objects (e.g. stone chipping) do not penetrate into the occupant compartment
- ECE-certification approval process

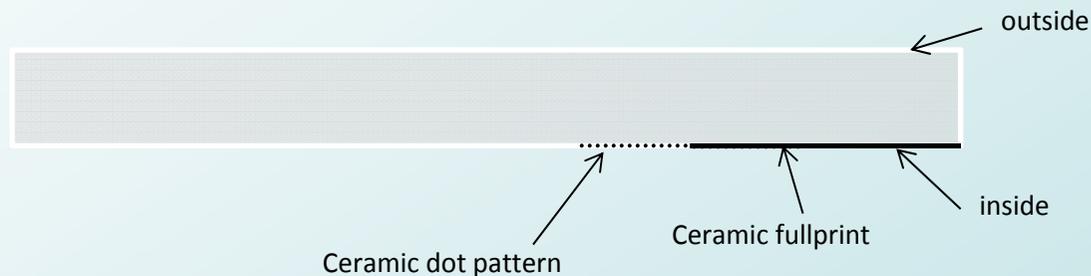
Figure 01: structure of a printed glass

- Figure 01 shows a typical glazing structure. Underneath the glass pane (inner face) a ceramic layer is located.
- Figure 01 is typical for each glazing element and not only for sunroofs. It is also representative for backlites, sidelites, etc.

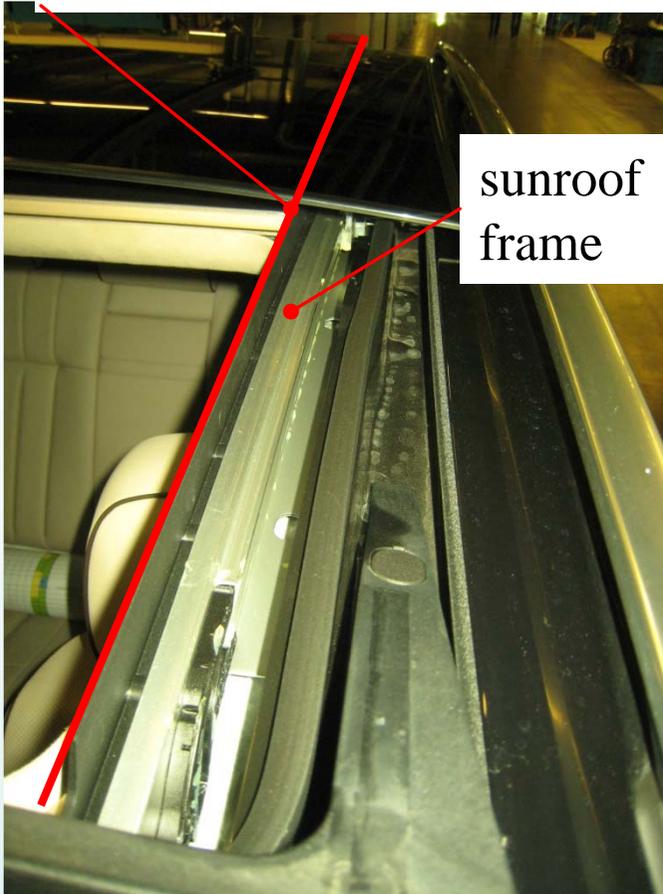
limitation ceramic area

## Size:

- Design aim is to keep the ceramic area as small as possible to provide customers a maximum large transparent area.
- Ceramic area is limited to cover hardware such as vehicle body and interior trim parts.

- Objects which impact the coated area cannot intrude into the vehicle cabin, because hardware such as vehicle body and interior trim parts are covered.
- If the glass breaks, it fragments into small harmless pieces.

- The ceramic area has both a design and a protection function
- **Design Character**
  - Ceramic area covers and hides hardware behind the glass such as parts of the vehicle body and assembled trim parts.
- **Ceramic protects**
  - Protects against UV Radiation: Important for organic materials like polyurethanes (encapsulation material) and the adhesive bead/glue which connects the glazing with the roof frame.

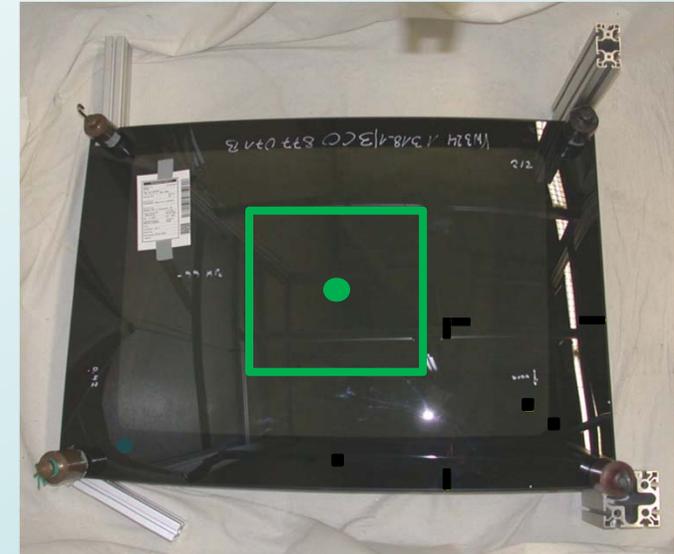
**ISO 3537:** „The point of impact shall be within 25 mm of the **geometric center of the test piece**”

**UNECE:** Geometric center of the test piece or Geometric center of the finished product

**FMVSS:** (Geometric) Center of the Test Piece

**GTR 6:** As UNECE  
Center of supported area (error on Page 34  
→ wording needs to be corrected)

**KOR Proposal :** Center of the supported Area (**GRSG 106-10, GRSG 107-06**)

- According to international standards, the point of impact is the geometric center of the test piece
- The Korean proposal includes the typing error from GTR 6
