TA LLC JV “Anzob”

Tailing Pond

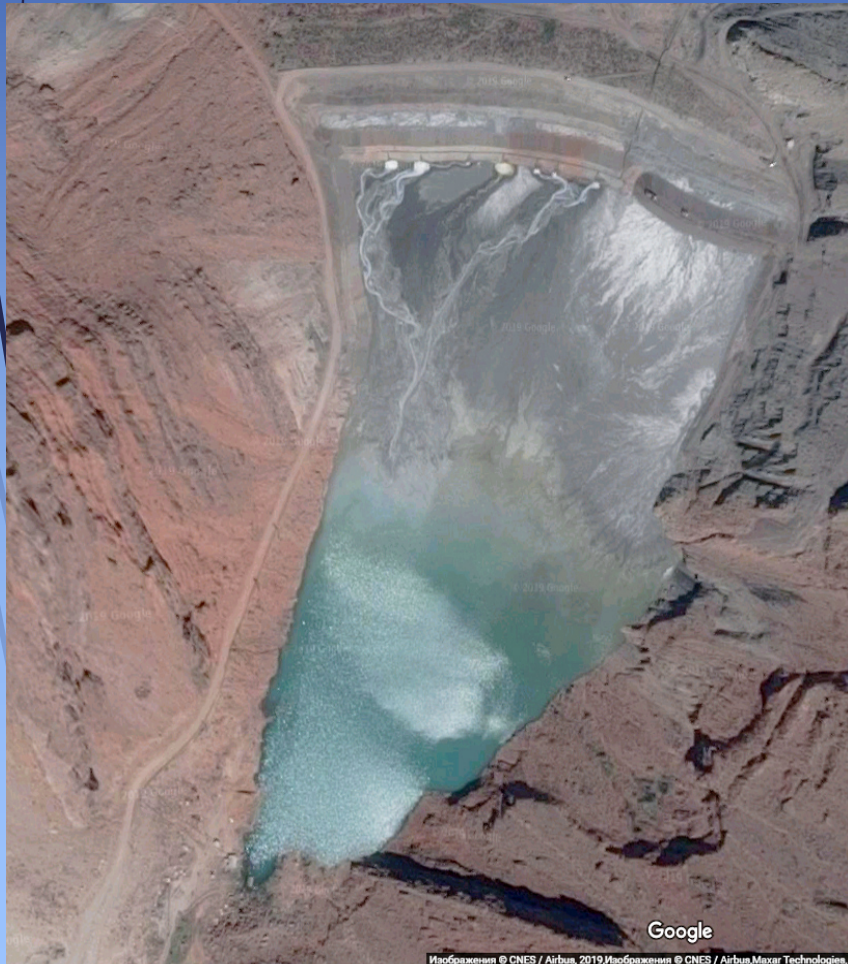
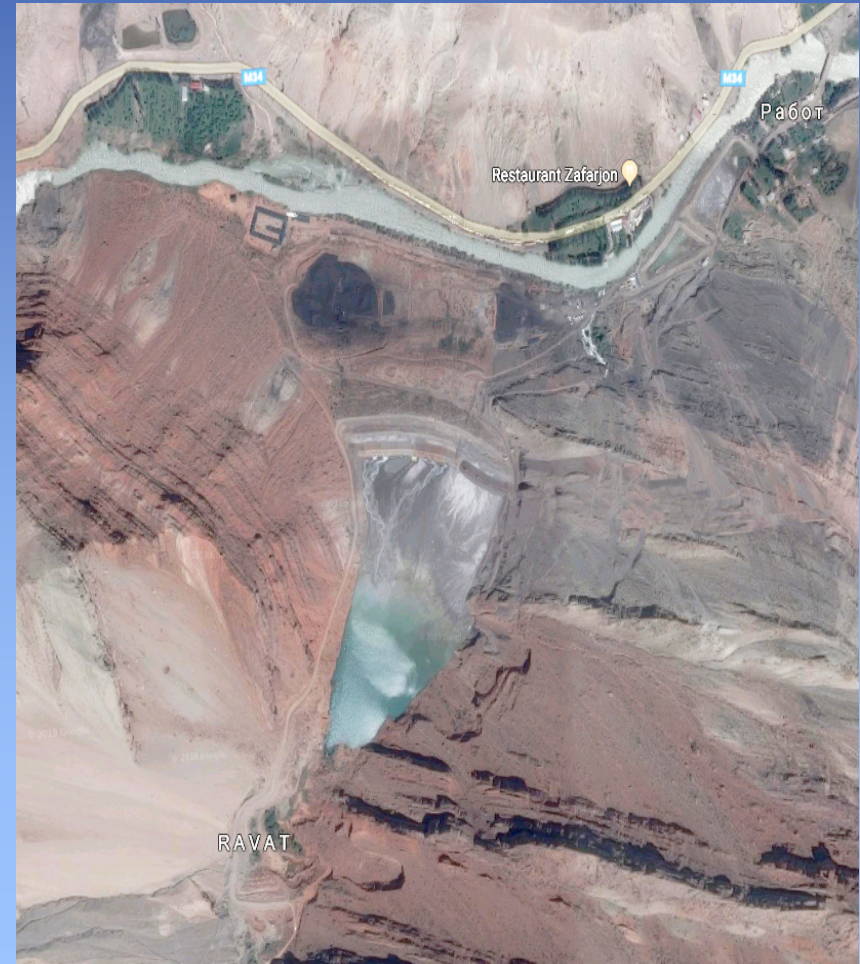
A dam with height around 45 m construed the Tailing Pond's 1st line. Refer to the type of tails being stored the Tailing Pond is a liquid. The width of the dam at the bottom is 50-60 meters, at the top - from 12 to 18 meters. The length of the dam is around 400 meters.

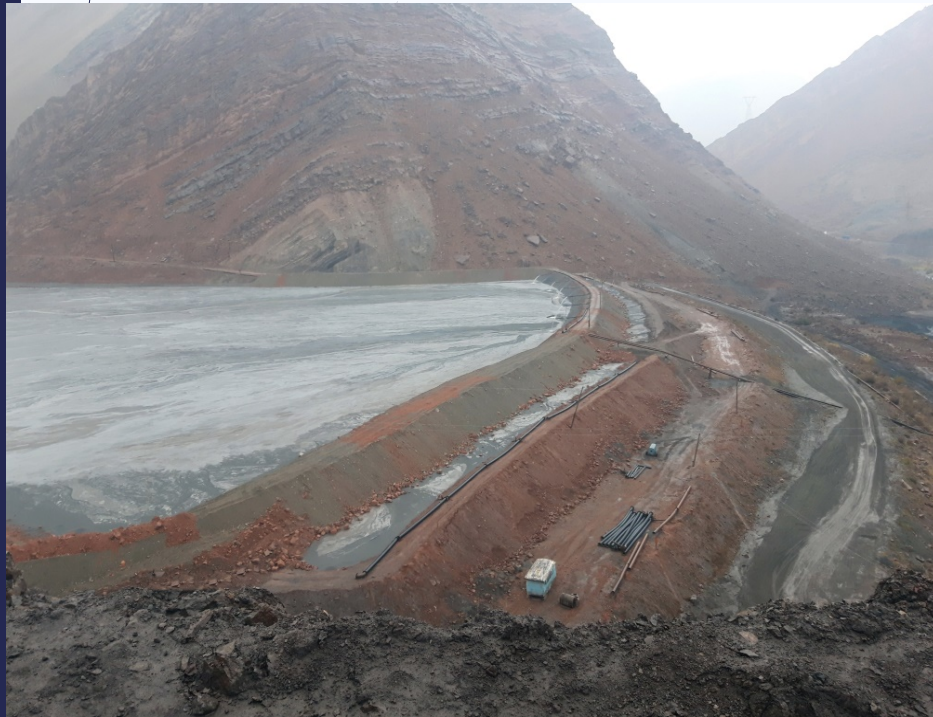
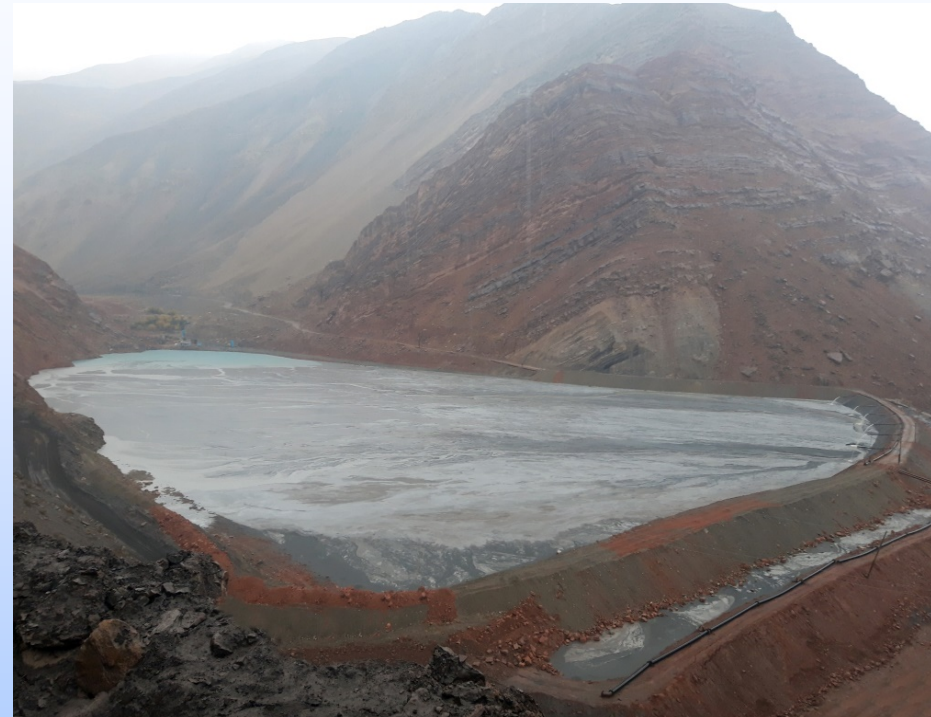
Tailing Pond

Composition of the filling soil consists mainly of rocky soil of various solid, crushed stone soil, sandy and clay materials.

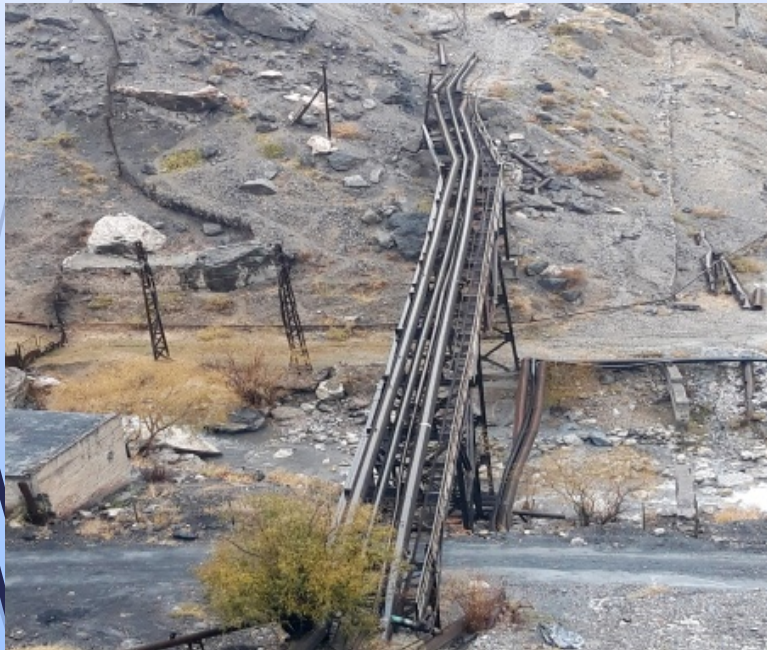
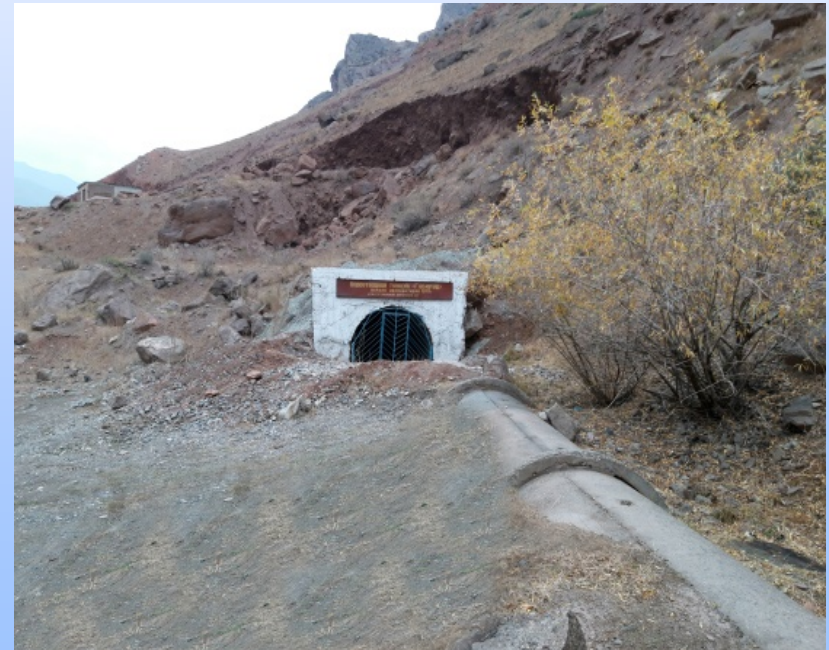
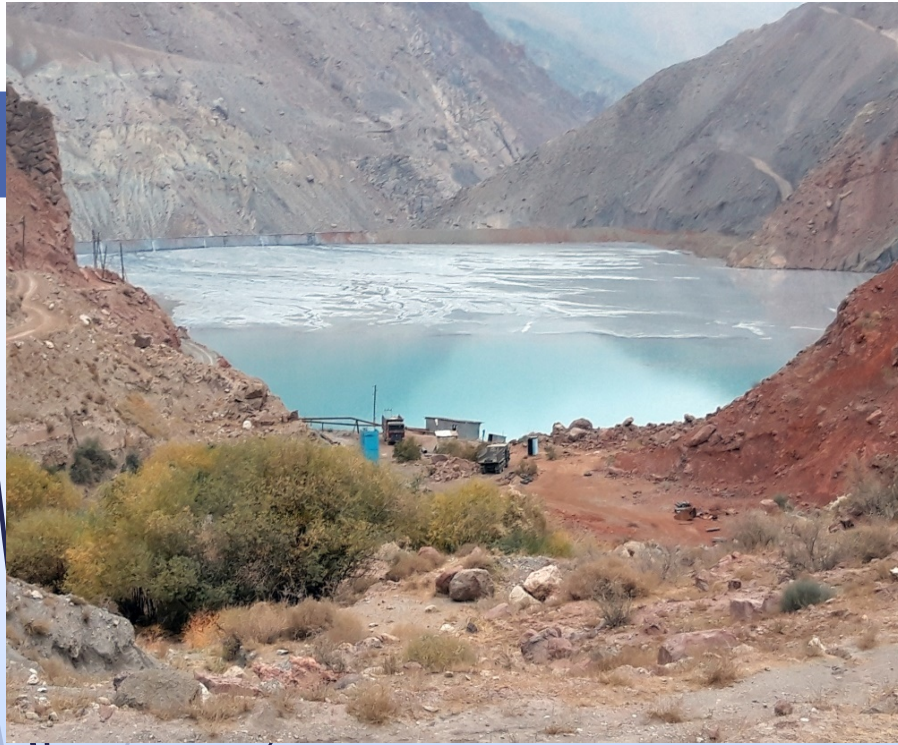
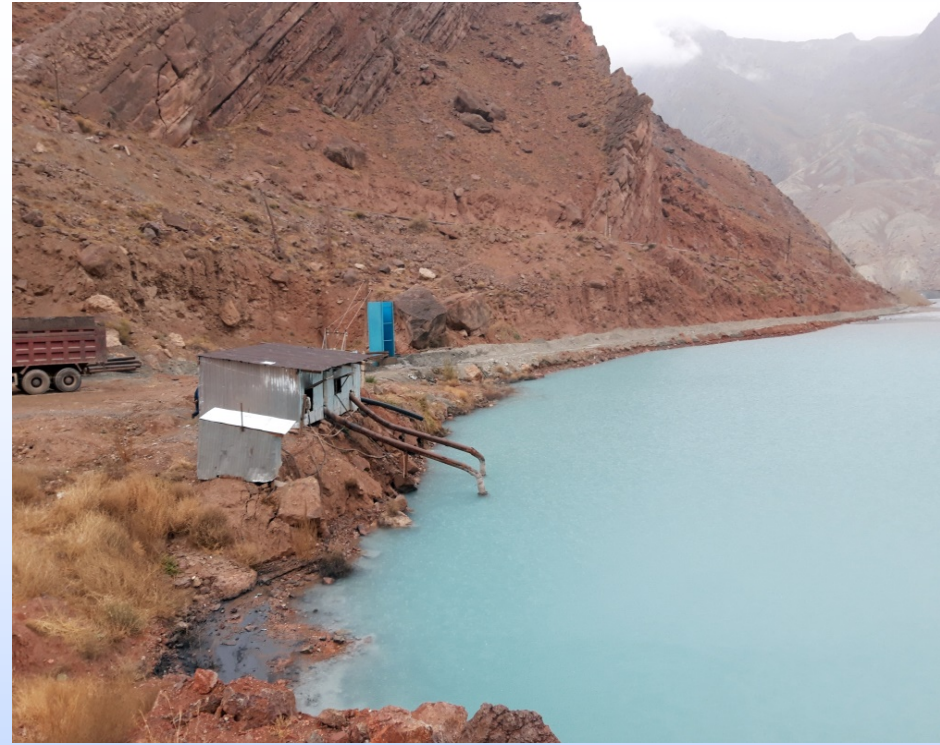
For the storage of production wastes of processing (tails) according to the project of Institute «Kazmehanobr» the 1st line of Tailing Pond was constructed and commissioned in 1986 at 6 km from the Processing Plant. For natural water diversion and not falling into Tailing Pond it was passed and completed 1250 meter reinforced-concrete tunnel with two drainage channels.

- Tails supply is conducted through pipeline by pumps.
- There is an operating recycling water supply system of closed cycle.
- Pump station is settled inside the Tailing Pond.
