IWG Safer Transport of Children in Buses and Coaches

Fifth meeting 28/01/2021 OICA

OCRS installation in buses & coaches

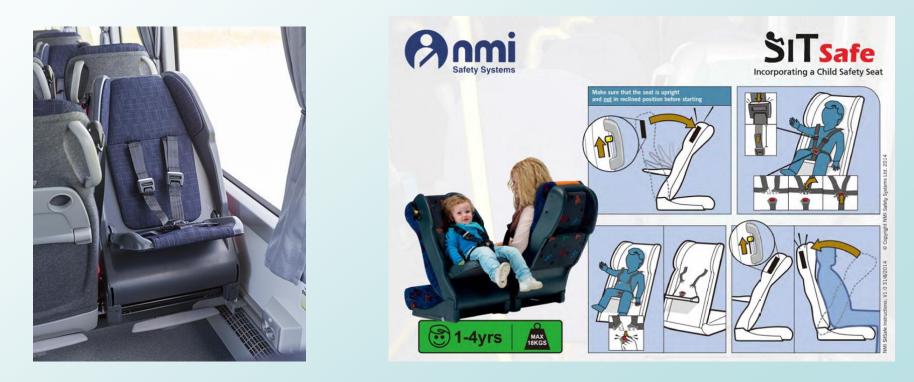
Influence on interior arrangements of buses 5) In-vehicle child seats CRS-bus approval shall follow prescriptions on UN R 80 – basis, shall be technology neutral and not focused on existing R 129-CRS

Eg: SiTSafe as a solution for option in Nordic bus procurement requirements « At least 2 child seats for 3 years of age (UN-R44) »
