FPS **MOBILITY AND TRANSPORT**
DG **ROAD TRANSPORT AND ROAD SAFETY**

Changes (substantial) WP1 on the EGRSS
final report & proposal for Annex 1 & 3

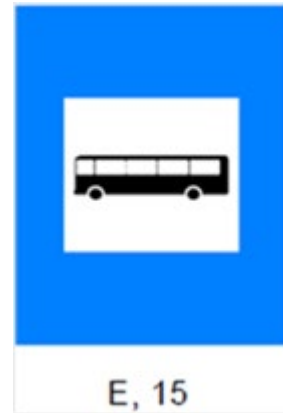
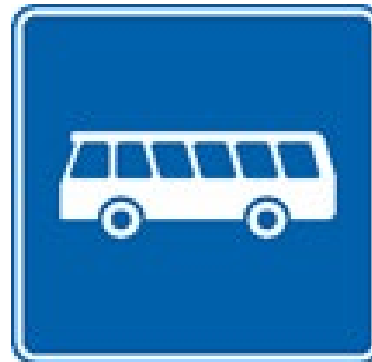
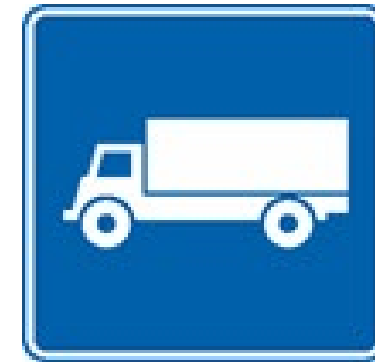
1. The depictions of E, 11; and E, 16 signs do not follow the general characteristics of E signs . To this end, the Group recommends changing the depictions to be in line with the general characteristics of E signs (see subsection 1.2 of this document on amendments to Annex 1 and 3 of the Convention, section E, paragraphs II.9 and II.13). **The same goes for the E,15 sign, however, to avoid confusion with the additional panels H, 5 and the use of the symbol of the bus on the G, 18 sign, the E, 15 sign will be kept as is.**

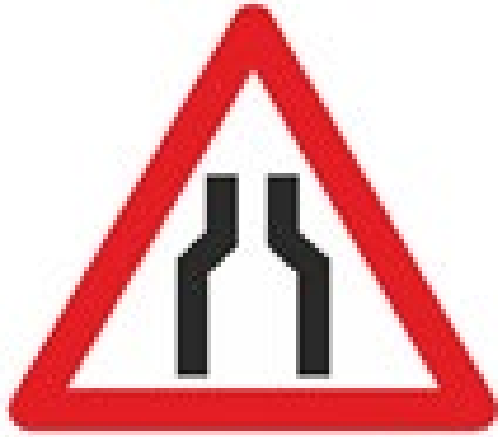
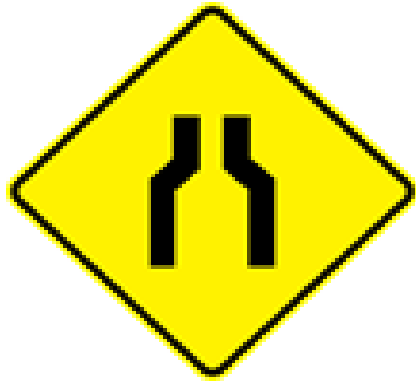
A, 4 a (A-04.1) gives warning that the carriageway ahead is narrower **on the left hand side and on the right hand side**. This sign shall not be used for indicating lane reduction ahead.

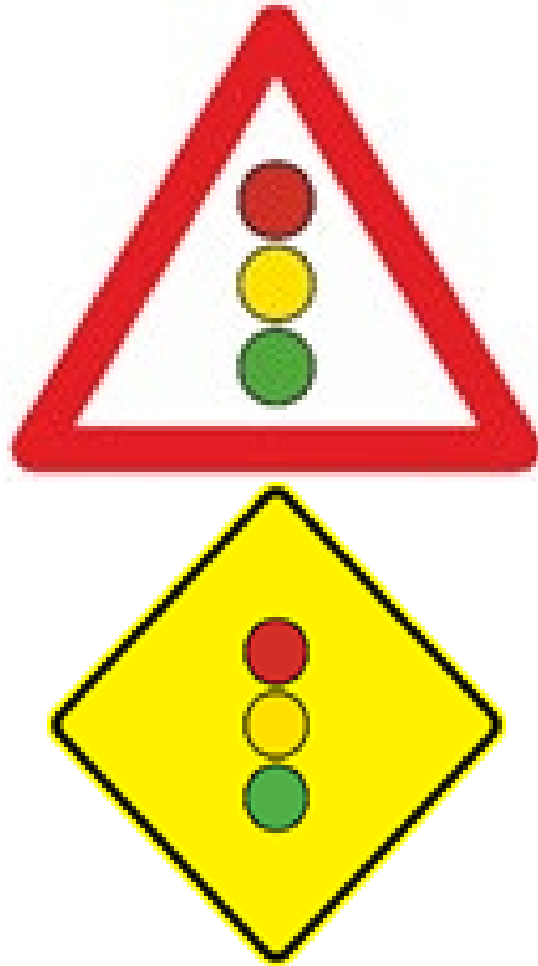
A, 17 (A-17.0) gives warning of a section of road on which traffic is regulated by three-colour traffic light signals. **The symbol shall be in the three colours of the traffic lights of which it gives warning. These three colours ~~symbol of traffic lights signals~~ shall be surrounded by a dark colour narrow strip.**

This sign shall only be used on road sections on which road users would not expect traffic light signals. **~~The symbol shall be in the three colours of the traffic lights of which it gives warning.~~**

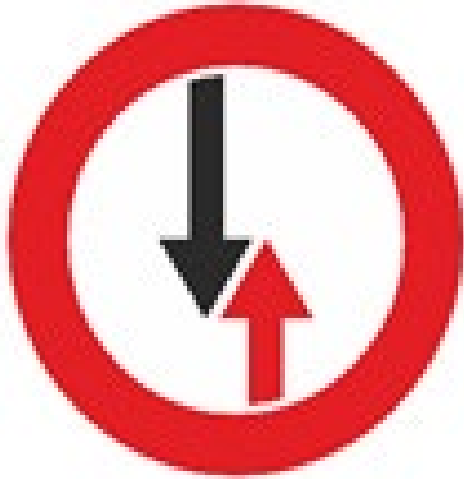
These signs must have a short red arrow.

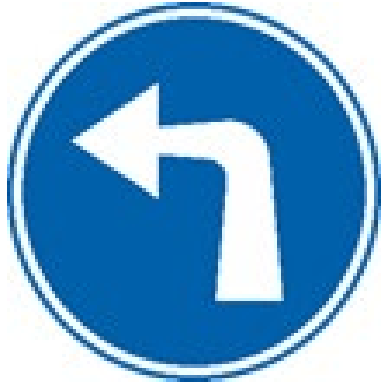
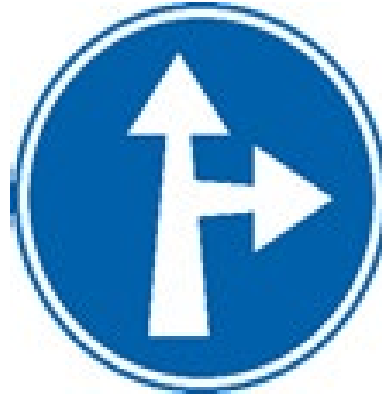
D, 1 a (D-01.2) notifies that the only direction in which vehicles are obliged to proceed is to the **forward** left.

D, 1 a (D-01.3) notifies that the only directions in which vehicles are obliged to proceed are **forward** left or straight

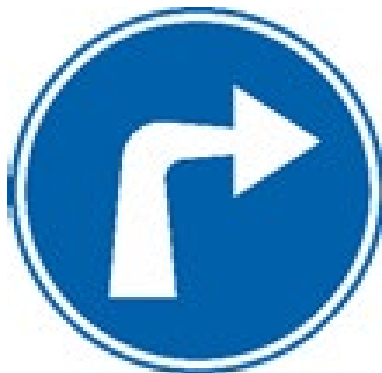
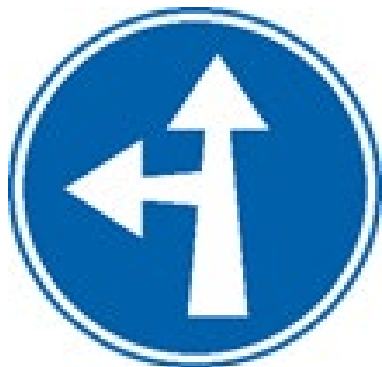
D, 1 a (D-01.6) notifies that the only direction in which vehicles are obliged to proceed is **forward**-to the right

D, 1 a (D-01.7) notifies that the only directions in which vehicles are obliged to proceed are **forward** to the right or straight.

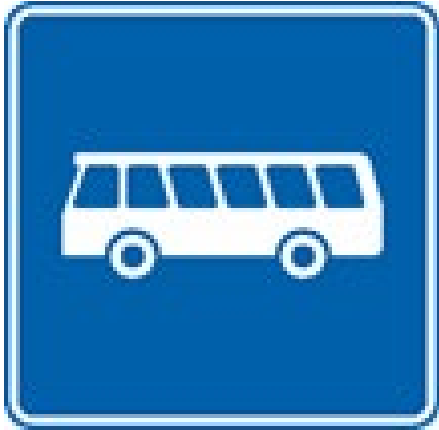
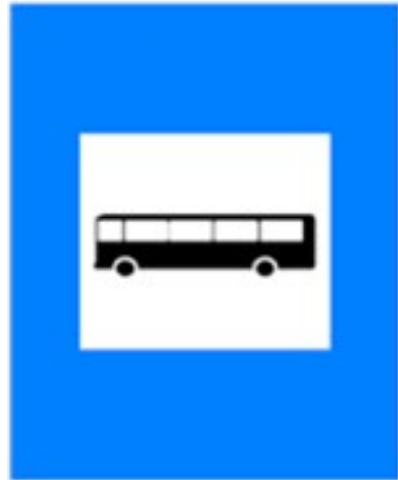
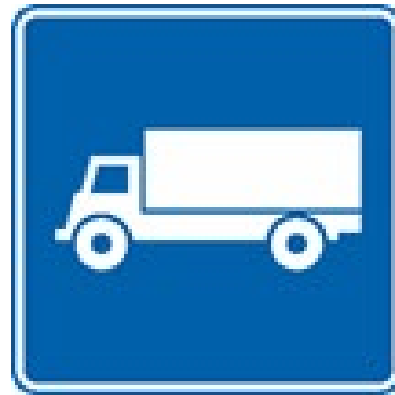
Sign E, 15 will be kept in its present form. As it cannot be mistaken with the advisory itinerary for buses, G, 18 (with the symbol of a bus).

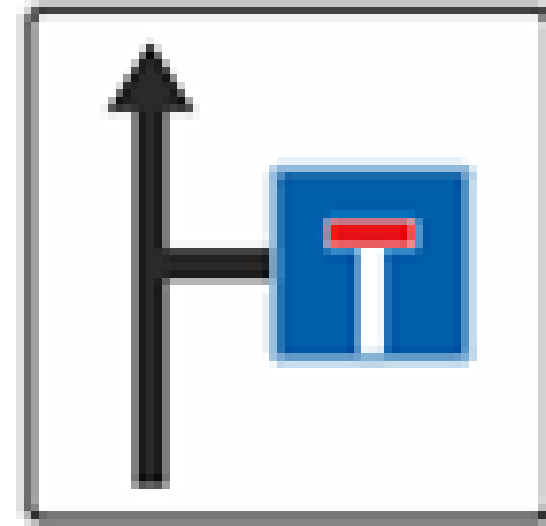
The sign with the white background is wrong and thus replaced by the correct sign on the left.

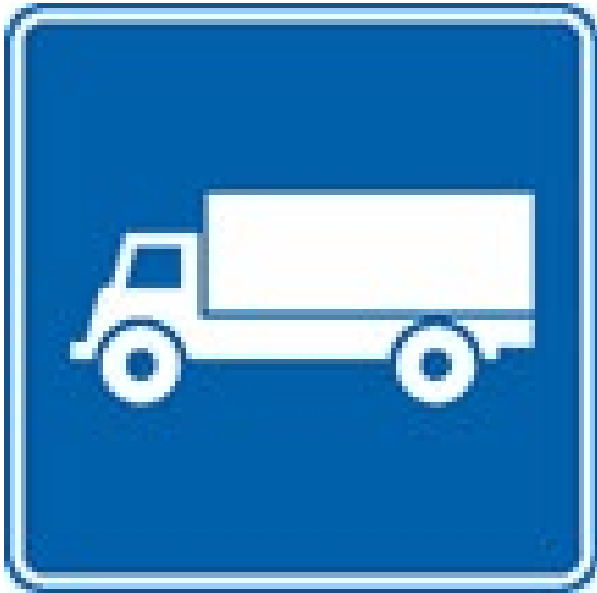
G, 18 (G-18.0) notifies **drivers of an advised itinerary for the type of road user indicated by the symbol displayed on the sign.**
